JAMES ROBERTSON PKWY. Crossing CUMBERLAND RIVER

Inspection Date(s): 05/15/2025 - 05/15/2025

IDENTIFICATION	
(1) State Names	47 - Tennessee
(8) Structure Number	19SR0060015
(5) Inventory Route	1
(2) Highway Agency District	Region 3
(3) County Code	19 - Davidson

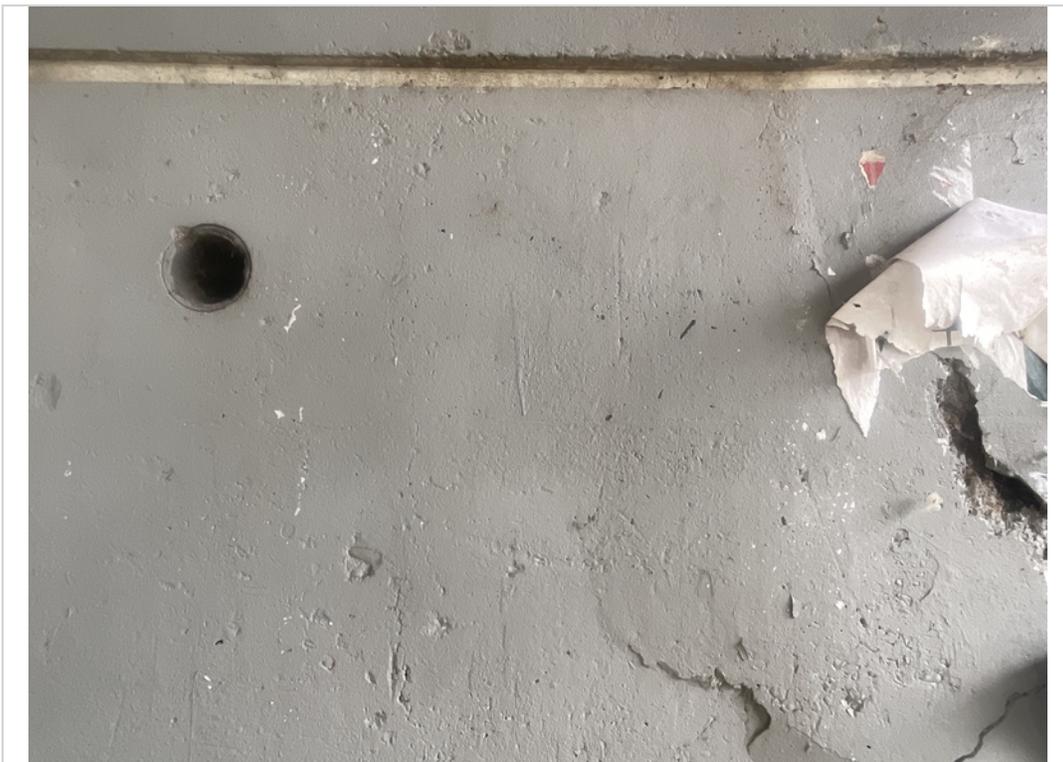
Bridge Number and Underwater Inspection Date have been Painted Over since the last inspection

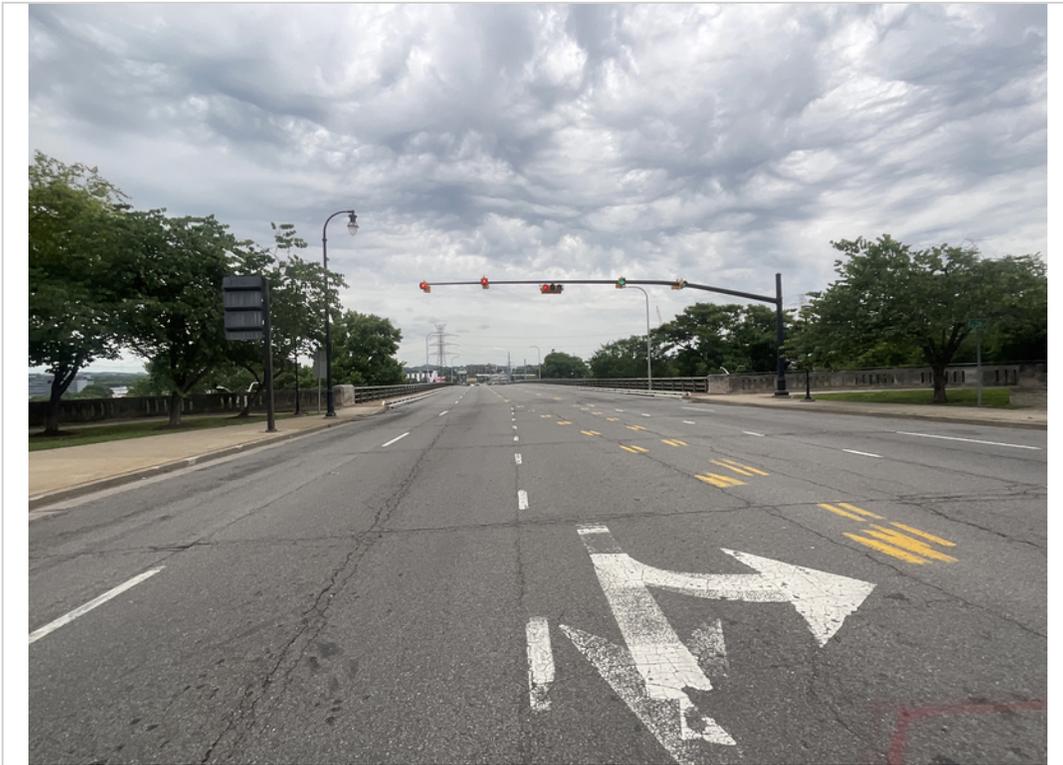
Approach1 Looking Ahead

The approach roadway alignment is Good with approach embankments in Good condition. The approach pavement is rated Fair due to numerous medium to wide longitudinal/transverse cracks, small shallow potholes, and numerous asphalt patched potholes. Approach drains at all four corners of the bridge are in Good condition. The concrete drainage flume on the left side at approach 2 has damage and minor settlement.

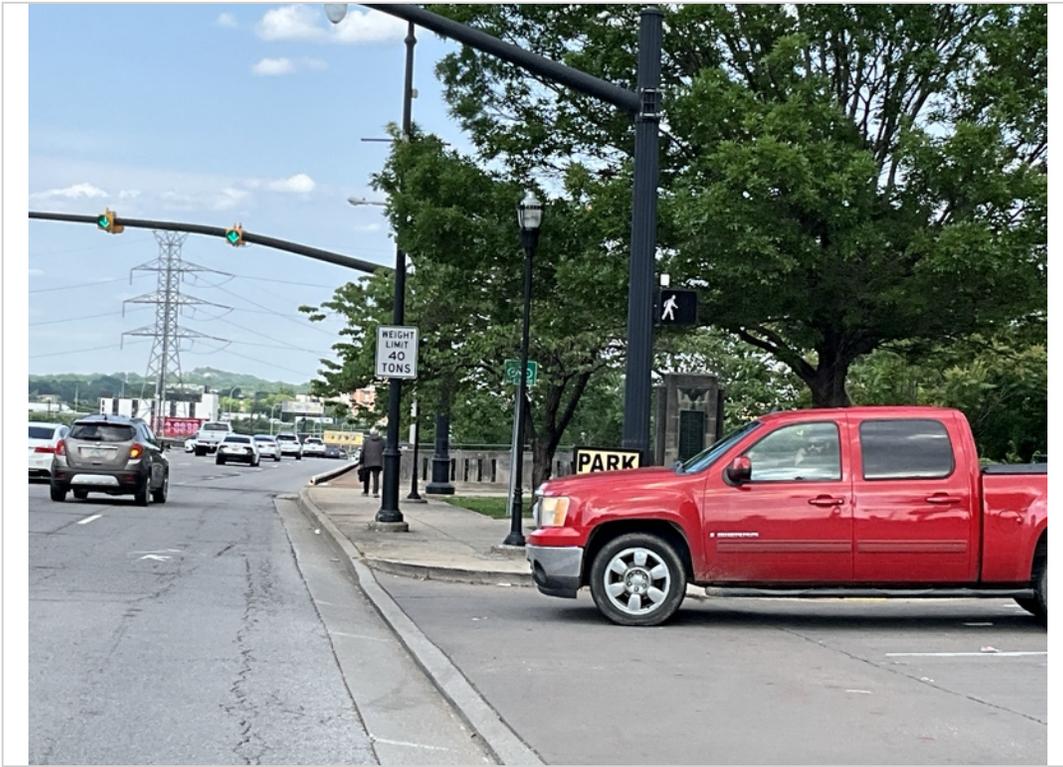
The bridge carries a total of 5 lanes of traffic and is currently load posted for 40 tons at both approaches. Gay Street is currently deficient in vertical underclearance with a minimum vertical clearance of 14'-6". Vertical clearance signs are posted on Gay Street at each side of the bridge for 14'-3".

'Weight Limit 40 Tons' Load Posting Sign at Approach 1

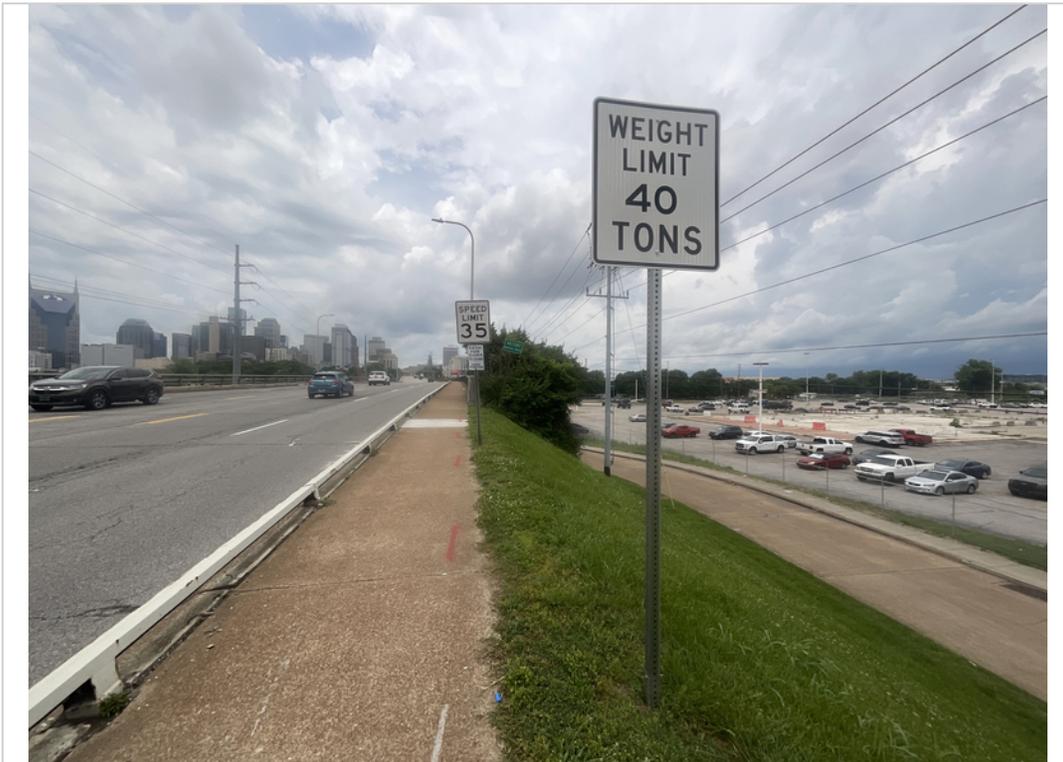
'Weight Limit 40 Tons' Load Posting Sign at Approach 2

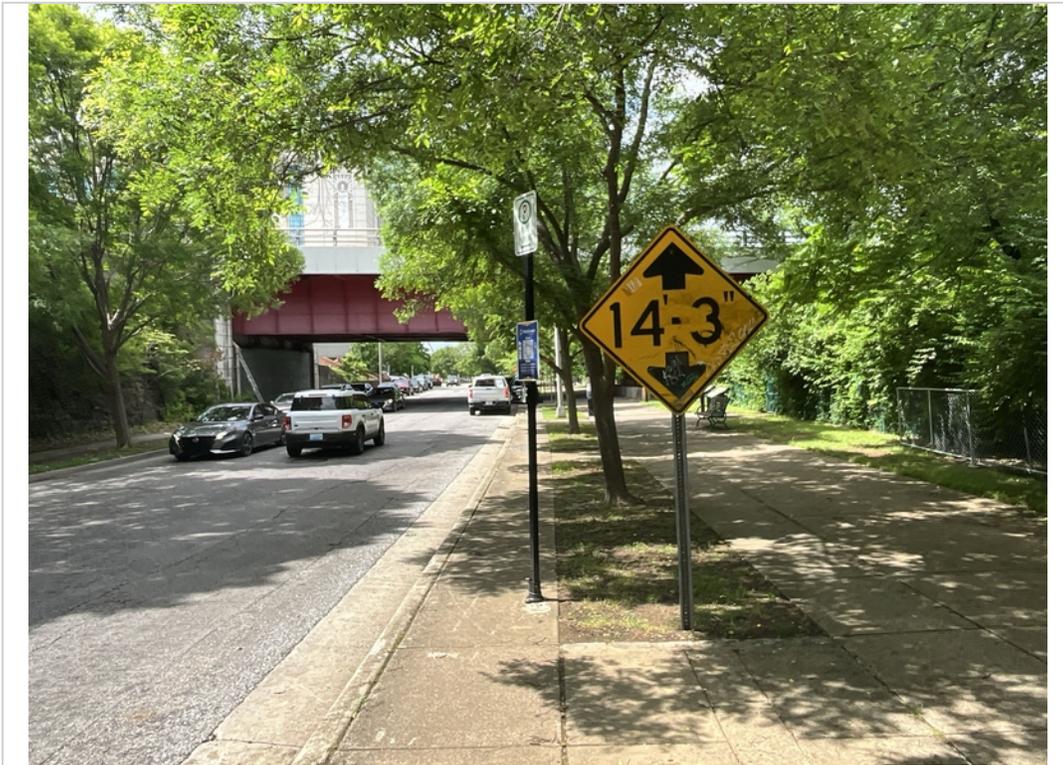
A 14'-3" Vertical Clearance Sign on Gay Street for Span 1, Right Side of Bridge

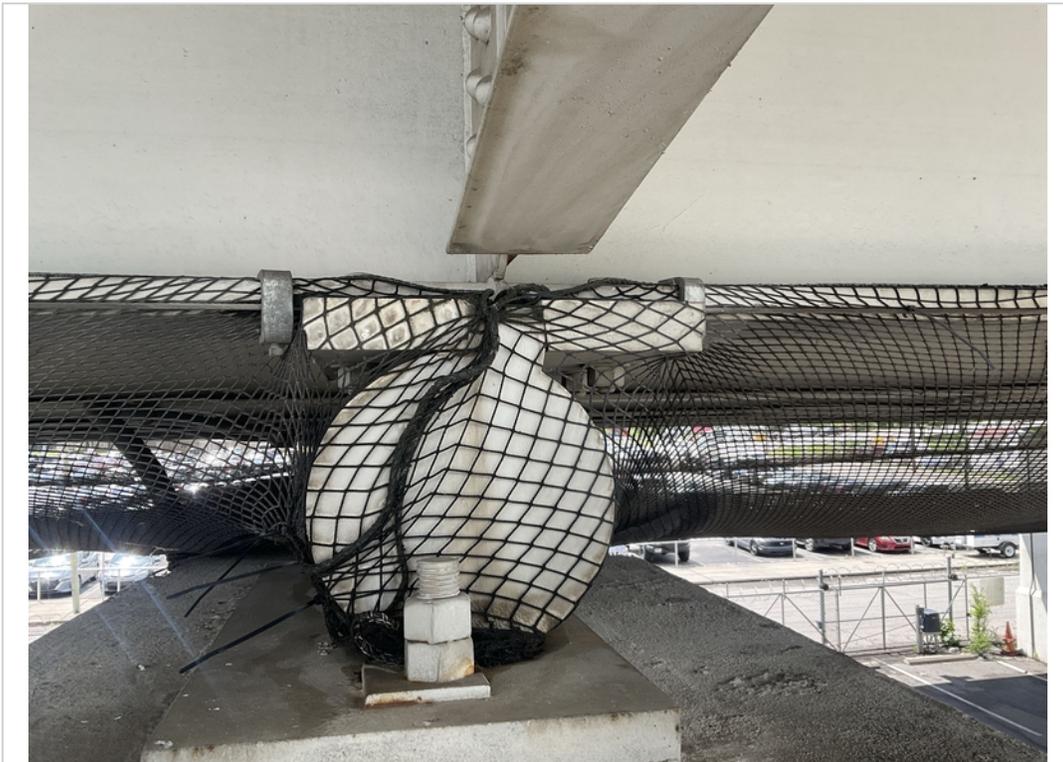
Typical roller bearings over extended ~3" back (showing exterior face roller bearing (Bent 14))

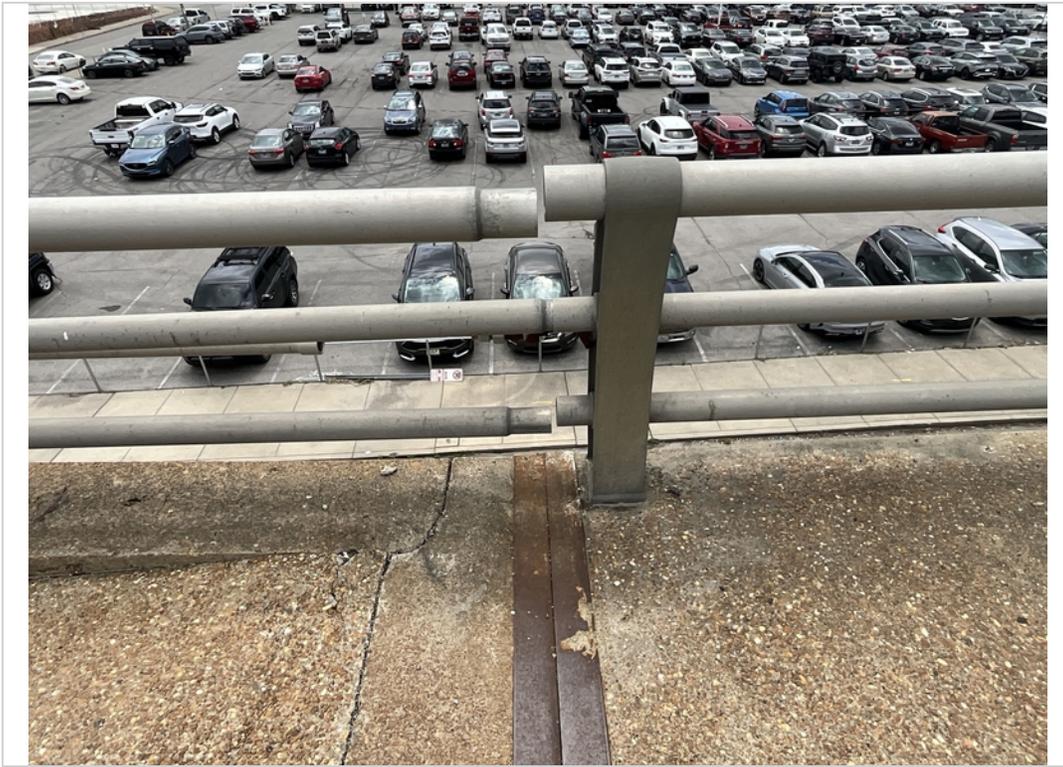
The bridge railing is in Good condition. There is an area of bridge rail separation directly over the abutment 2 joint on the right side. Other Traffic Safety Features do not exist for this structure.

Metal Bridge Rail Disconnected at Right Side above Abutment 2

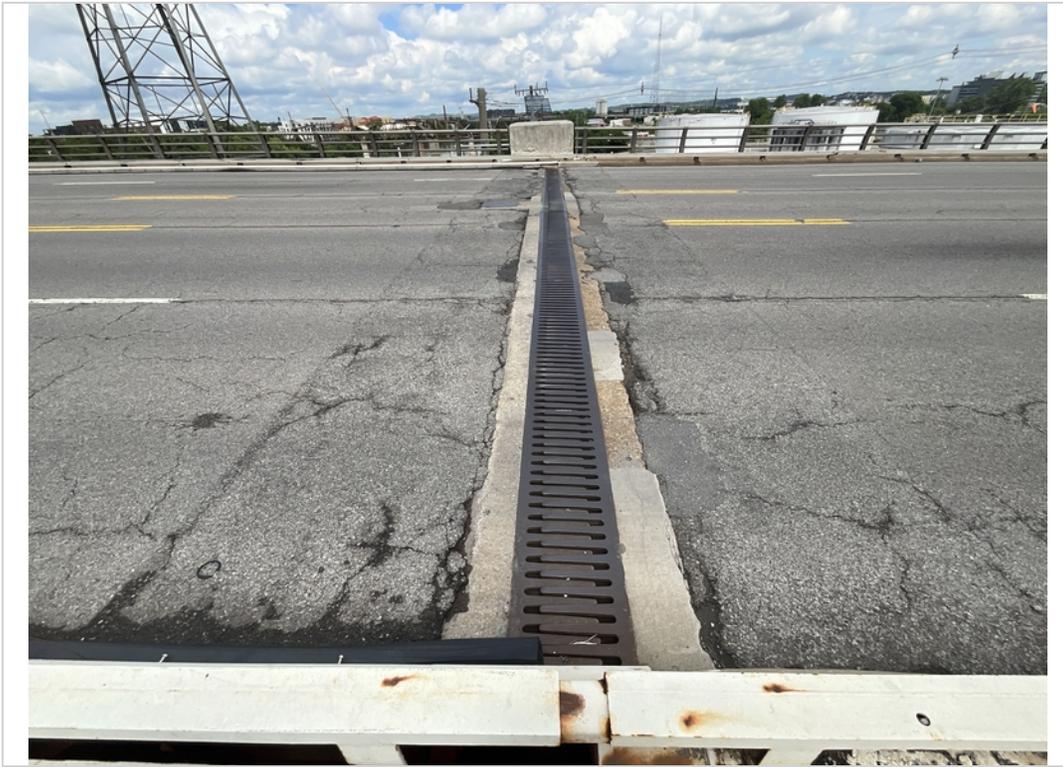
and 16, are in Fair condition as the concrete headers are noted to have spalls, concrete and asphalt patches, and vertical misalignment of up to 1/4". There are scattered spalls to steel with up to 100% section loss in the concrete on the bottom side of the joints throughout. The compression joint at Abutment 2 is near fully compressed at 75 degrees. The protective netting in the approach spans has areas of damage and tearing due to dislodged concrete from spalling.

Pier 3 Finger Joint Looking Left

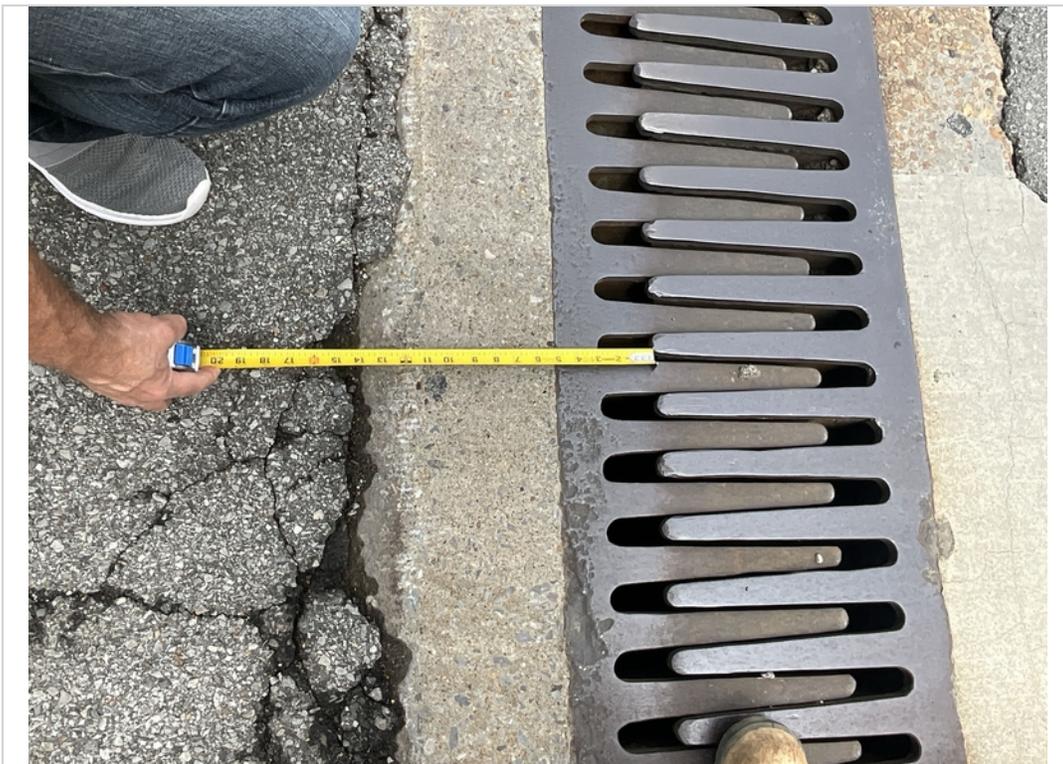
Pier 3 Finger Joint Open approx. 3"

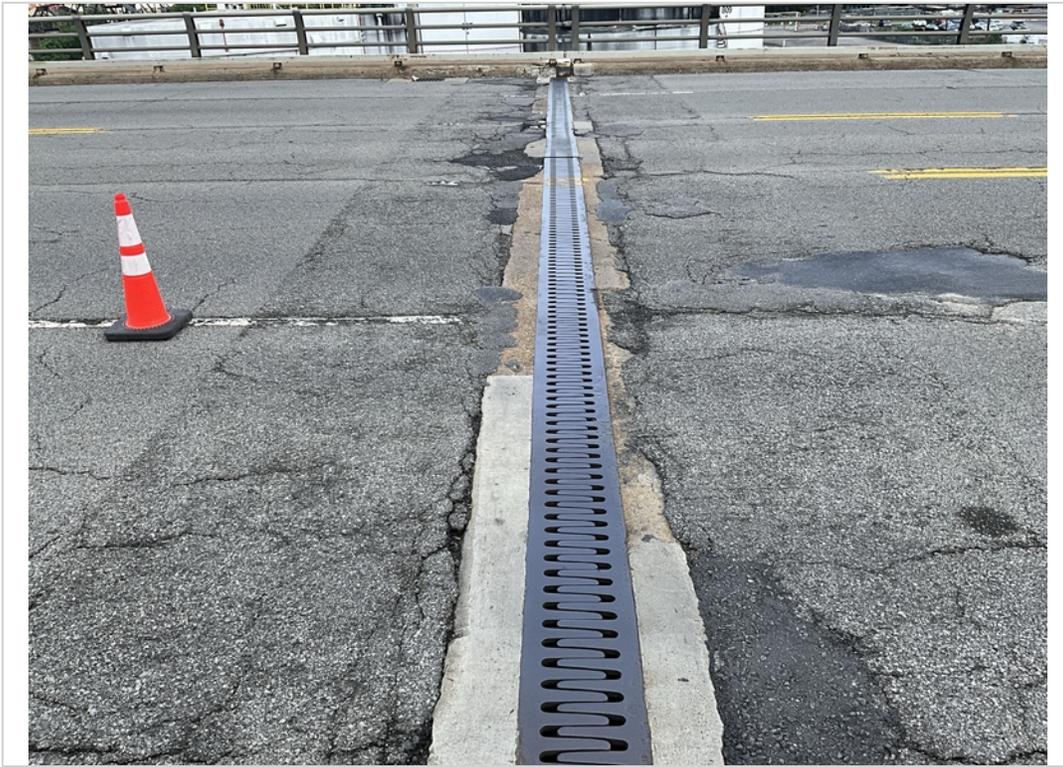
Span 7 Finger Joint Looking Left

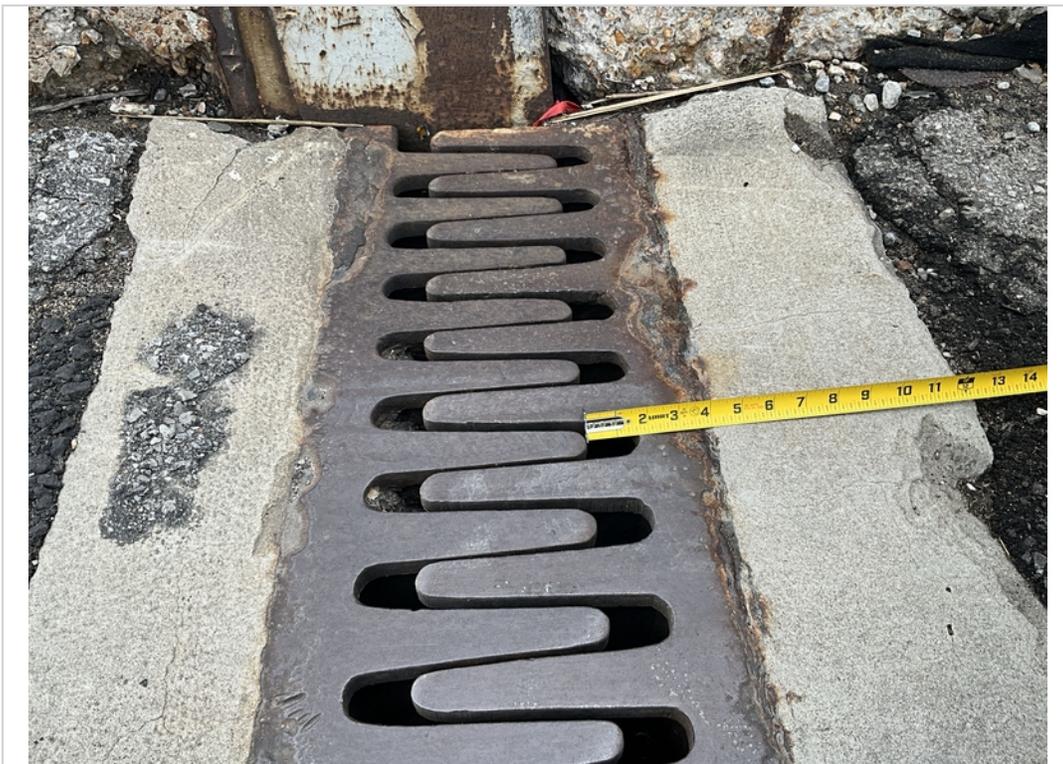
Span 7 Finger Joint Open 1-3/4"

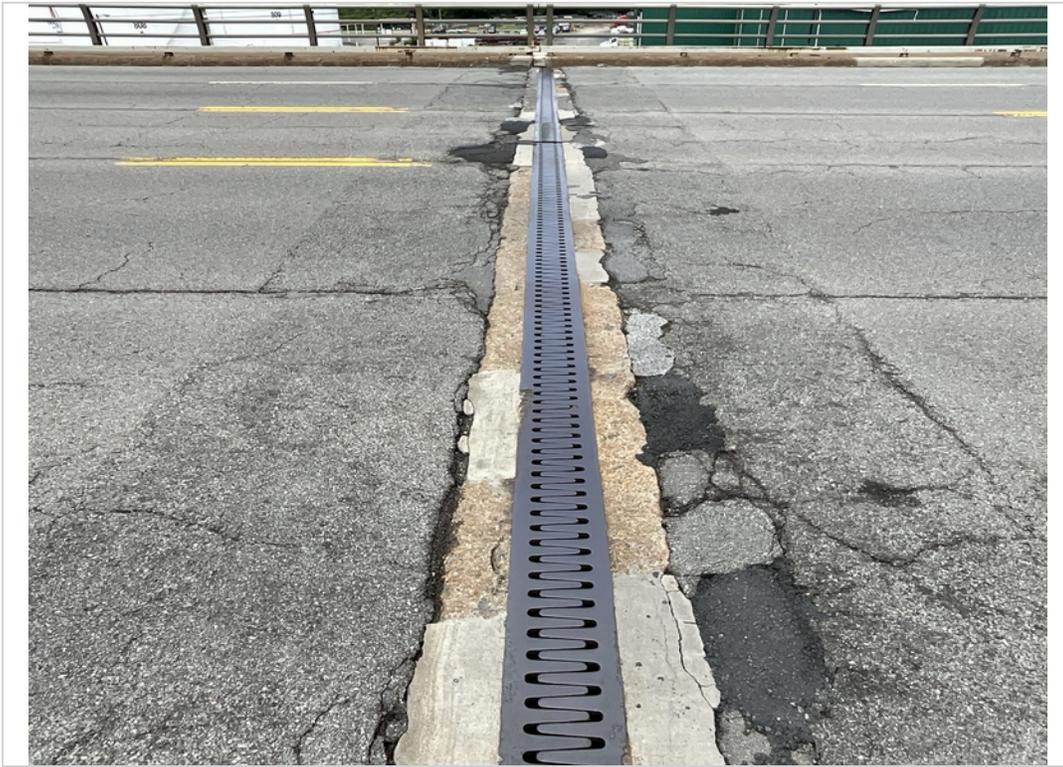
Span 11 Finger Joint Looking Left

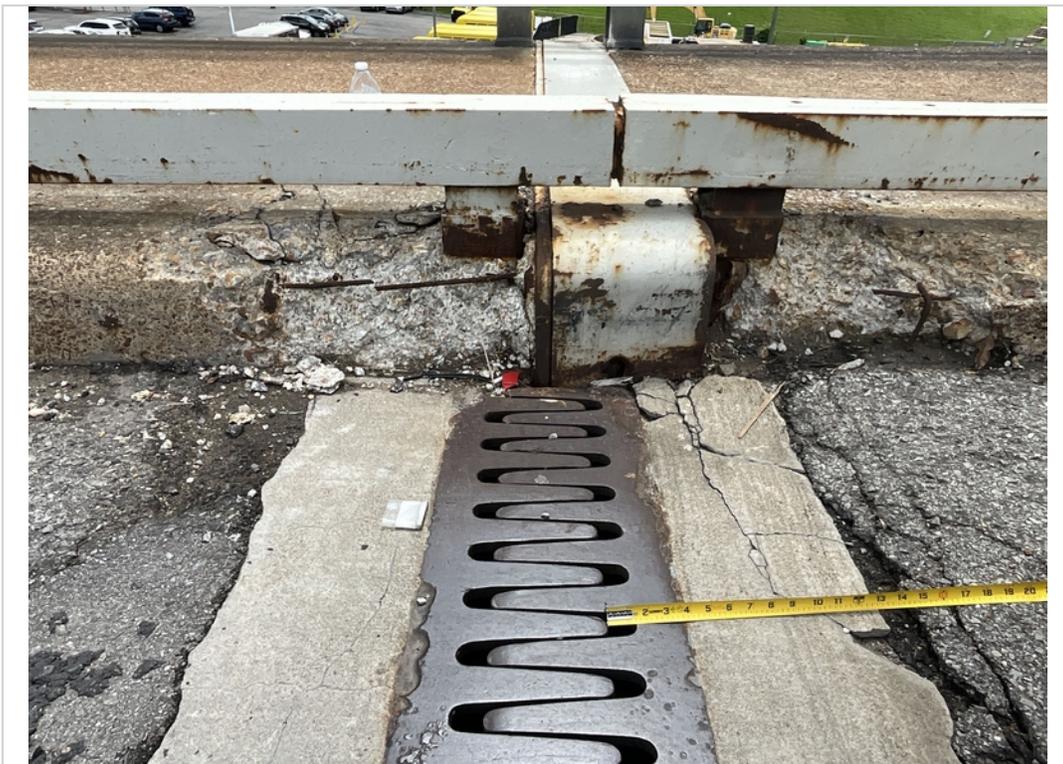
Span 11 Finger Joint Open 1-3/8"

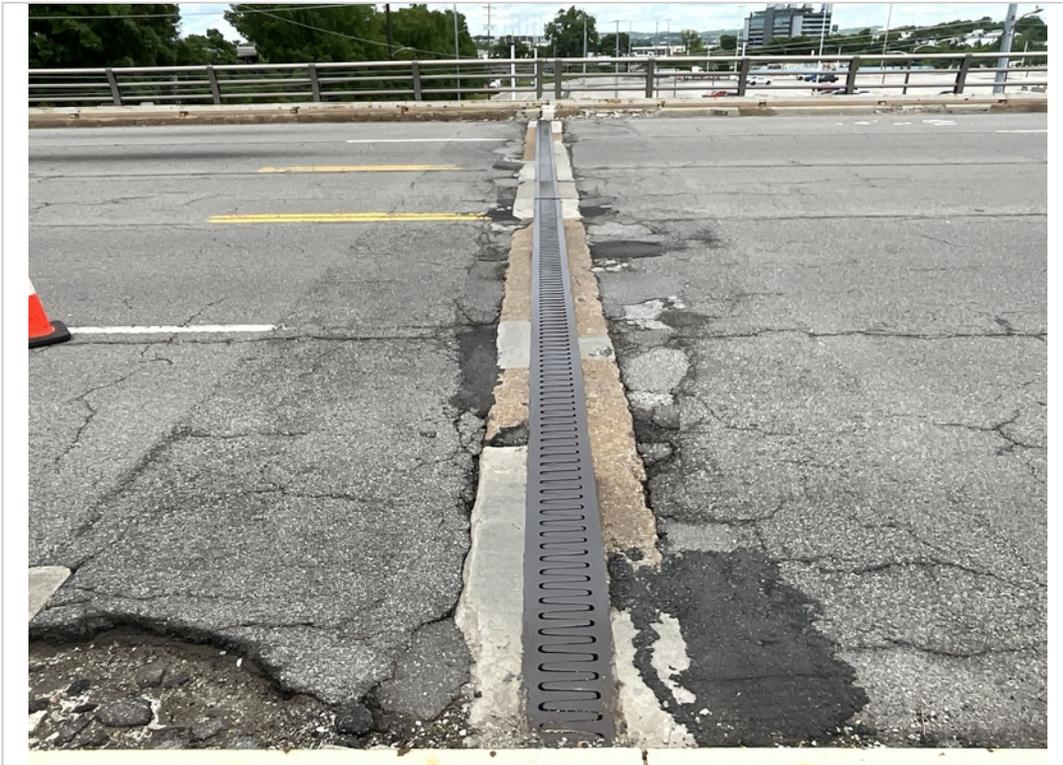
Span 16 Finger Joint Looking Left

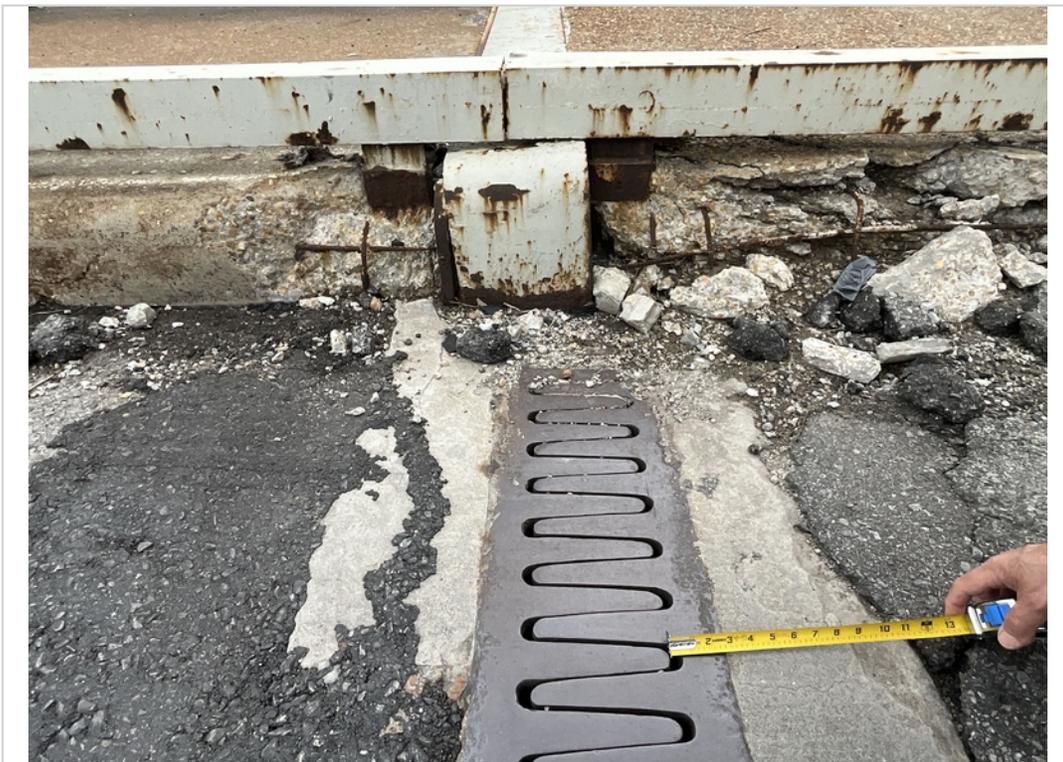
Span 16 Finger Joint Open 1/2"

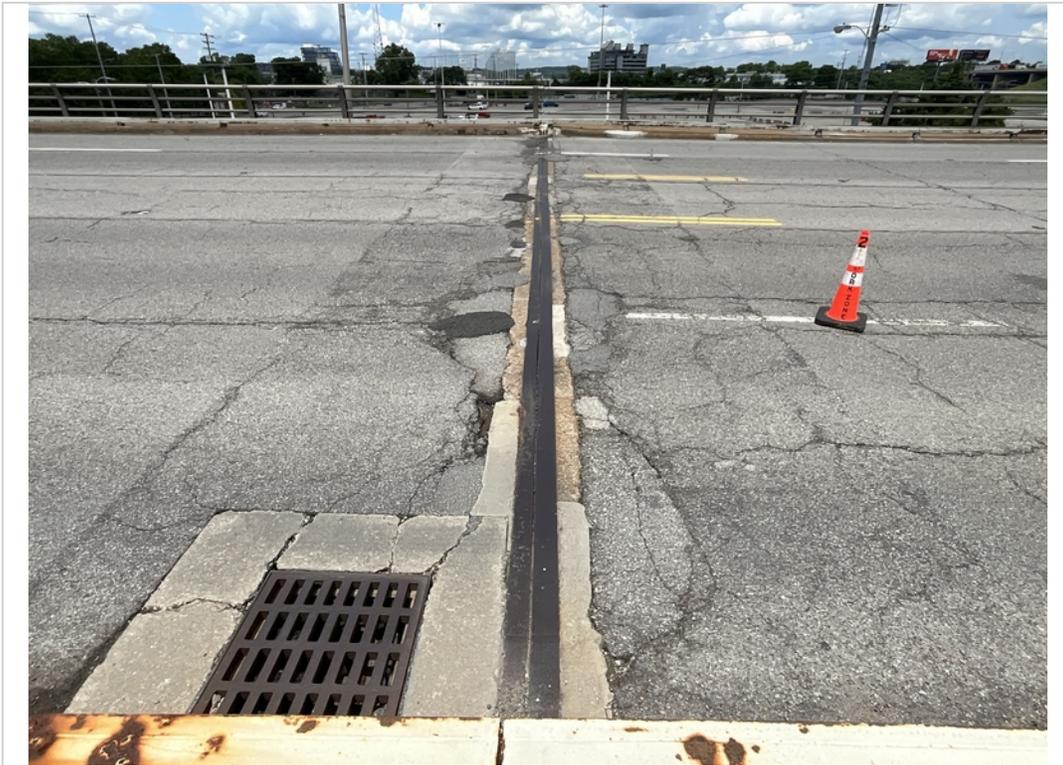
Abutment 2 Compression Joint Looking Left

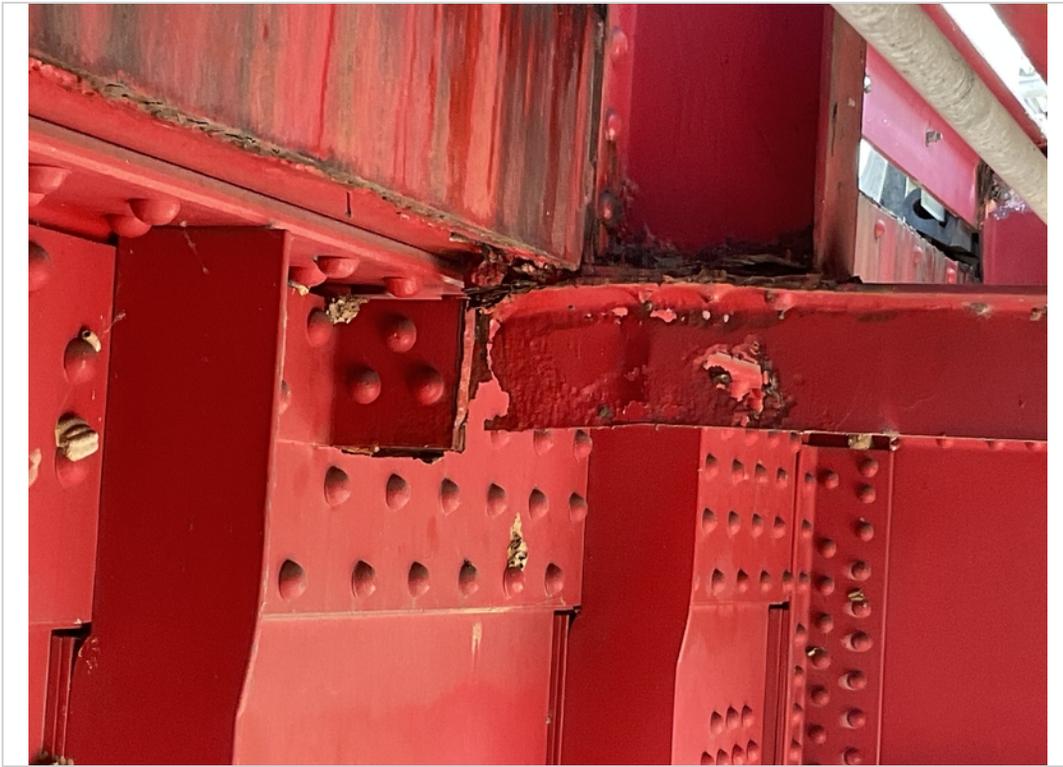
Span 2, Left Overhang in Panel 14 - 100% Section Loss of Strut Connection to Girder A

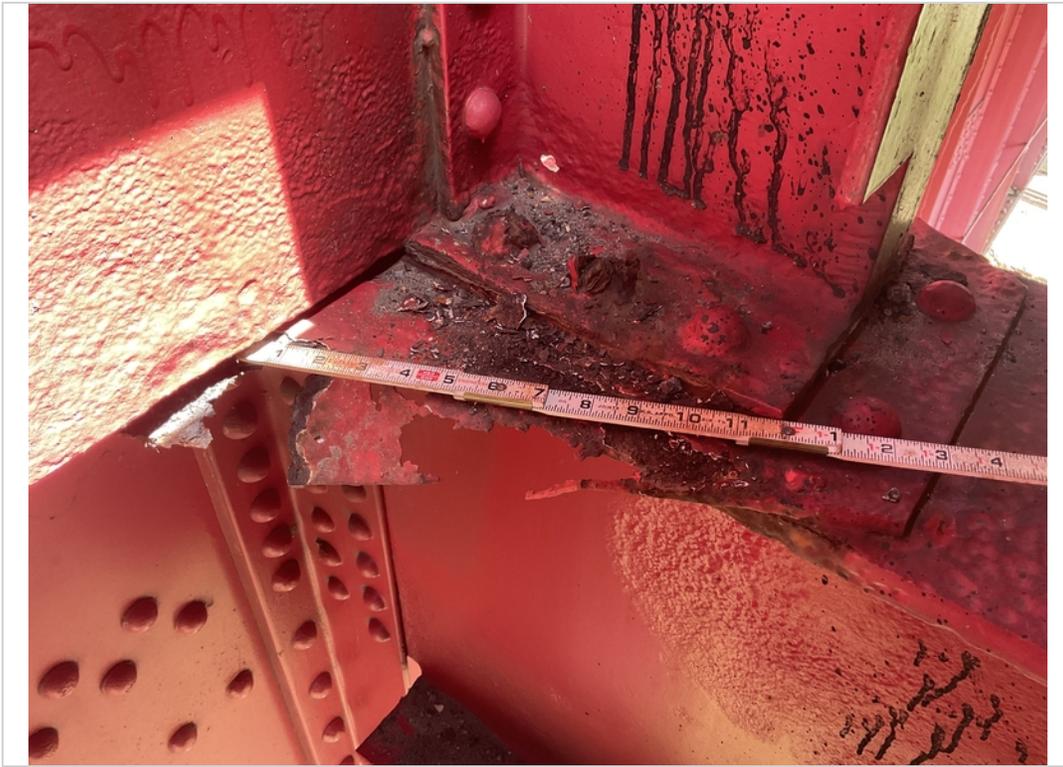
Span 3, Right side Overhang Bracket Tie-Plate for Panel 5/6. 100% Section Loss 9" L x 3" W

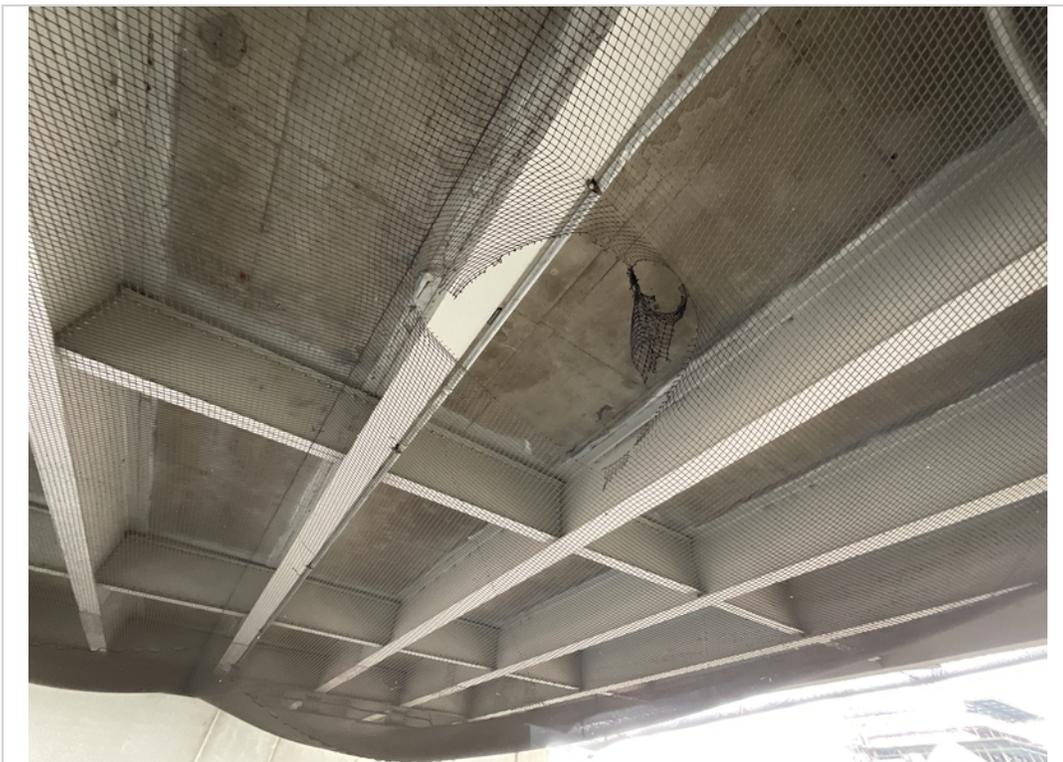
Span 17 - Damaged and Torn Netting

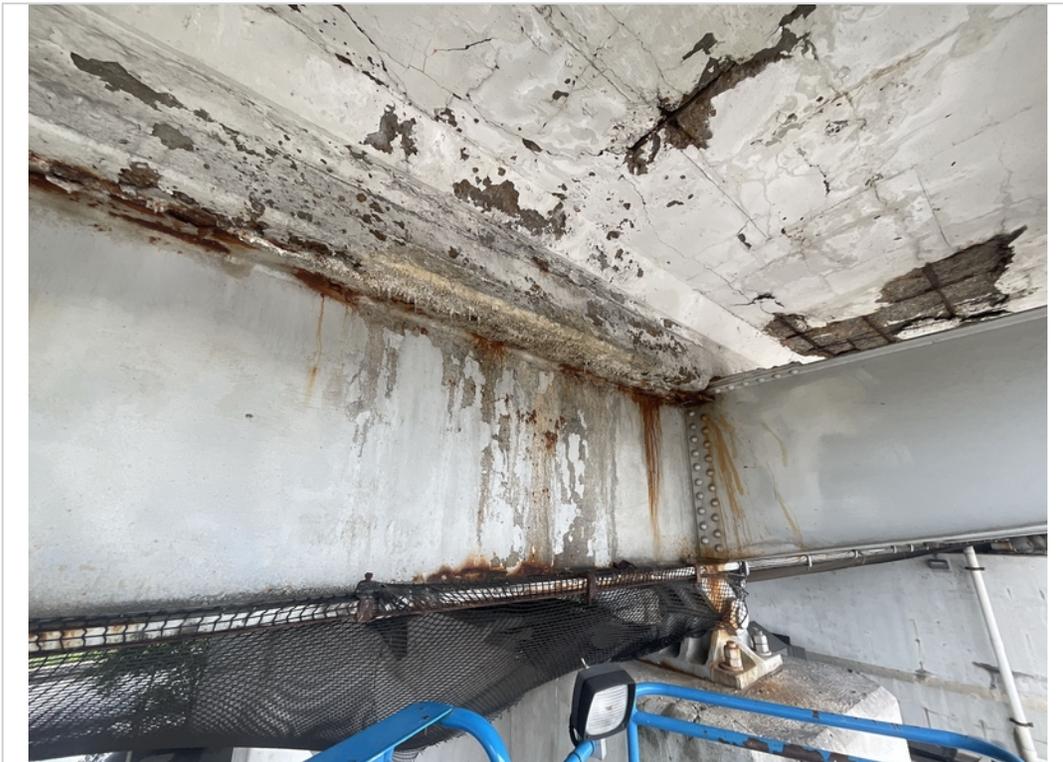
Typical Leakage with Efflorescence and Rust Stain at Top Flange of Beam in the Overhang (Showing Span 18 Right Side Beam H)

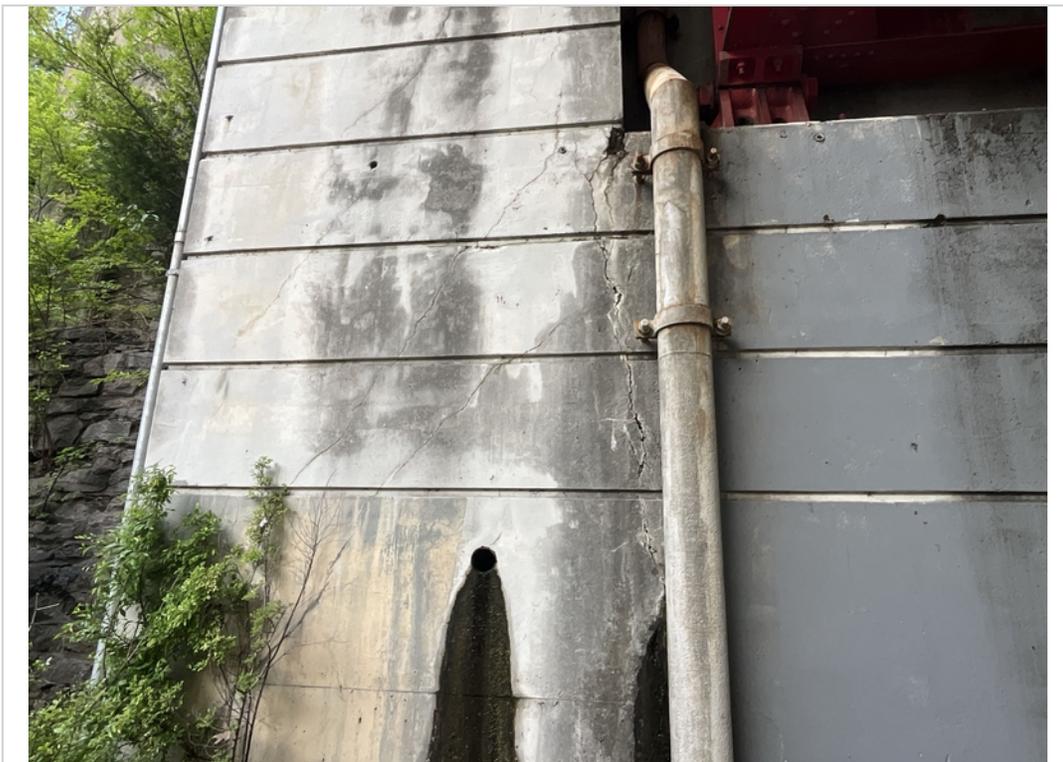
Abutment 1 Right Side - Typical Cracks

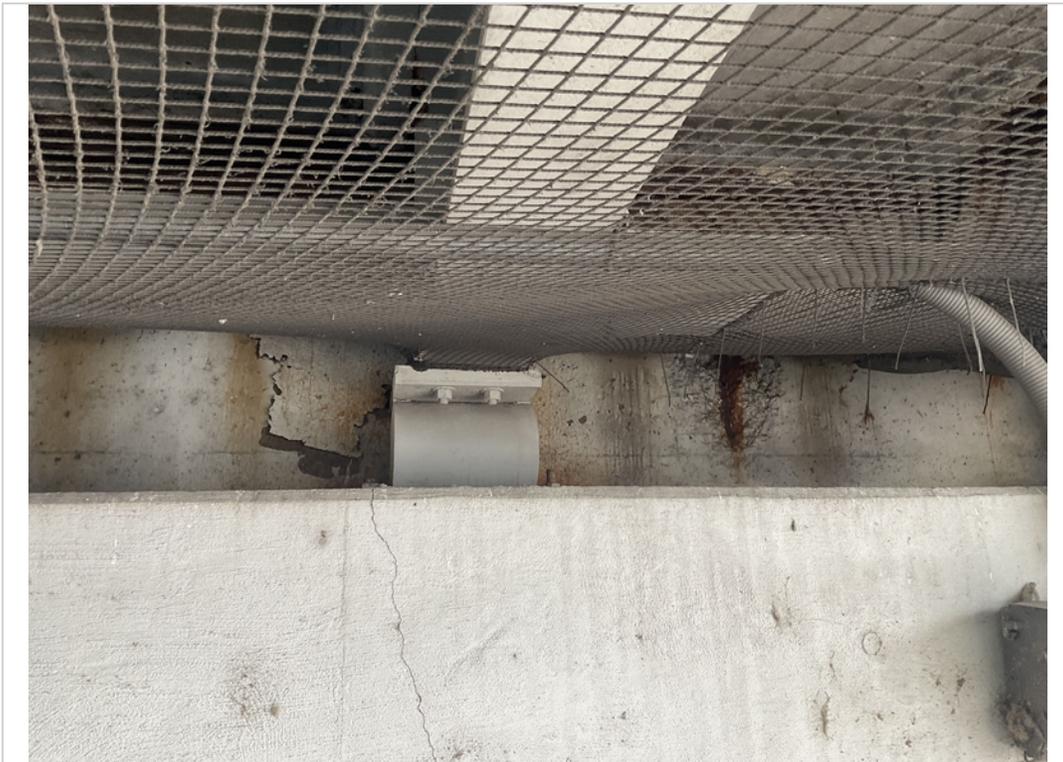
Abutment 2 Backwall - Impending Spall and Spall to Steel on either side of Girder C

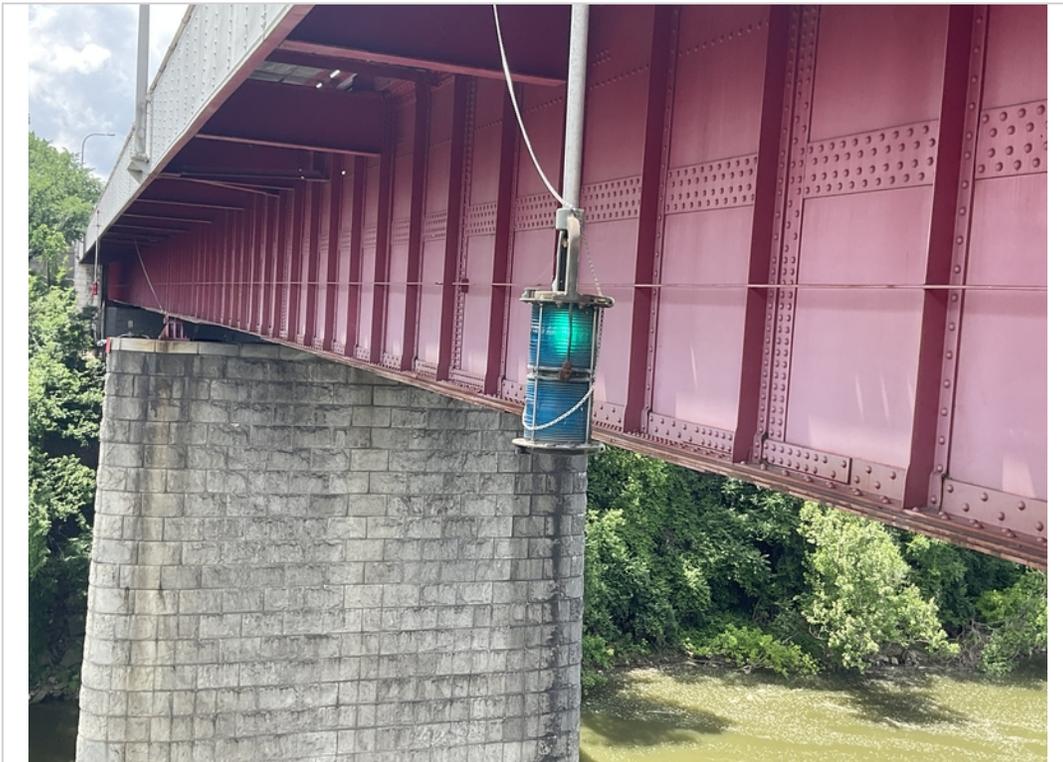
Span 2 Right Center Navigation Light. Bottom Light is not Illuminated. Similar condition to Center Light  
Left for Top and Top Light at Pier 1 Left

Date Added	Recommendation	Priority
05/24/2021	REPLACE LIGHTING FOR NAVIGATIONAL LIGHTS IN SPAN 2	
05/22/2017	REPAIR SPALLED CURBS IN SPANS 4 THROUGH 19	
08/11/2019	REPAIR BOTTOM OF DECK SPALLS AND DELAMINATION IN ALL SPANS	3
08/11/2019	CLEAN AND PAINT ALL STRUCTURAL STEEL	2
08/11/2019	CLEAN AND PAINT BEARINGS	(Inactive) (Inactive) 4
08/11/2019	RESET BEARINGS AT BENTS 11 THRU 14	(Inactive) (Inactive) 5
08/11/2019	RECONSTRUCT HEADERS FOR ALL BRIDGE FINGER JOINTS	
08/11/2019	REPAIR CURB RUBBER SHEATHING IN SPANS 1 THROUGH 3	
05/06/2024	REPAIR SPALLS AND DELAMINATION ON BOTH ABUTMENTS AND PIER 3.	
05/15/2025	CLEAN & PAINT SCRAPE MARKS FROM IMPACT DAMAGE TO GIRDER D IN SPAN 1 OVER GAY ST.	
05/15/2025	REPAIR CRACKS IN THE STEEL STEPS AND LANDINGS OF THE STAIRCASE IN SPAN 14	
05/15/2025	REPAIR IMPACT DAMAGED BRIDGE MOUNTED SIGN 19SIGN003393 ON LEFT FASCIA IN SPAN 15	
05/15/2025	REPAIR ELEC. JUNCTION BOX COVERS FOR OVERHEAD TRAFF LIGHT STR AND IN SPAN 14

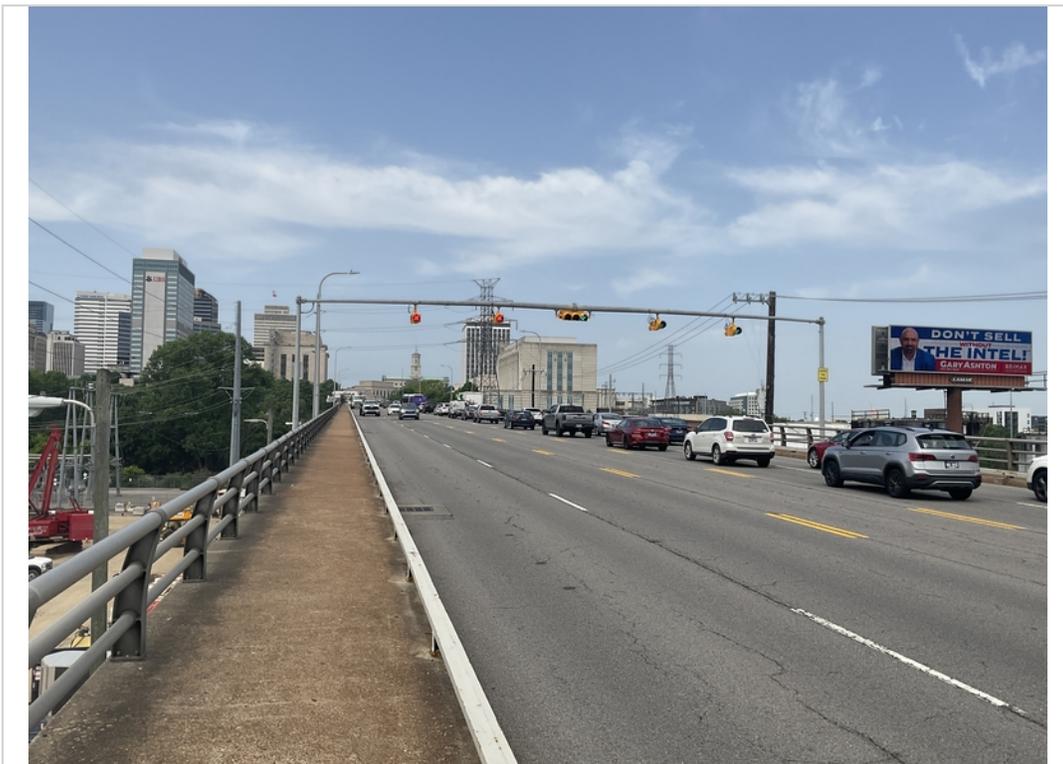
Overhead Traffic Light Structure above Bridge Deck Attached to Bent 6

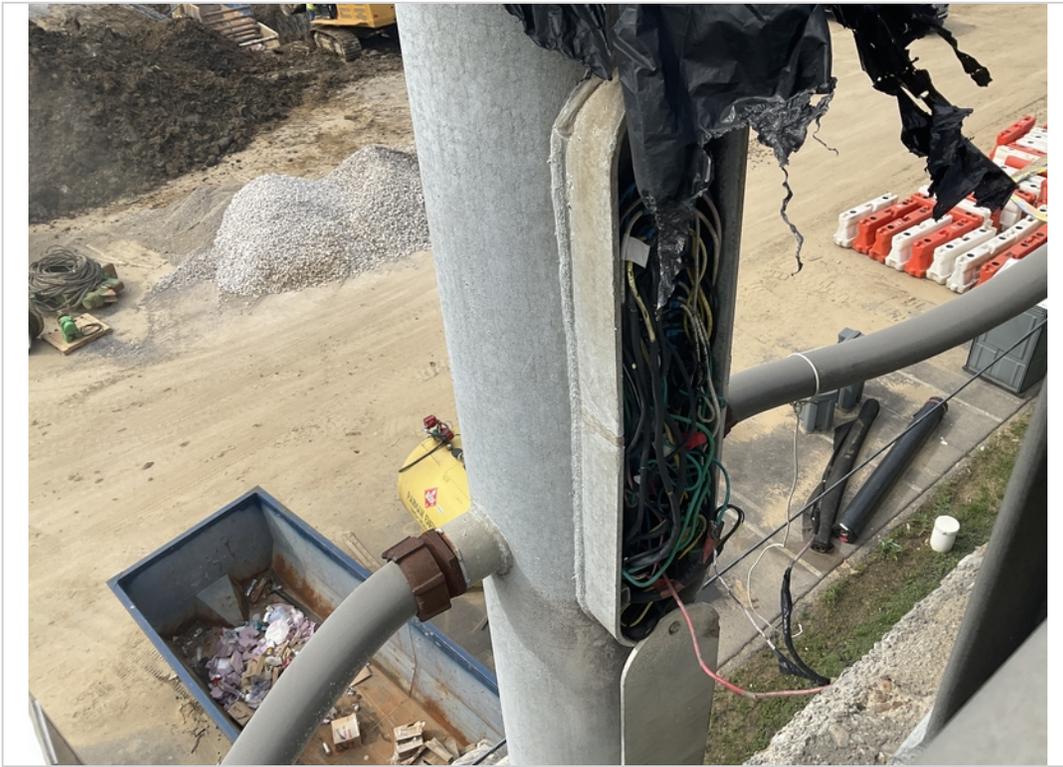
Right Side Tower of Overhead Traffic Light Structure - Unsecured Cover Plate Exposing Electrical Wires

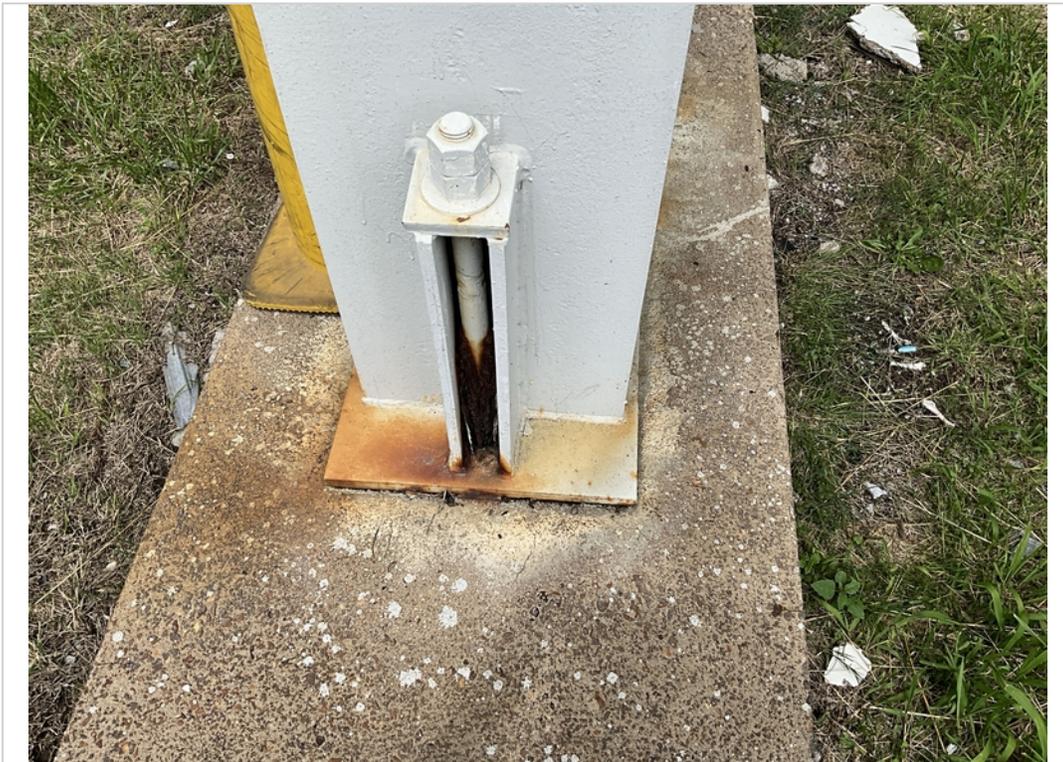
Anchor Bolt for Staircase Column - Moderate to Heavy Corrosion. Similar to opposite side Anchor Bolt
