JAMES ROBERTSON PKWY. Crossing CUMBERLAND RIVER

Inspection Date(s): 05/15/2025 - 05/15/2025

IDENTIFICATION	
(1) State Names	47 - Tennessee
(8) Structure Number	19SR0060015
(5) Inventory Route	1
(2) Highway Agency District	Region 3
(3) County Code	19 - Davidson

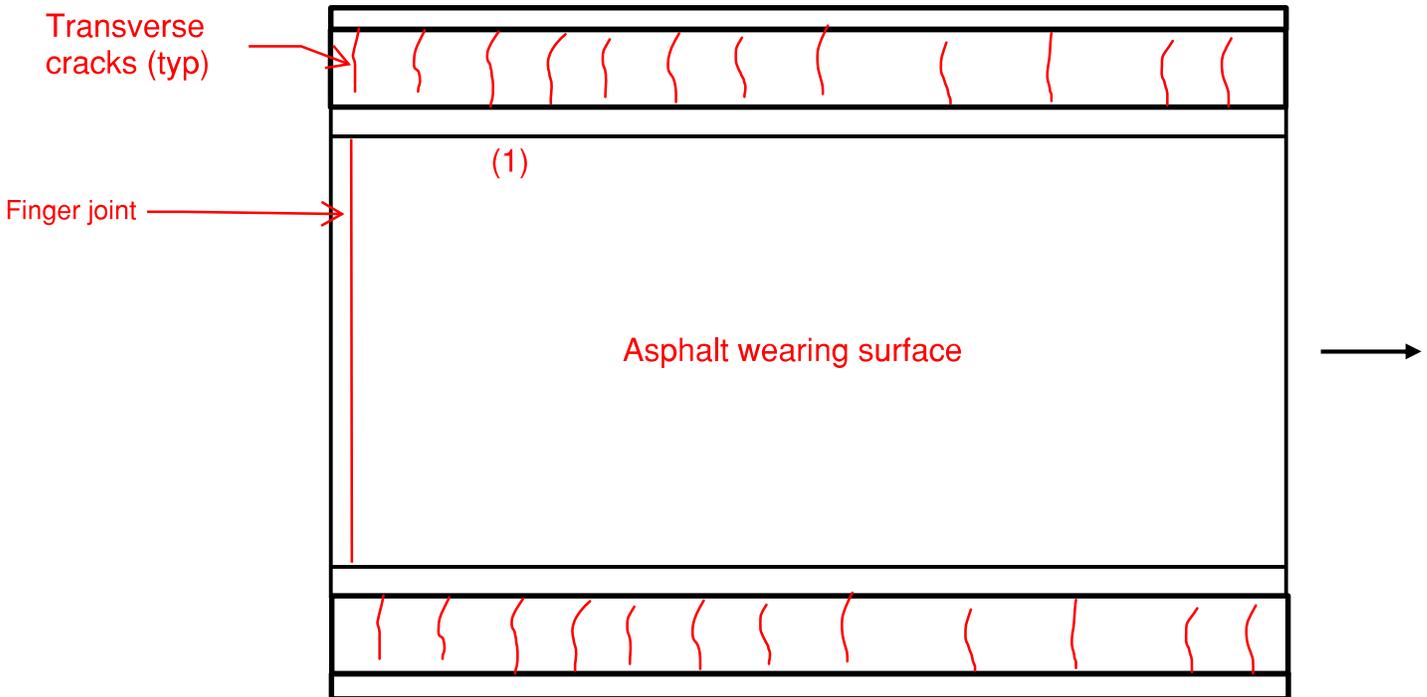
DECK	N/V	Longitudinal and transverse cracks up to 1"
CURBS	Fair	(1) Rubber loose
RAILS	Good	
SIDEWALK	Fair	Cracks up to 3/4" every 6 ft and minor surface raveling
DRAINS	N/A	
JOINTS	Fair	Finger Joint at Abut 1 has deteriorated concrete headers, previous conc and asphalt repairs. Approach side of joint is 1/4" higher than span side.

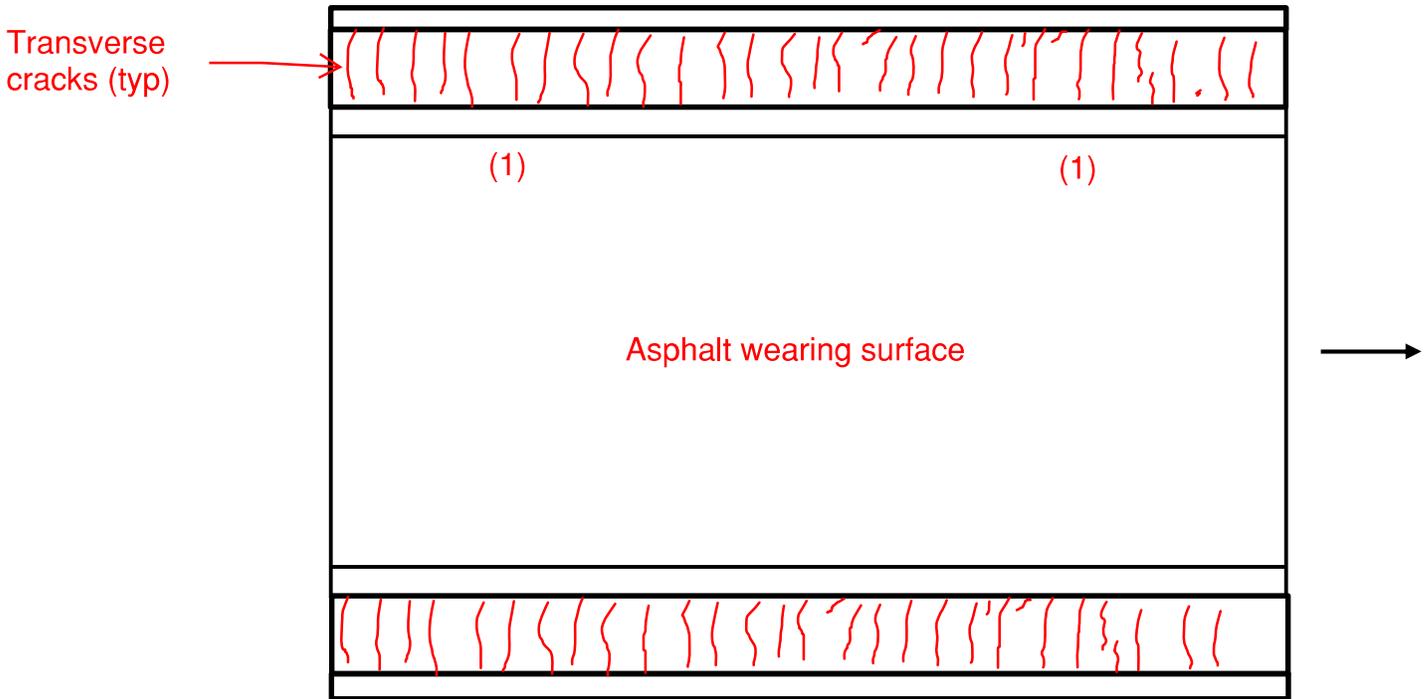
PIER 1	PIER 2
DECK	N/V	Longitudinal and transverse cracks up to 1", potholes, patching
CURBS	Fair	(1) Rubber sealant loose
RAILS	Good	
SIDEWALK	Fair	Cracks up to 1/2" every 3-5 ft
DRAINS	N/A	
JOINTS	N/A

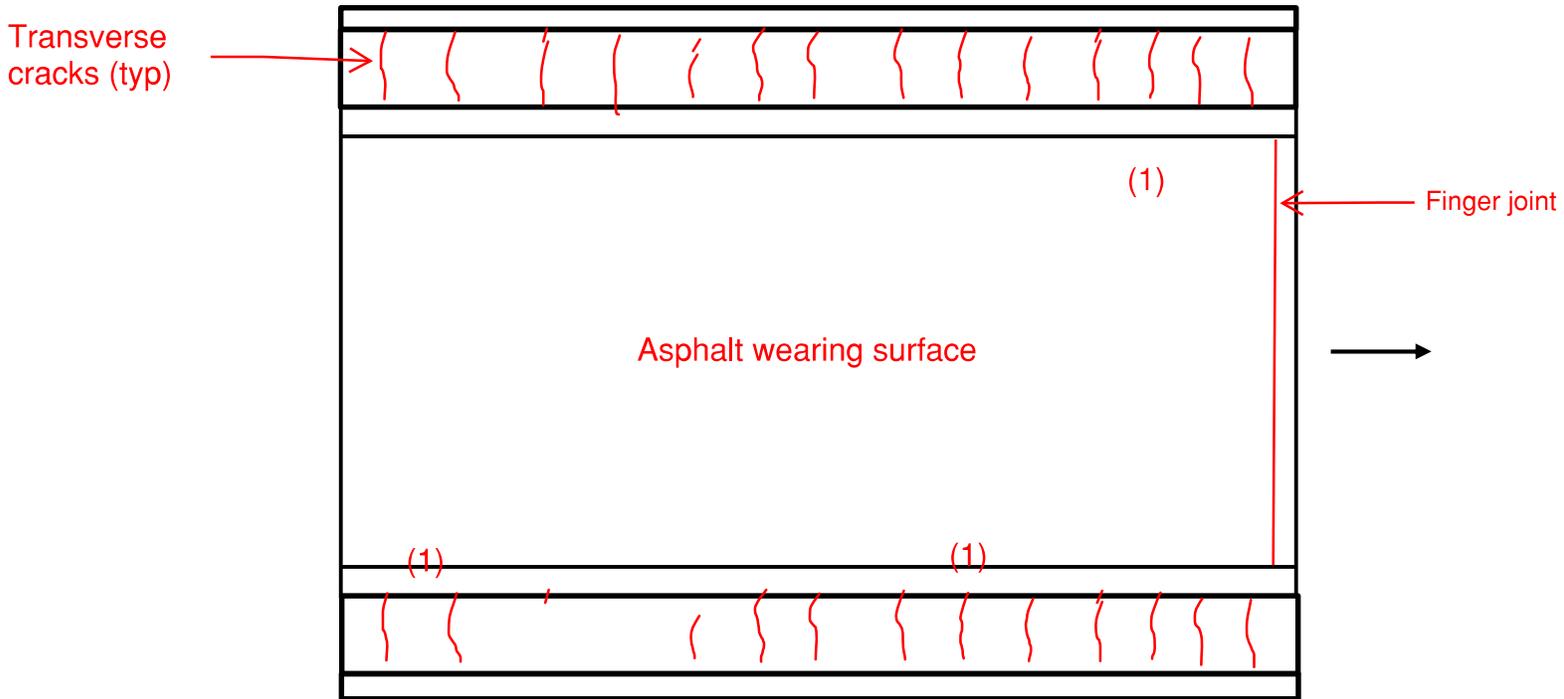
Top of Deck Span No. 3

DECK	N/V	Longitudinal and transverse cracks up to 1", shallow potholes and asphalt patching
CURBS	Fair	(1) Rubber sealant loose
RAILS	Good	
SIDEWALK	Fair	Cracks up to 1/8" every 3-6ft
DRAINS	N/A	
JOINTS	Fair	Finger Joint at Pier 3 has deteriorated concrete headers, previous conc and asphalt repairs. Joint is open for 3".

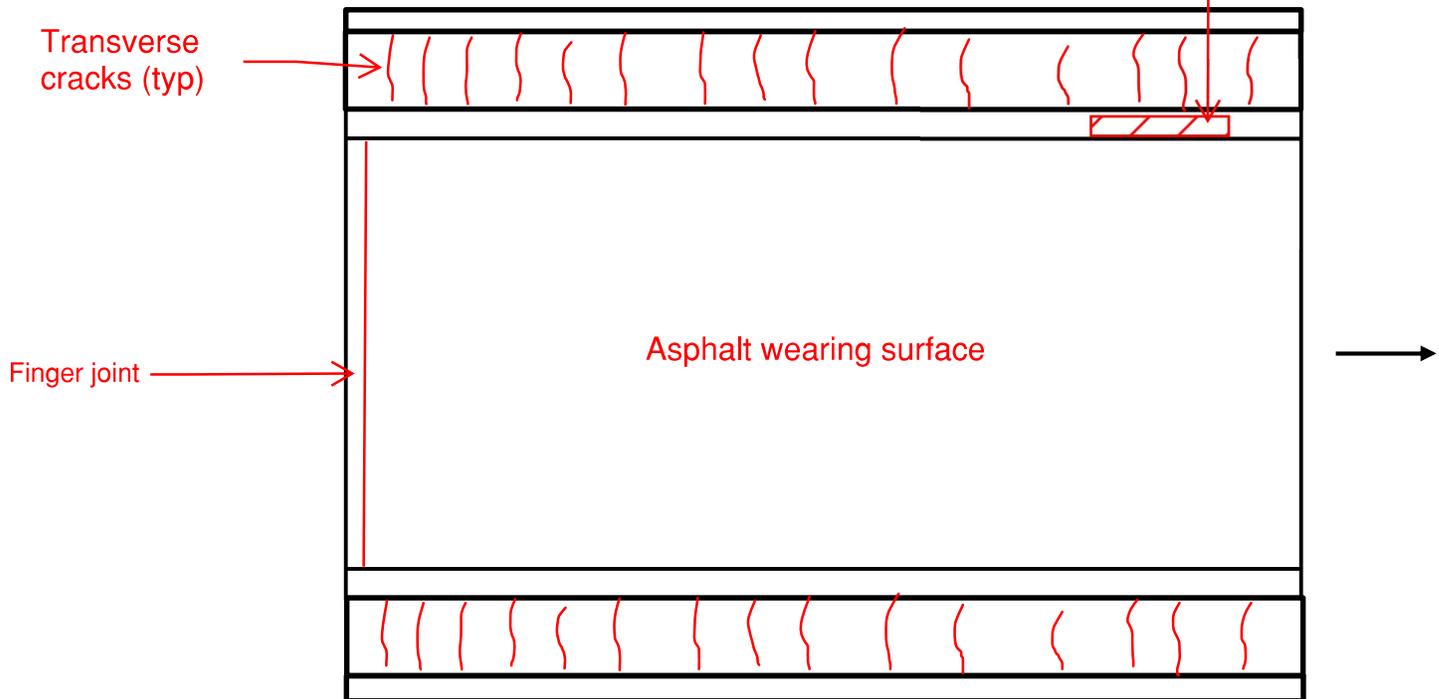
Spall with exposed rebar  
 6' long, x 14" wide x 5" deep

DECK	N/V	Longitudinal and transverse cracks up to 1"; asphalt patches along the joint.
CURBS	Fair	Damage/spalling with exposed rebar
RAILS	Good	
SIDEWALK	Fair	Cracks up to 1/8" every 3-6ft
DRAINS	N/A	
JOINTS	Fair	See Span 3

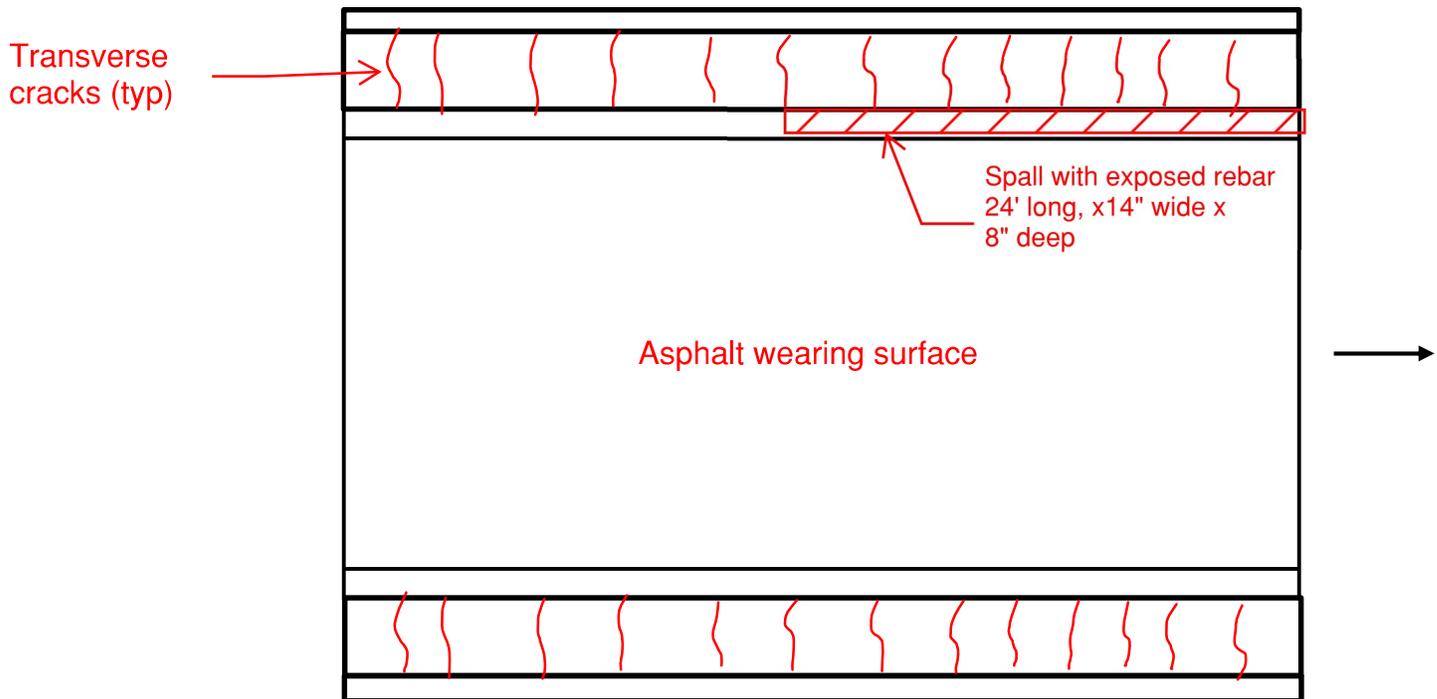
DECK	N/V	Longitudinal and transverse cracks up to 1"
CURBS	Poor	Deep spalling with exposed rebar
RAILS	Good	
SIDEWALK	Fair	Cracks up to 1/8" every 3-6ft
DRAINS	N/A	
JOINTS	N/A

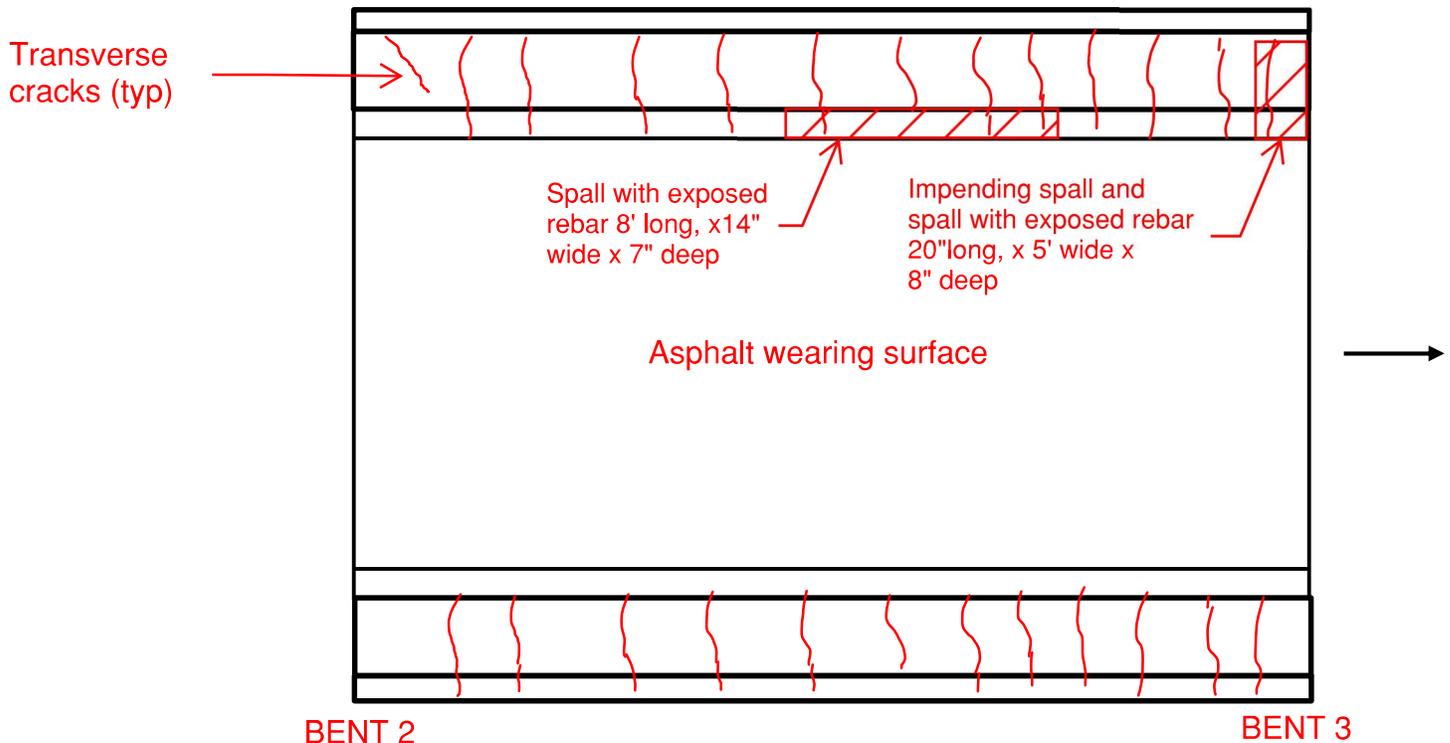
Top of Deck Span No. 6

DECK	N/V	Longitudinal and transverse cracks up to 1", patching near joint
CURBS	Fair	Spalling with exposed rebar and Impending spalls
RAILS	Good	
SIDEWALK	Fair	Cracks up to 1/8" every 3-6ft, impending spall
DRAINS	N/A	
JOINTS	N/V	Joint paved over

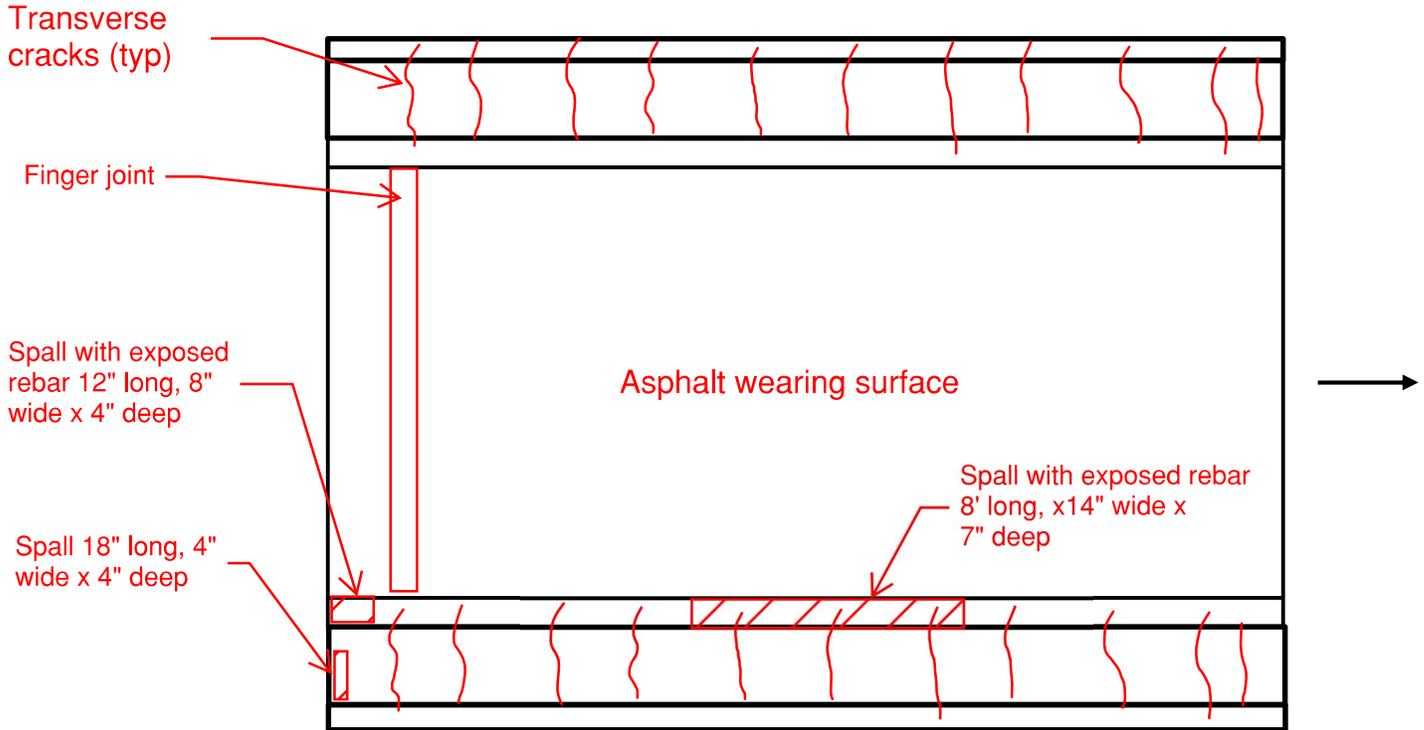
Top of Deck Span No. 7

BENT 3	BENT 4
DECK	N/V	Longitudinal and transverse cracks up to 1", patching near joint
CURBS	Fair	Spalls to steel
RAILS	Good	
SIDEWALK	Fair	Cracks up to 1/8" every 3-6ft and spalling
DRAINS	Good	
JOINTS	Fair	Finger Joint at has deteriorated concrete headers, previous conc and asphalt repairs. Joint is open for 1-3/4".

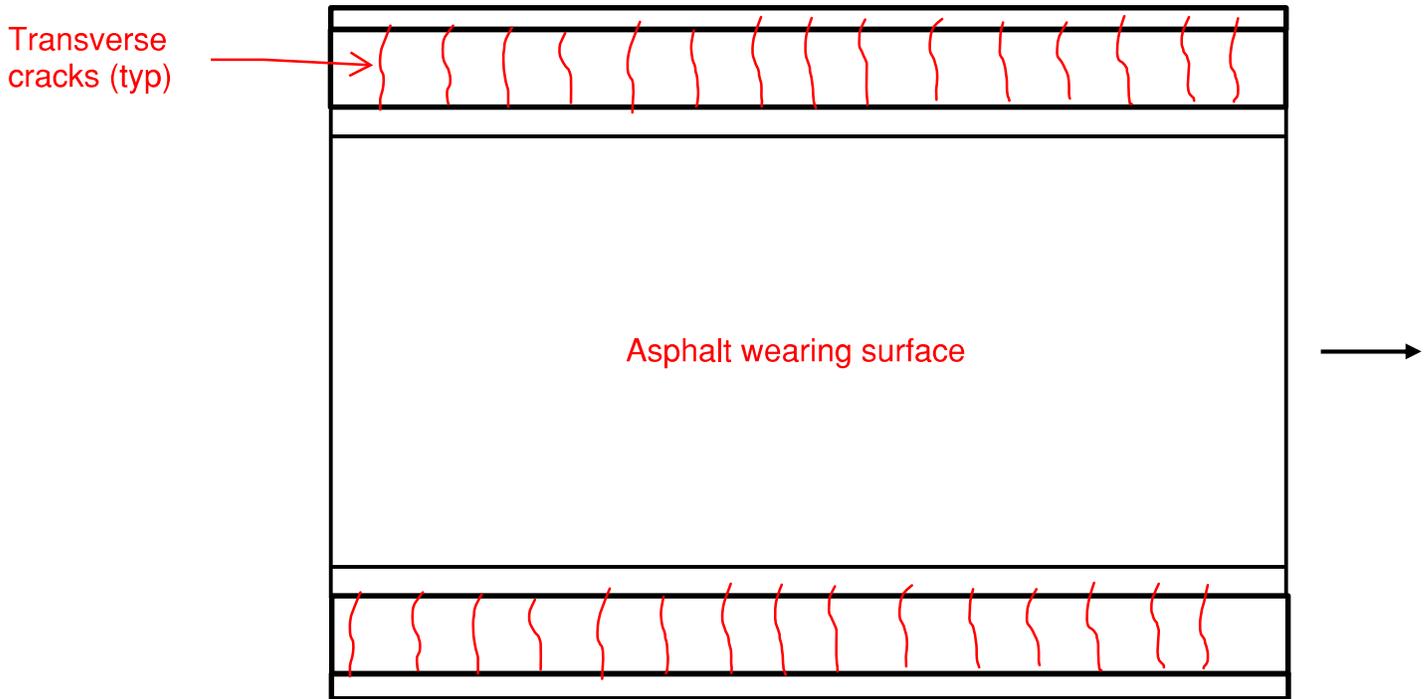
Top of Deck Span No. 8

DECK	N/V	Longitudinal and transverse cracks up to 1"
CURBS	Good	
RAILS	Good	
SIDEWALK	Fair	Cracks up to 1/8" every 3-6ft
DRAINS	Good	
JOINTS	N/A	Joint paved over

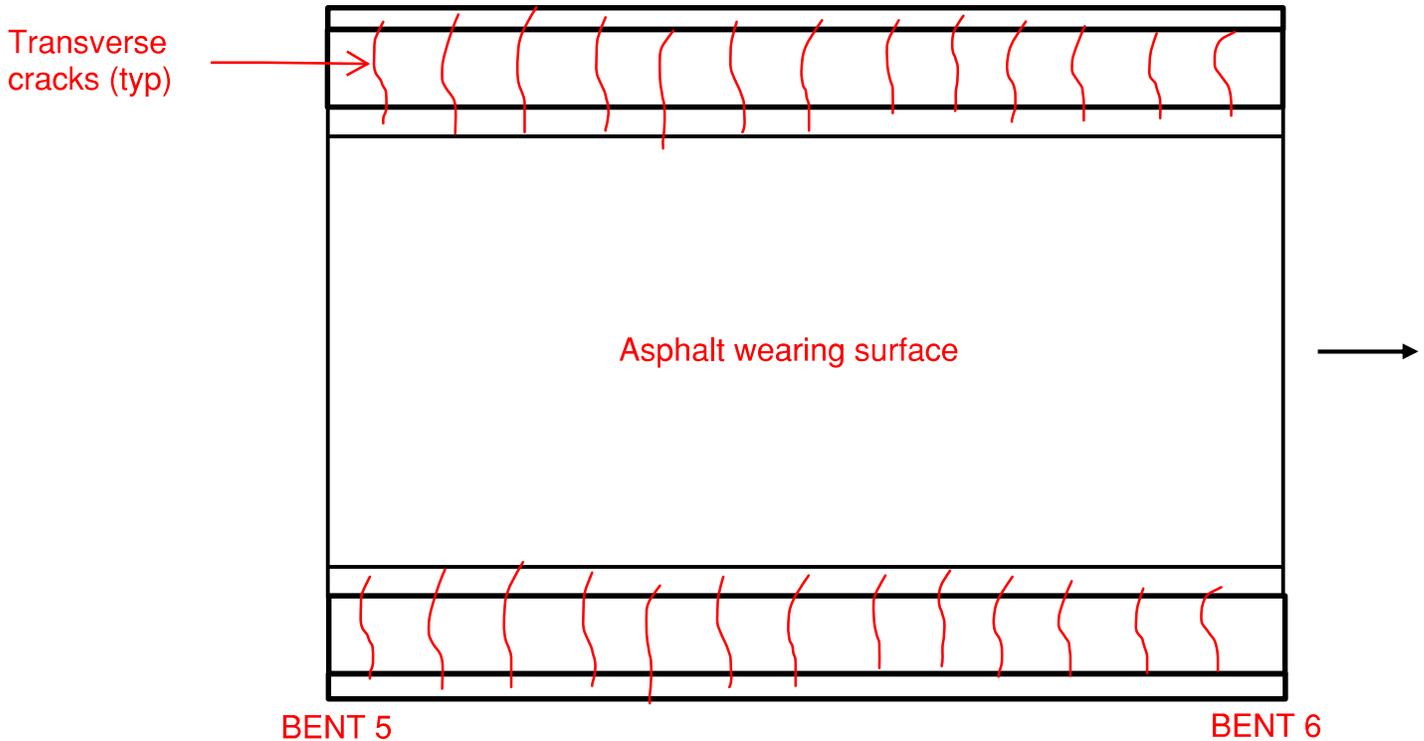
DECK	N/V	Longitudinal and transverse cracks up to 1",
CURBS	Good	
RAILS	Good	
SIDEWALK	Fair	Cracks up to 1/8" every 3-6ft
DRAINS	Good	
JOINTS	N/A	Joint paved over

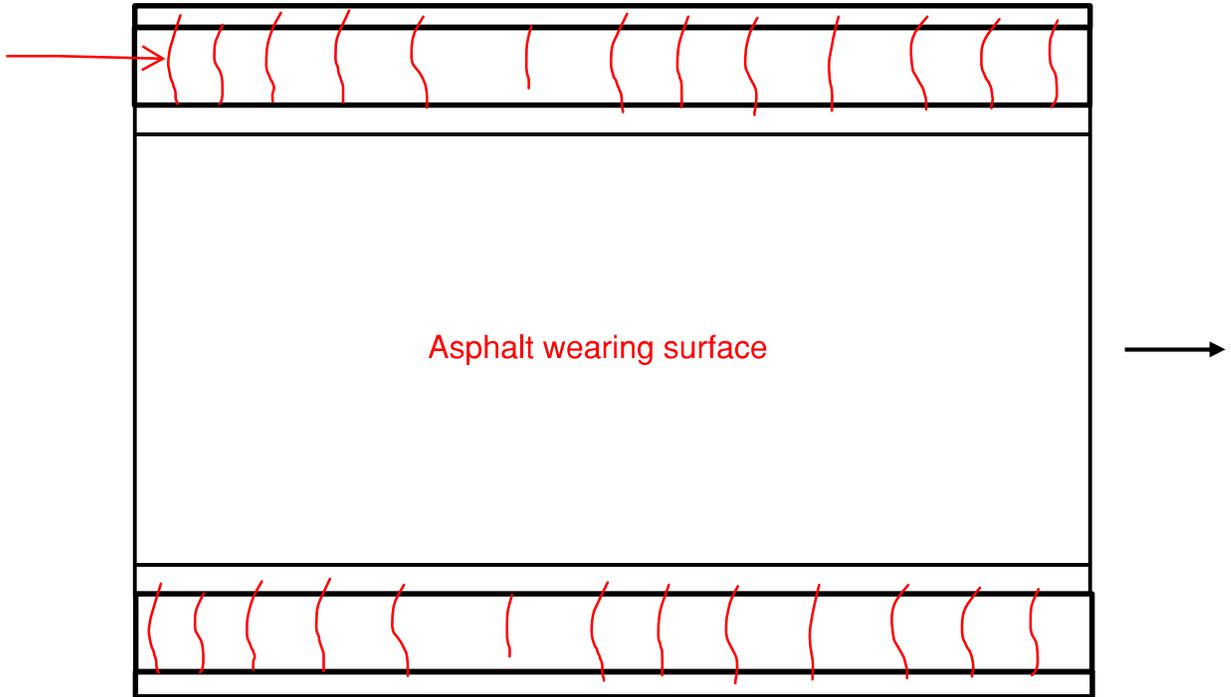
Transverse cracks (typ)

DECK	N/V	Longitudinal and transverse cracks up to 1",
CURBS	Good	
RAILS	Good	
SIDEWALK	Fair	Cracks up to 1/8" every 3-6ft
DRAINS	Good	
JOINTS	N/A	Joint paved over

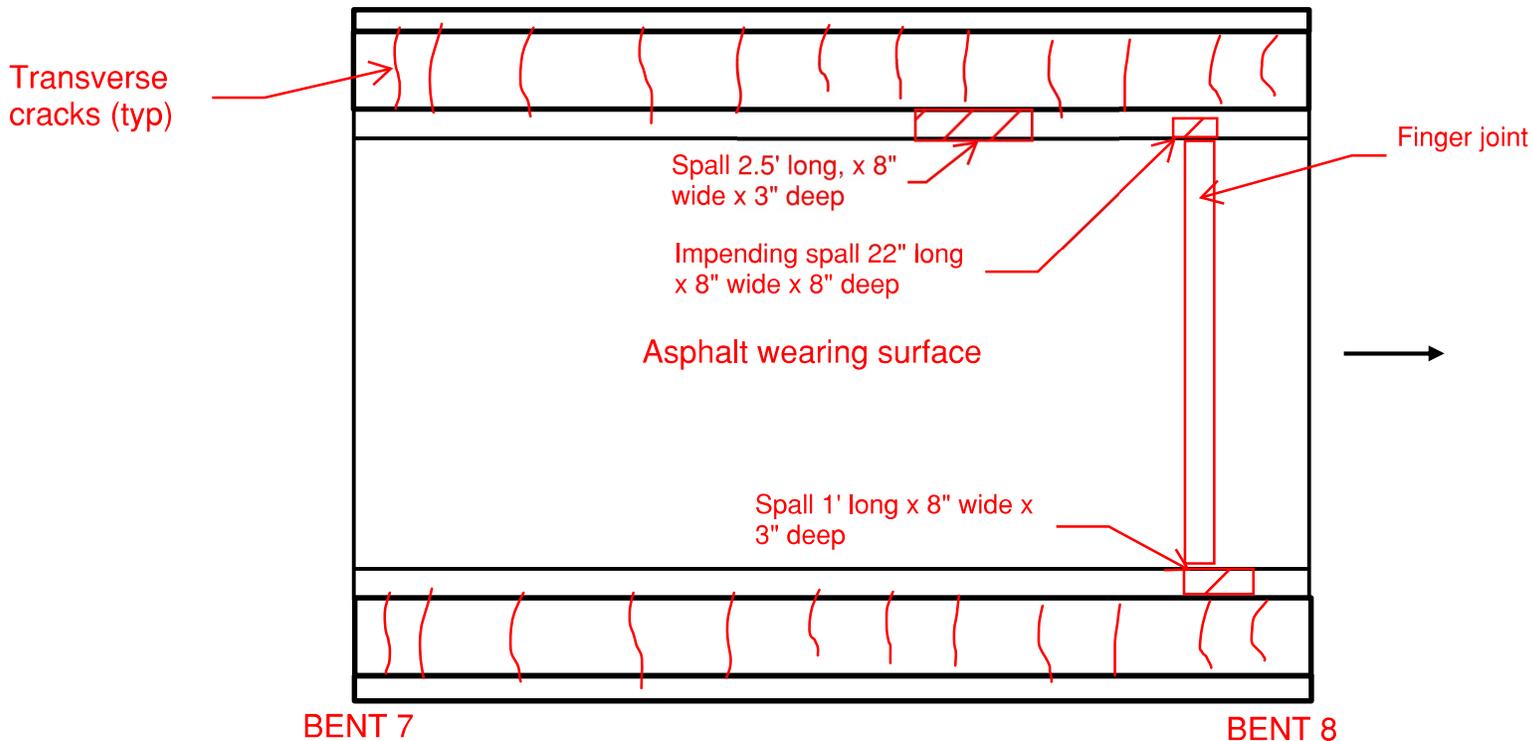
DECK	N/V	Longitudinal and transverse cracks up to 1", patching near joint
CURBS	Fair	Spalls and Impending spalls
RAILS	Good	
SIDEWALK	Fair	Cracks up to 1/8" every 3-6ft
DRAINS	Good	
JOINTS	Fair	Finger Joint has deteriorated concrete headers, previous conc and asphalt repairs. Joint is open for 1-3/8".

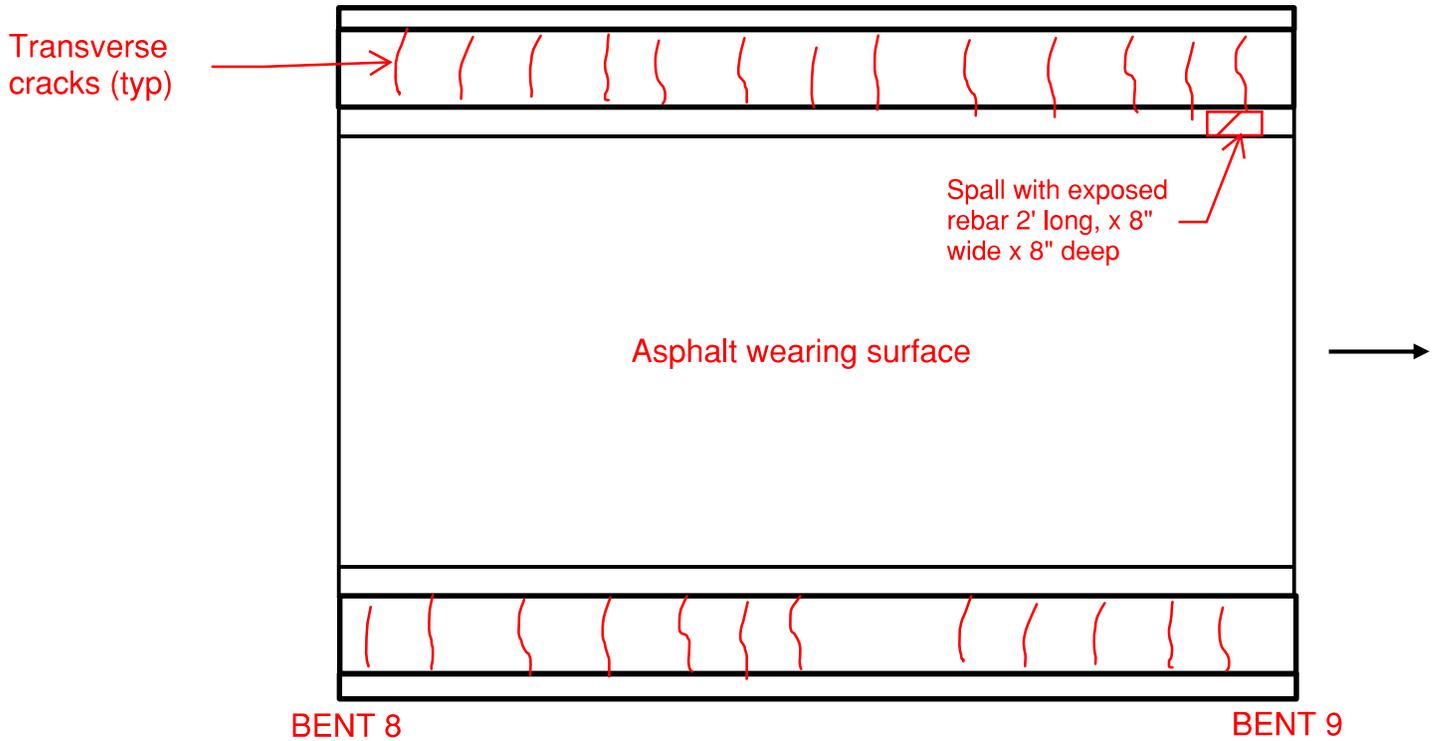
Top of Deck Span No. 12

DECK	N/V	Longitudinal and transverse cracks up to 1"
CURBS	Fair	Spalling with exposed rebar
RAILS	Good	
SIDEWALK	Fair	Cracks up to 1/8" every 3-6ft
DRAINS	N/A	
JOINTS	N/A

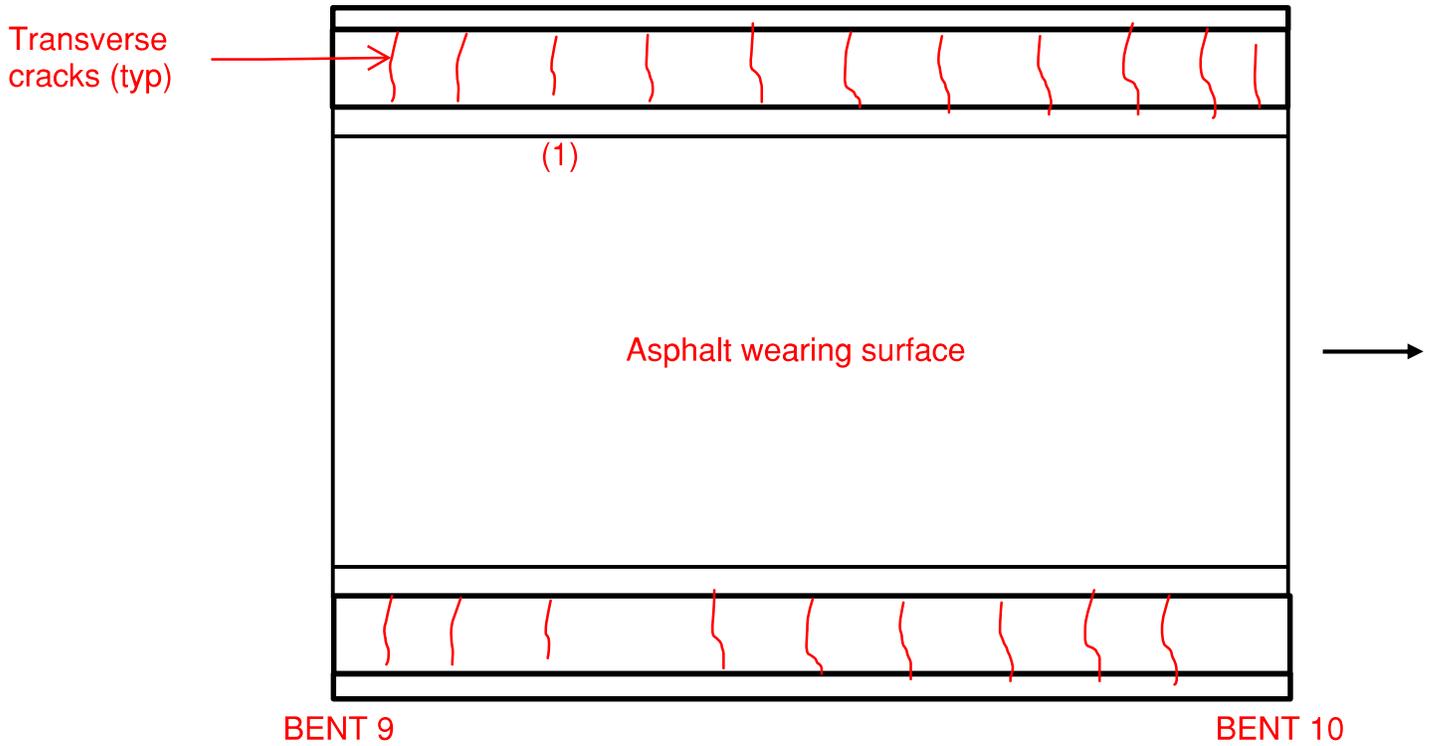
Top of Deck Span No. 13

DECK	N/V	Longitudinal and transverse cracks up to 1"
CURBS	Fair	(1) Area of rub-rail damage
RAILS	Good	
SIDEWALK	Fair	Cracks up to 1/8" every 3-6ft
DRAINS	Good	
JOINTS	N/A

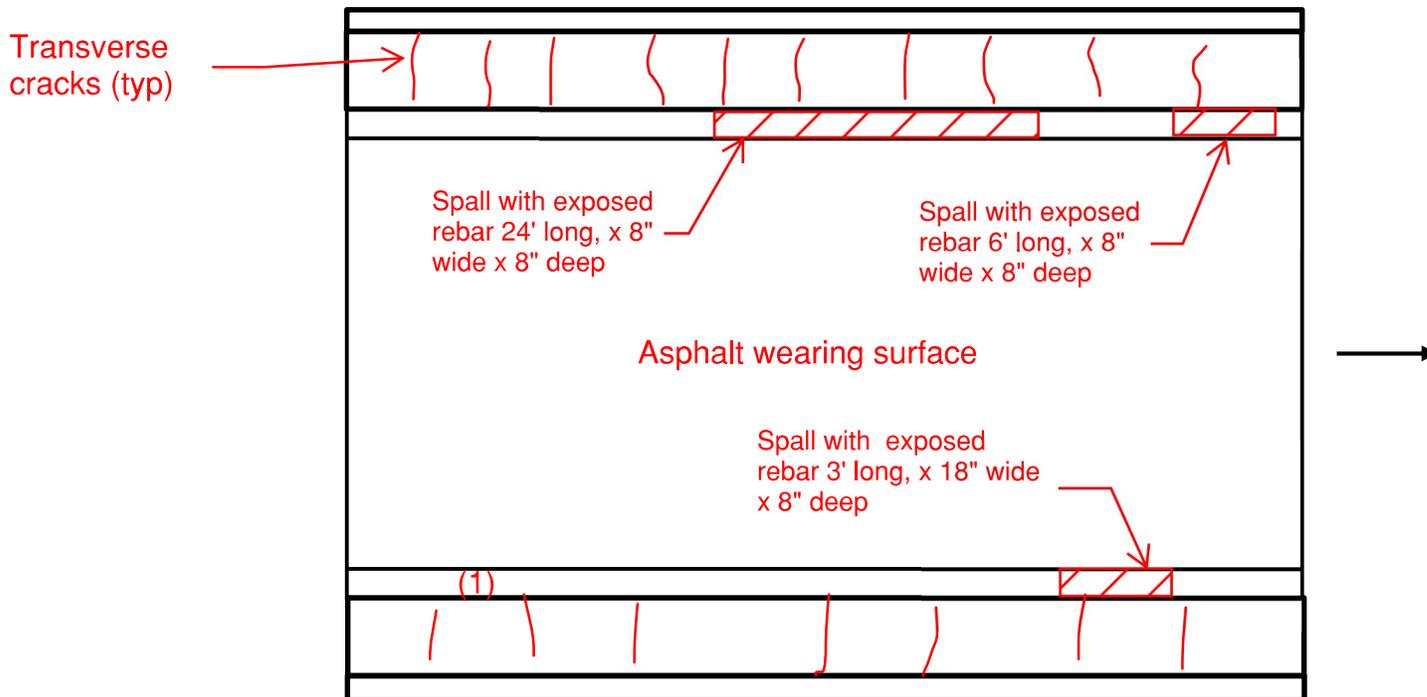
Top of Deck Span No. 14

DECK	N/V	Longitudinal and transverse cracks up to 1"
CURBS	Fair	(1) Area of rub-rail damage; spalling with exposed rebar
RAILS	Good	
SIDEWALK	Fair	Cracks up to 1/8" every 3-6ft
DRAINS	N/A	
JOINTS	N/A

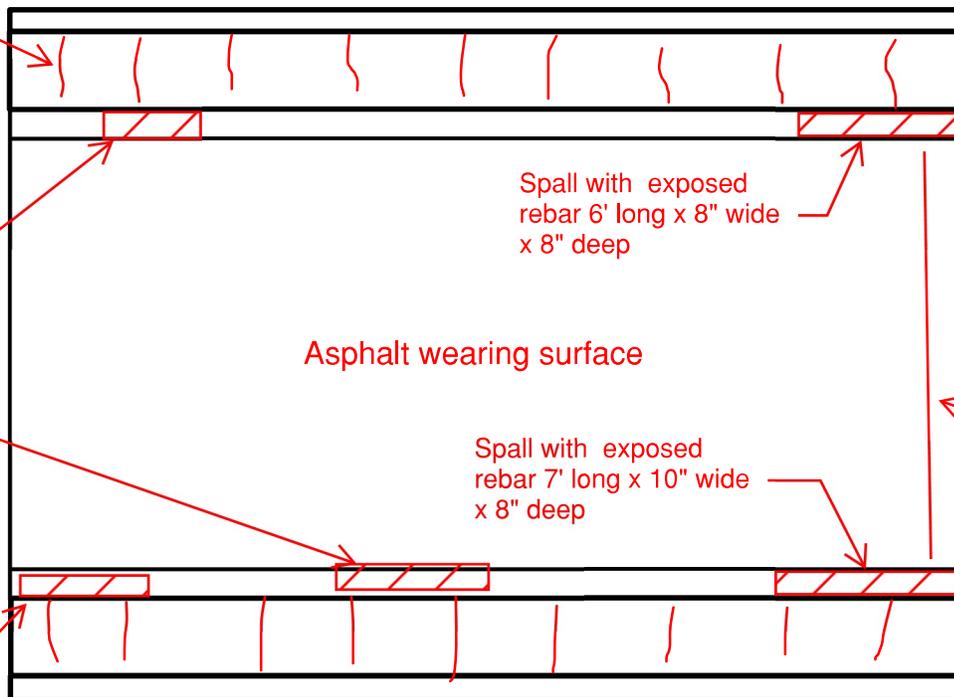
Transverse cracks up to 1/8" every 3-6 ft

Impending spall with 6' long x 8" wide x 8" deep

Impending spall and spall with exposed rebar 12' long x 10" wide x 8" deep

Spall with exposed rebar 7' long x 10" wide x 8" deep

Spall with exposed rebar 6' long x 8" wide x 8" deep

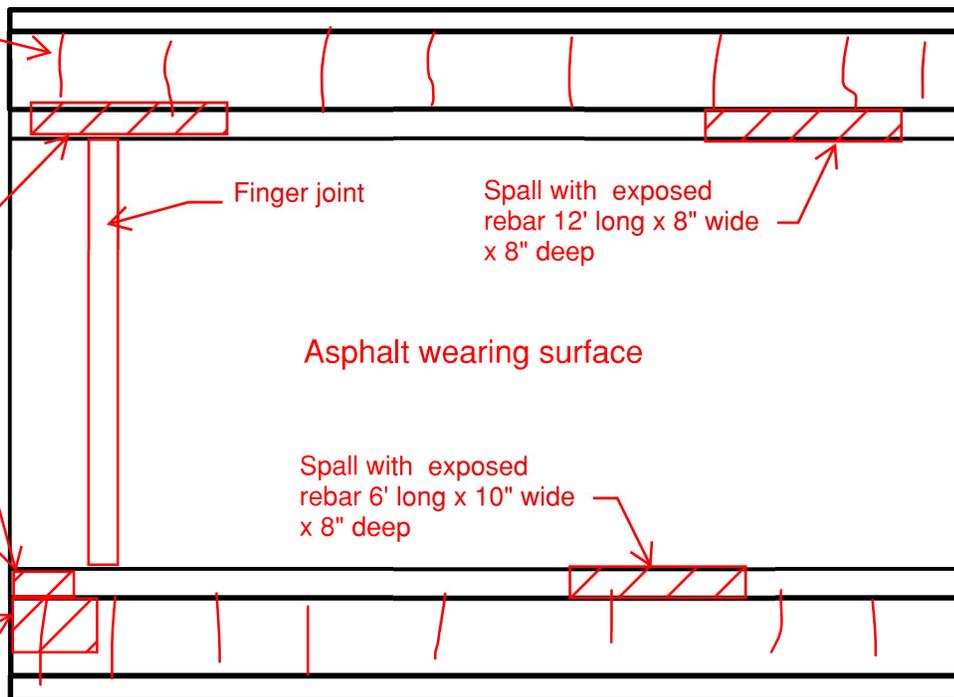
Transverse cracks up to 1/8" every 3-6 ft

Spall with exposed rebar 7' long x 8" wide x 8" deep

Spall with exposed rebar 16" long x 10" wide x 8" deep

Impending spall and spall with exposed rebar with 4' long x 3' wide x 1/4" deep

DECK	N/V	Longitudinal and transverse cracks up to 1"
CURBS	Fair	spalling with exposed rebar
RAILS	Good	
SIDEWALK	Fair	Cracks up to 1/8" every 3-6ft, impending spall
DRAINS	N/A	
JOINTS	Fair

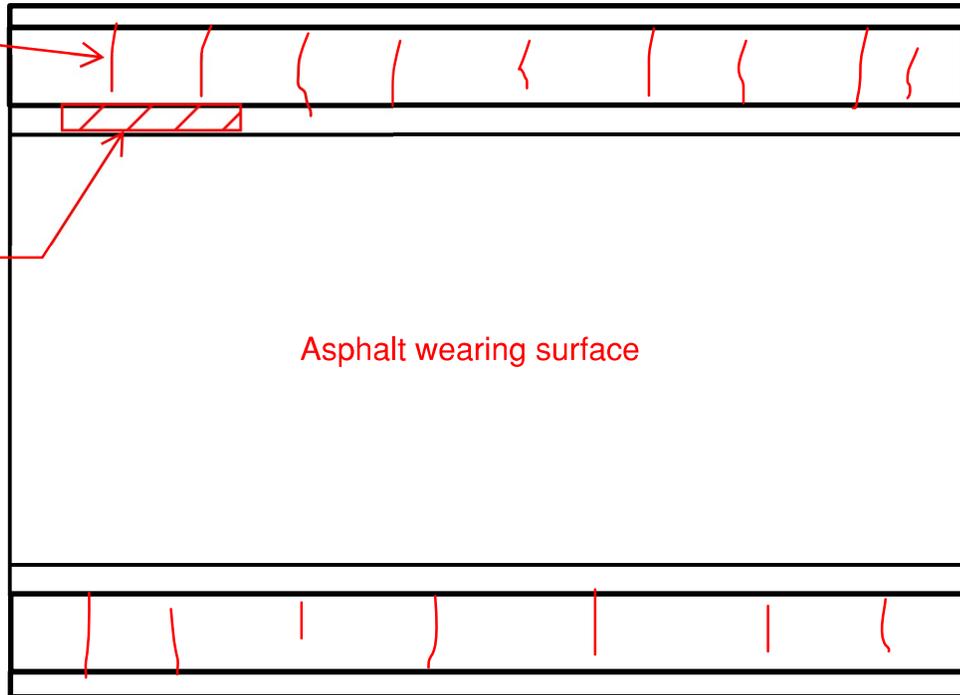
Transverse cracks (typ)

Spall with exposed rebar 4' long x 8" wide x 8" deep

DECK	N/V	Longitudinal and transverse cracks up to 1"
CURBS	Fair	spalling with exposed rebar
RAILS	Good	
SIDEWALK	Fair	Cracks up to 1/8" every 3-6ft
DRAINS	Good	
JOINTS	N/A

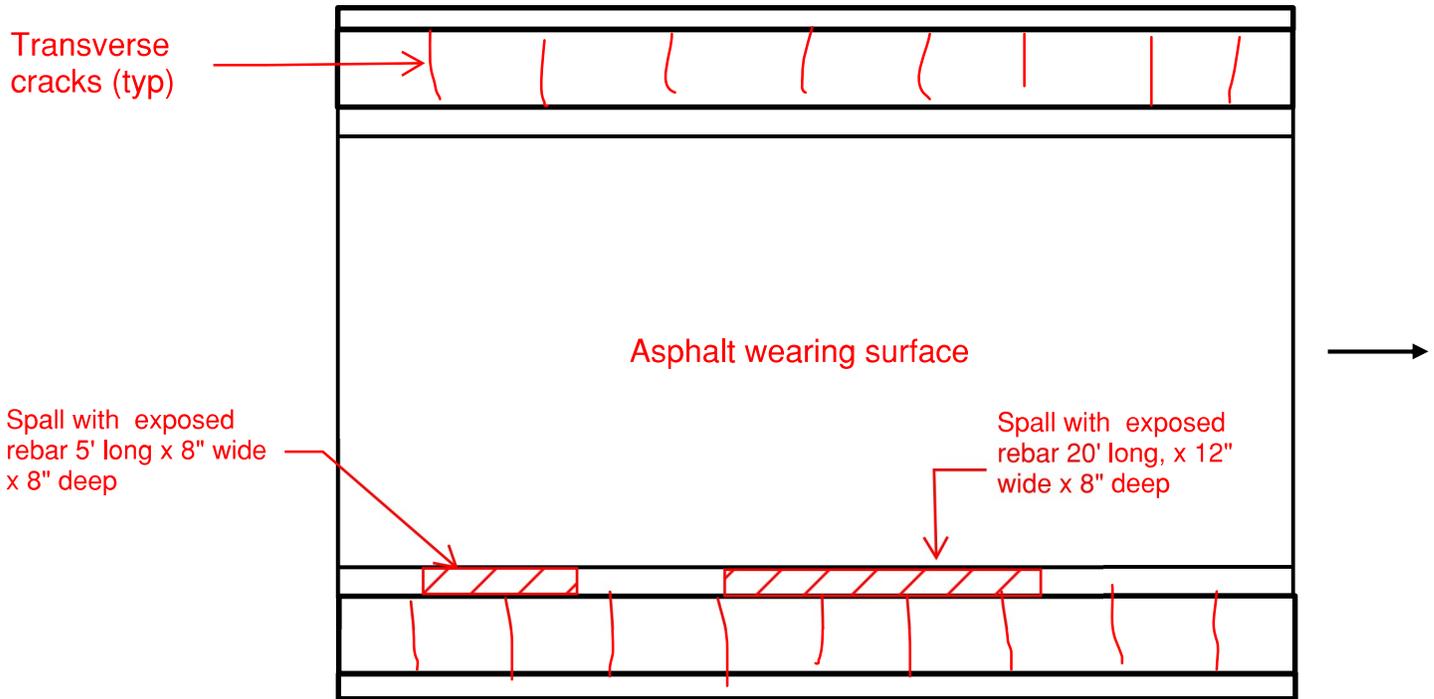
DECK	N/V	Longitudinal and transverse cracks up to 1",
CURBS	Fair	spalling with exposed rebar
RAILS	Good	
SIDEWALK	Fair	Cracks up to 1/8" every 3-6ft
DRAINS	N/A	
JOINTS	N/A

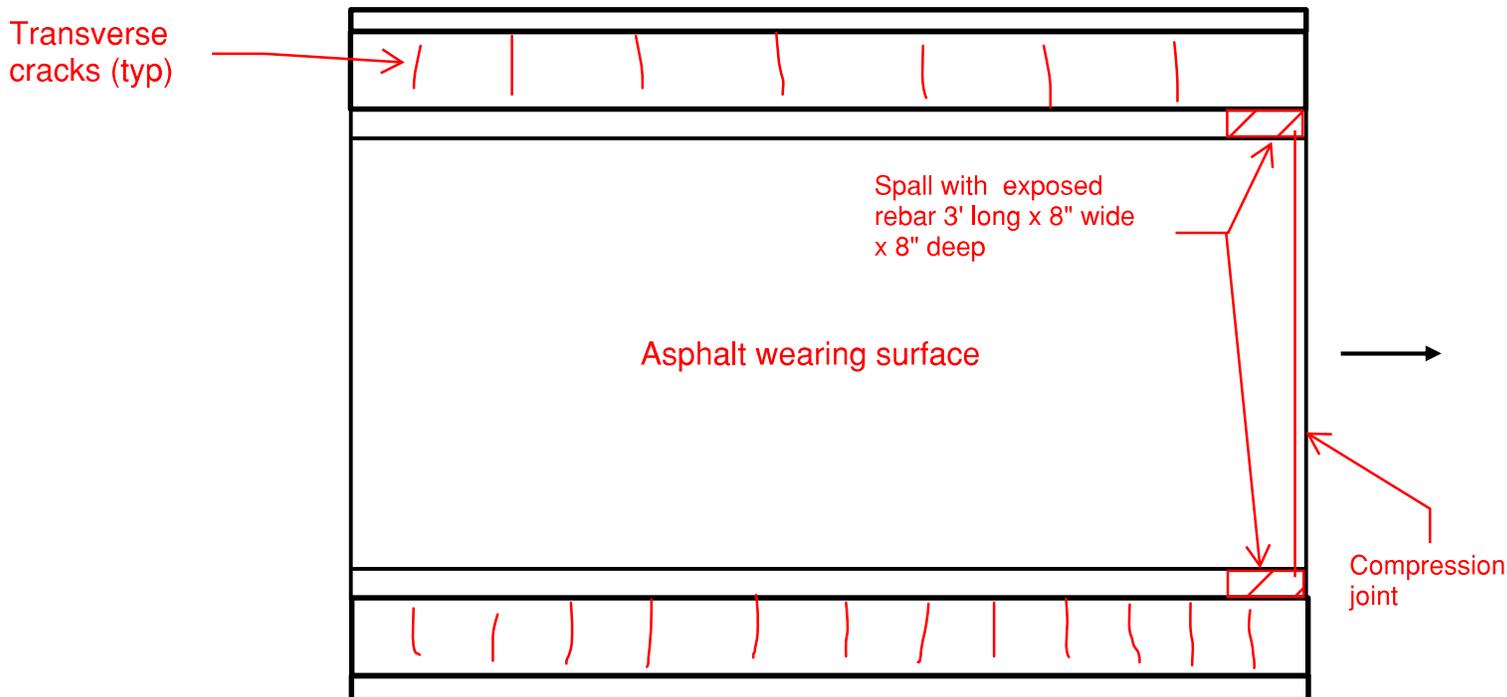
DECK	N/V	Longitudinal and transverse cracks up to 1", patching near joint
CURBS	Fair	spalling with exposed rebar
RAILS	Good	
SIDEWALK	Fair	Cracks up to 1/8" every 3-6ft
DRAINS	Fair	Medium to wide cracks in the concrete header
JOINTS	Fair	Joint seal is near fully compressed at 75 deg. Deteriorated concrete header with edge spalls, previous conc and asphalt repair patches.

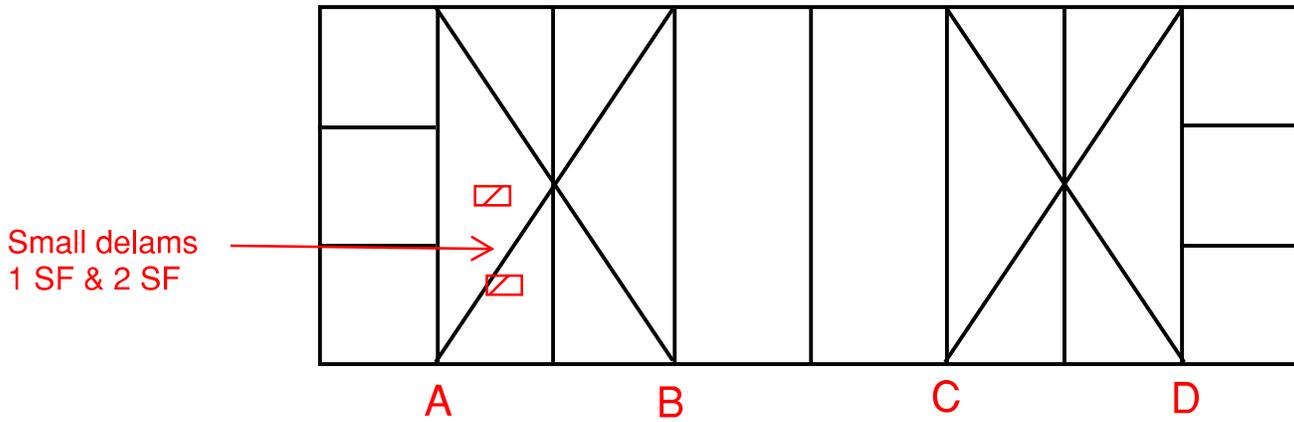
Panel # 1

DECK	Good	
FLOOR BEAMS	Good	
GIRDERS	Good	
STRINGERS	Good	
LATERAL BRACING	Good	
SIDEWALK BRACKETS	Good

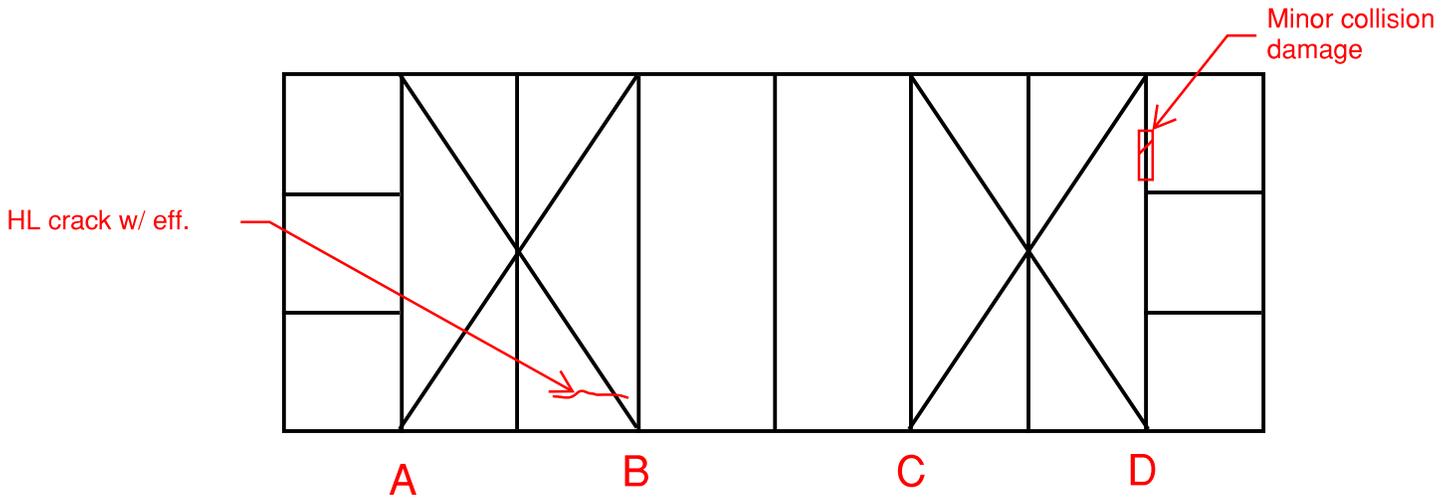
Panel # 2

DECK	Good	HL crack w/ eff
FLOOR BEAMS	Good	
GIRDERS	Good	Minor collision damage to Girder D
STRINGERS	Good	
LATERAL BRACING	Good	
SIDEWALK BRACKETS	Good

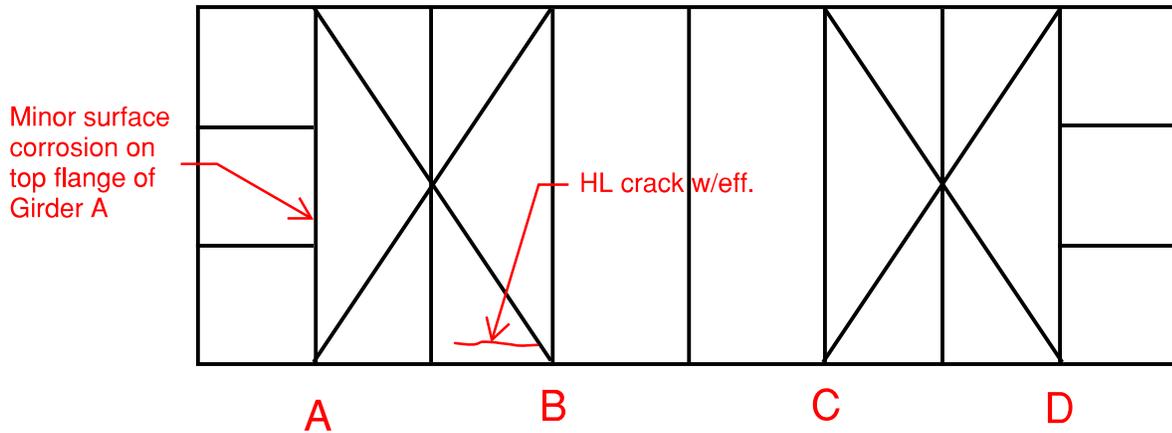
Panel # 3

DECK	Good	HL crack w/ eff
FLOOR BEAMS	Good	
GIRDERS	Good	Minor surface corrosion on top flange of Girder A
STRINGERS	Good	
LATERAL BRACING	Good	
SIDEWALK BRACKETS	Good

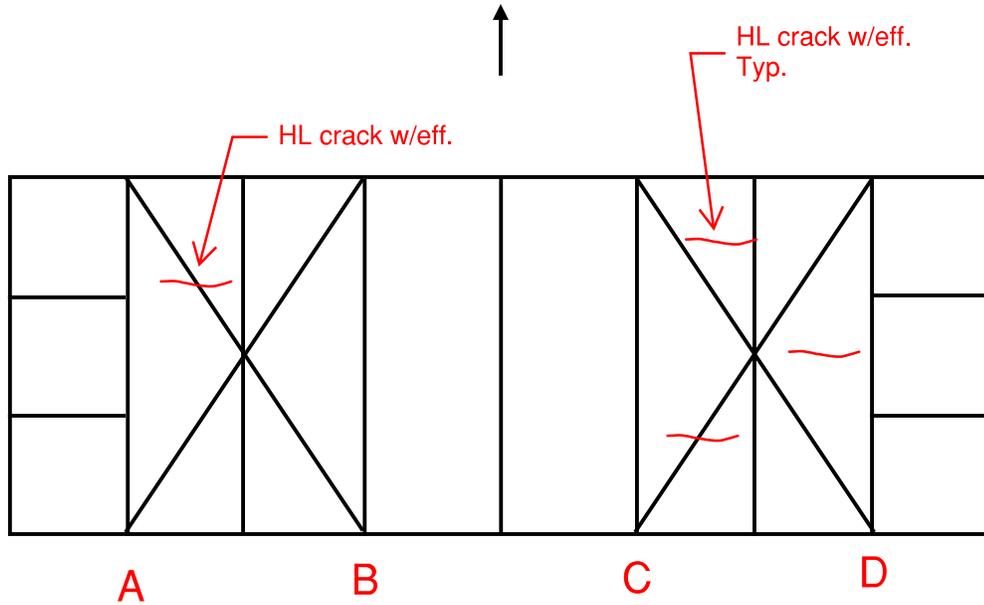
Panel # 4

DECK	Good	HL cracks w/ eff
FLOOR BEAMS	Good	
GIRDERS	Good	
STRINGERS	Good	
LATERAL BRACING	Good	
SIDEWALK BRACKETS	Good

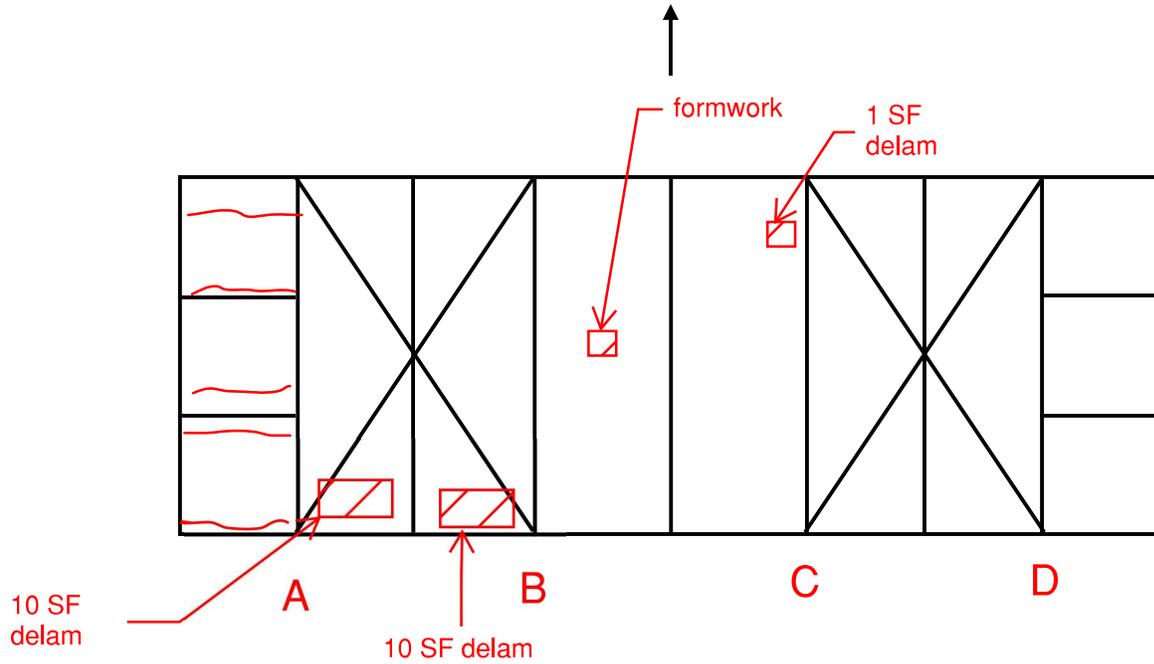
**Panel # 5**

DECK	Fair	Areas of delamination and previous formwork
FLOOR BEAMS	Good	
GIRDERS	Good	
STRINGERS	Good	
LATERAL BRACING	Good	
SIDEWALK BRACKETS	Good
