JAMES ROBERTSON PKWY. Crossing CUMBERLAND RIVER

Inspection Date(s): 05/15/2025 - 05/15/2025

IDENTIFICATION	
(1) State Names	47 - Tennessee
(8) Structure Number	19SR0060015
(5) Inventory Route	1
(2) Highway Agency District	Region 3
(3) County Code	19 - Davidson

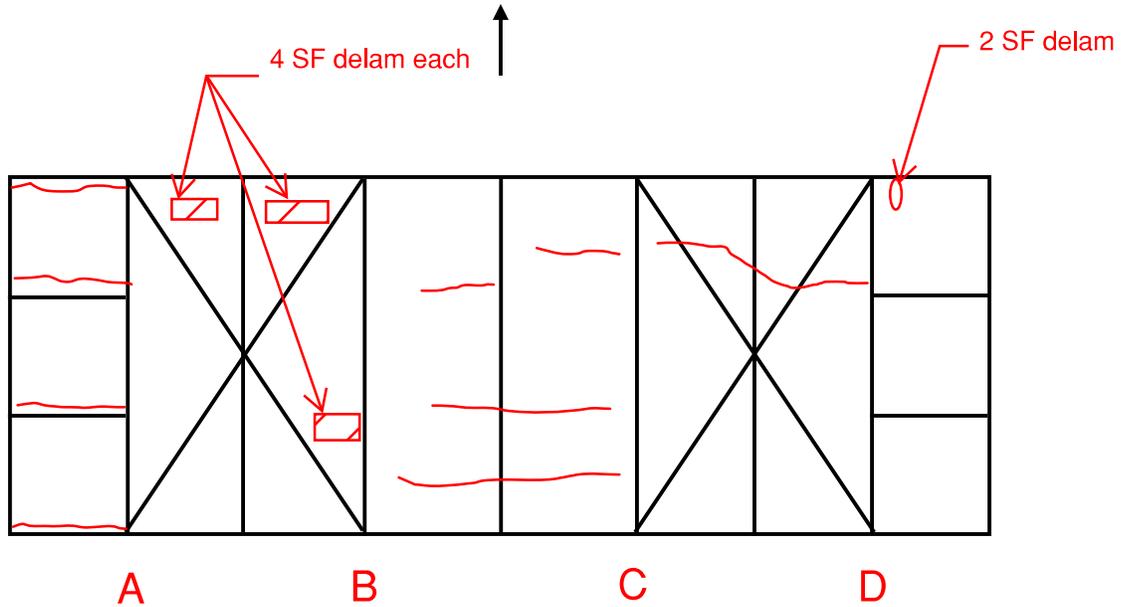
Panel # 6

DECK	Fair	Areas of delamination and cracks up to 1/32"
FLOOR BEAMS	Good	
GIRDERS	Good	
STRINGERS	Good	
LATERAL BRACING	Good	
SIDEWALK BRACKETS	Good

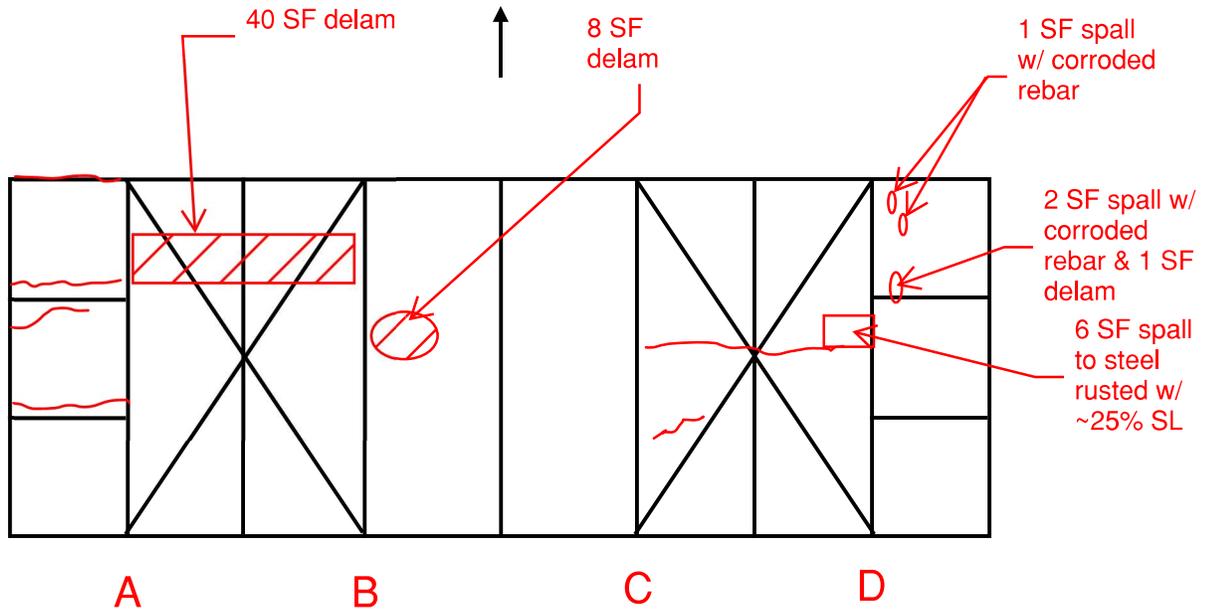
Panel # 7

DECK	Fair	Areas of delamination, spalls to steel with section loss, and cracks up to 1/32"
FLOOR BEAMS	Good	
GIRDERS	Good	
STRINGERS	Good	
LATERAL BRACING	Good	
SIDEWALK BRACKETS	Good	Spalls to steel with corrosion on rebar

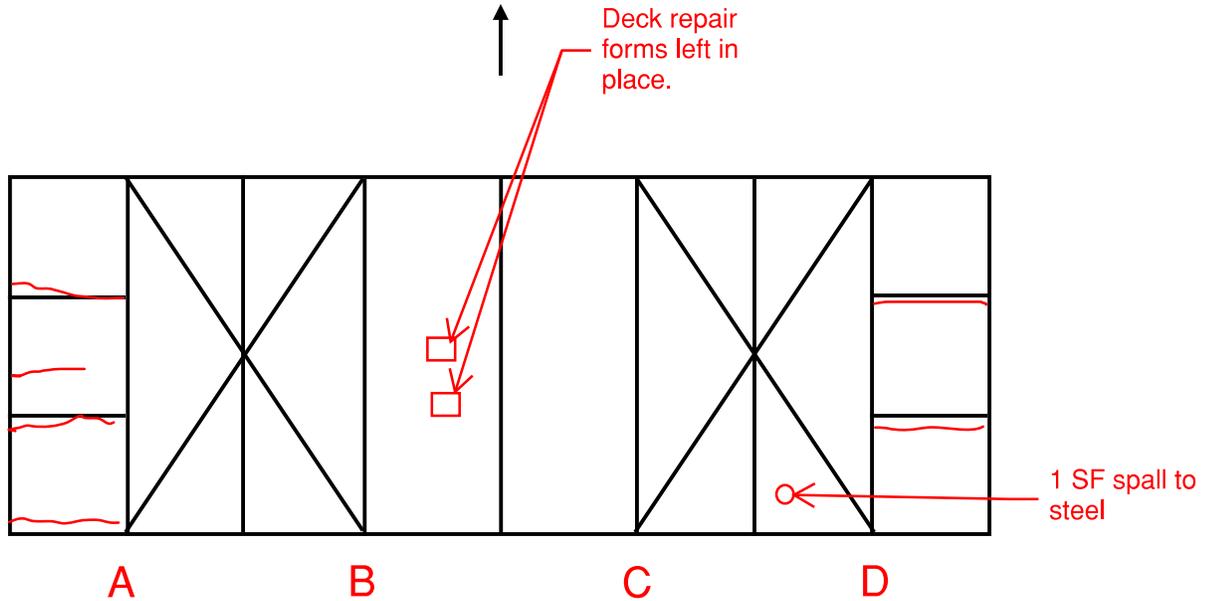
Panel # 8

DECK	Fair	Spalling to steel, cracks up to 1/32" and leftover formwork
FLOOR BEAMS	Good	
GIRDERS	Good	
STRINGERS	Good	
LATERAL BRACING	Good	
SIDEWALK BRACKETS	Good

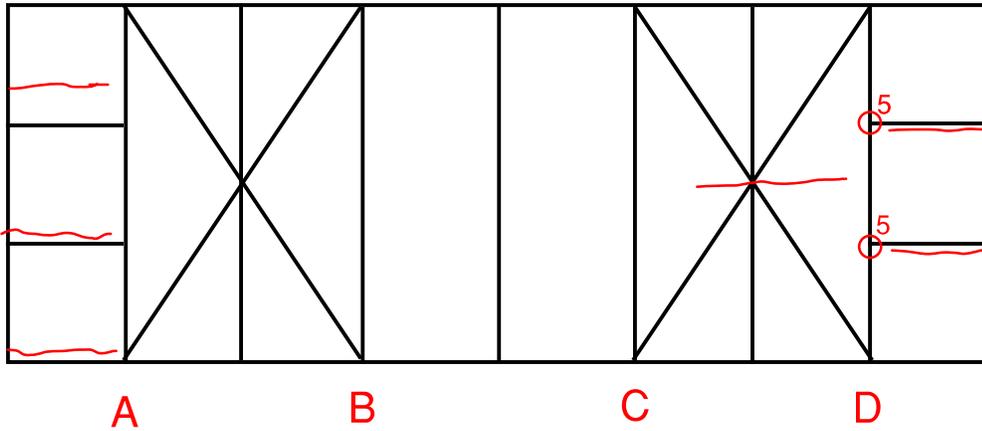
Panel # 9

5 - 100% SL of overhang strut at top flange of girder.

DECK	Good	HL cracks
FLOOR BEAMS	Good	
GIRDERS	Good	
STRINGERS	Good	
LATERAL BRACING	Good	
SIDEWALK BRACKETS	Fair	See 5

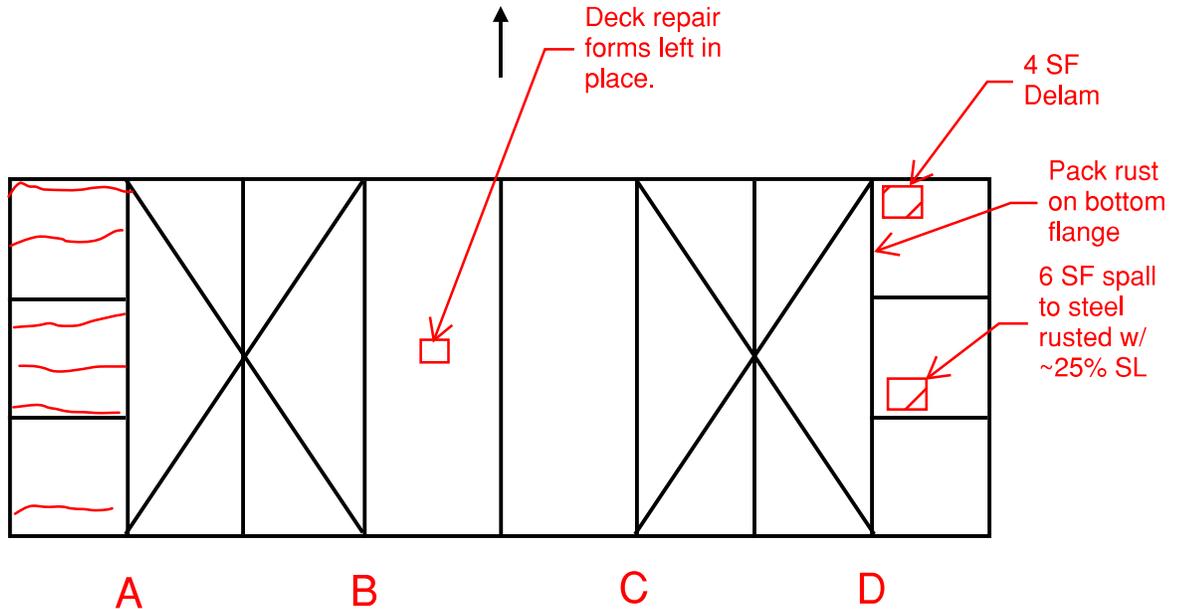
**Panel # 10**

DECK	Fair	Areas of delamination, spalls to steel with section loss, and HL cracks
FLOOR BEAMS	Good	
GIRDERS	Fair	Pack rust on bottom flange, exterior Girder D for 30 LF
STRINGERS	Good	
LATERAL BRACING	Good	
SIDEWALK BRACKETS	Poor	Delaminated areas, and areas of section loss up to 100%

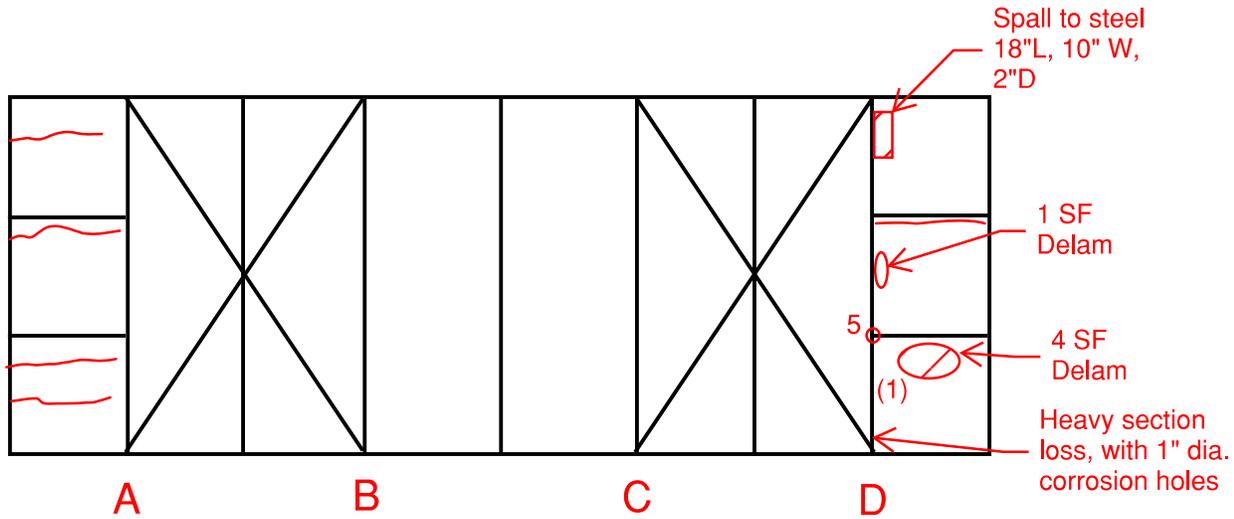
Panel # 1

5 - 100% SL of overhang strut at top flange of girder.

DECK	Good	HL cracks
FLOOR BEAMS	Good	
GIRDERS	Fair	(1) 25% localized section loss at top flange
STRINGERS	Good	
LATERAL BRACING	Good	
SIDEWALK BRACKETS	Poor	See 5, heavy section loss with corrosion holes present

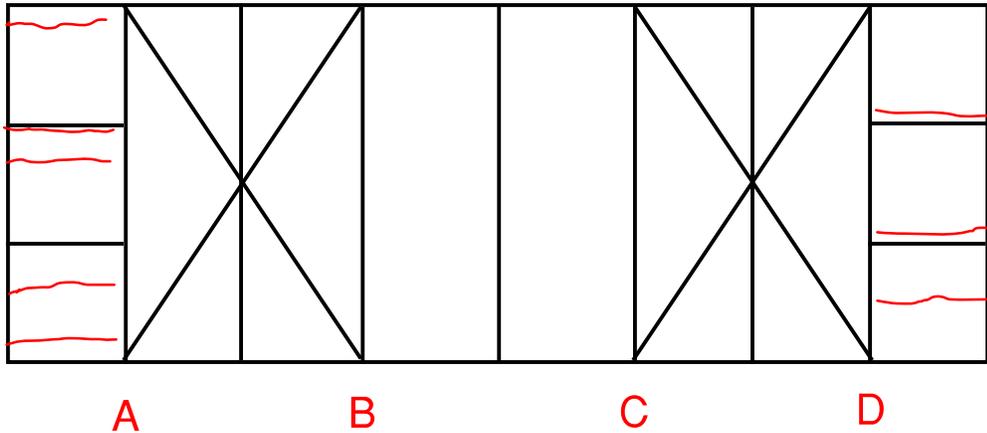
Panel # 2

DECK	Good	HL cracks
FLOOR BEAMS	Good	
GIRDERS	Good	
STRINGERS	Good	
LATERAL BRACING	Good	
SIDEWALK BRACKETS	Good

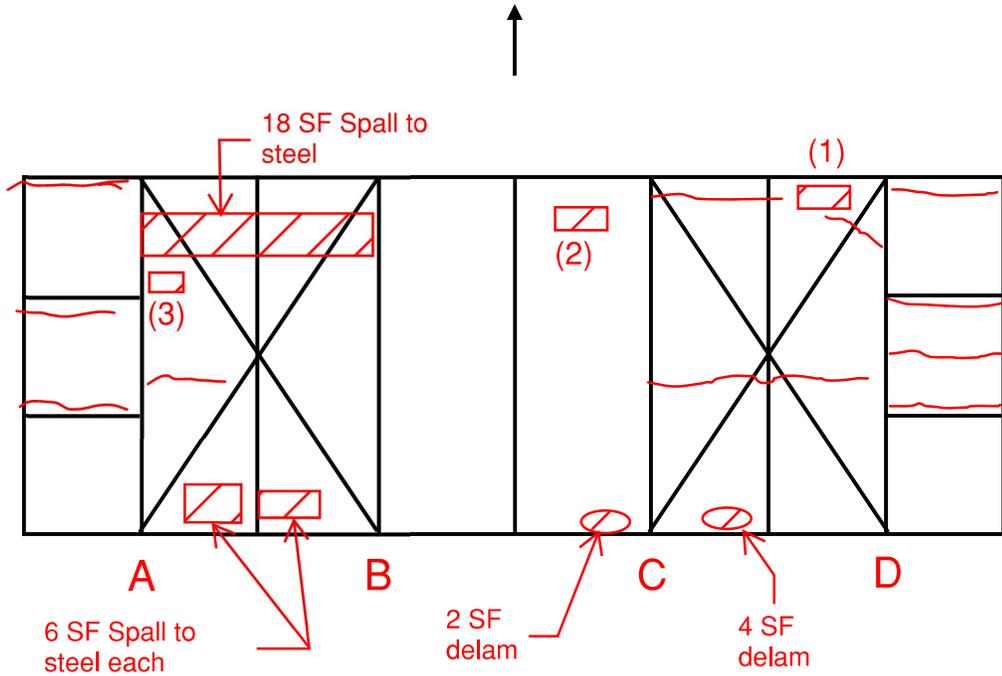
Panel # 3

DECK	Fair	See (1),(2),(3), spalls to steel, areas of delamination, cracks up to 1/32"
FLOOR BEAMS	Good	Minor surface corrosion on Floorbeam "D"
GIRDERS	Good	
STRINGERS	Good	
LATERAL BRACING	Good	
SIDEWALK BRACKETS	Good

- (1) Spall to steel 3 SF x up to 2" D
- (2) Spall/delam 4 SF x up to 2" D
- (3) Spall to steel 0.5 SF x up to 2" D

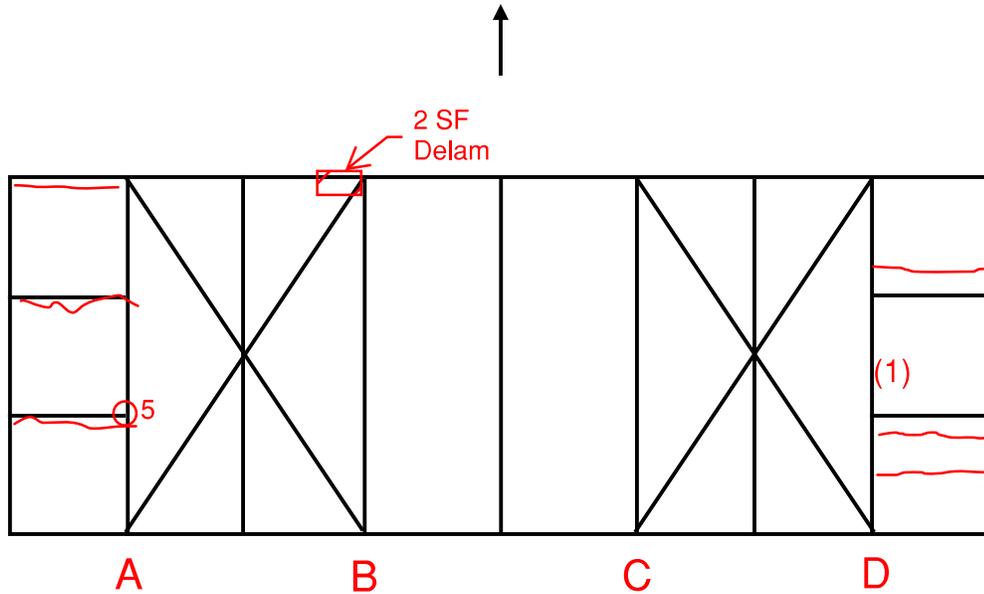
Panel # 4

5 - 100% SL of overhang strut at top flange of girder.

DECK	Good	
FLOOR BEAMS	Good	
GIRDERS	Fair	See (1)
STRINGERS	Good	
LATERAL BRACING		
SIDEWALK BRACKETS	Good

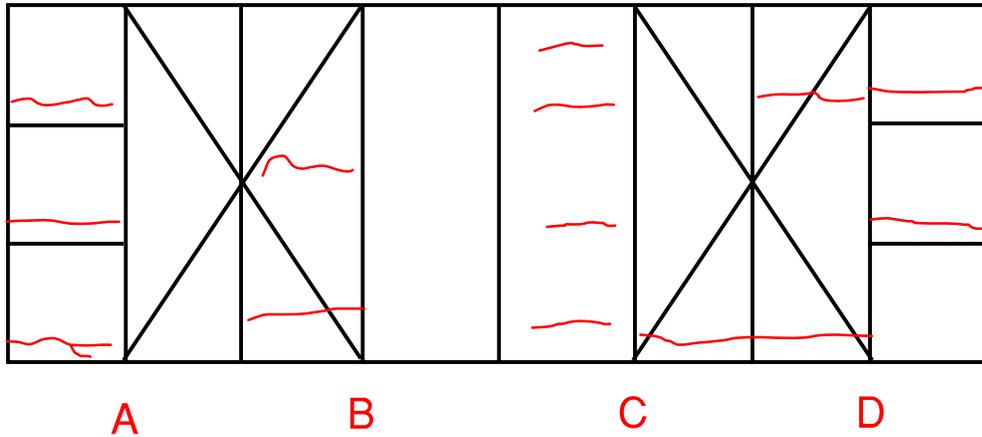
Panel # 5

DECK	Good	HL cracks
FLOOR BEAMS	Good	
GIRDERS	Good	
STRINGERS	Good	
LATERAL BRACING	Good	
SIDEWALK BRACKETS	Good

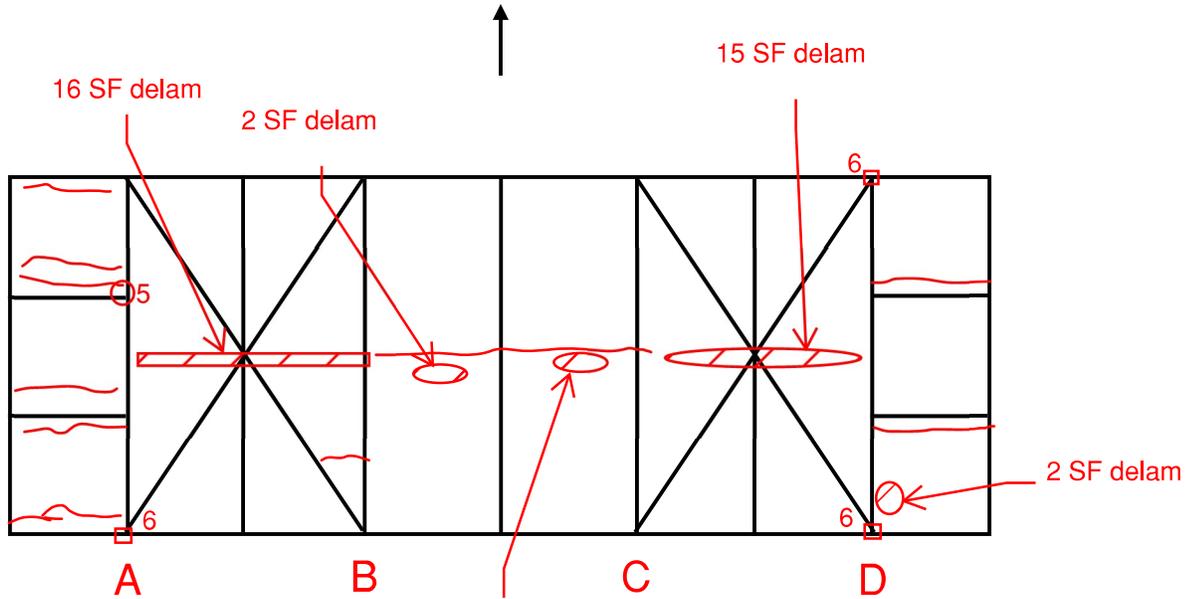
**Panel # 6**

5 - 100% SL of overhang strut at top flange of girder.  
 6 - heavy corrosion of tie plate for overhang bracket.

2 SF spall w/ 1 rusted rebar

DECK	Fair	HL cracks, areas of delamination, spalls to steel with rebar corrosion
FLOOR BEAMS	Good	
GIRDERS	Good	
STRINGERS	Good	
LATERAL BRACING	Good	
SIDEWALK BRACKETS	Poor	Areas of heavy corrosion with up to 100% section loss See 5 and 6

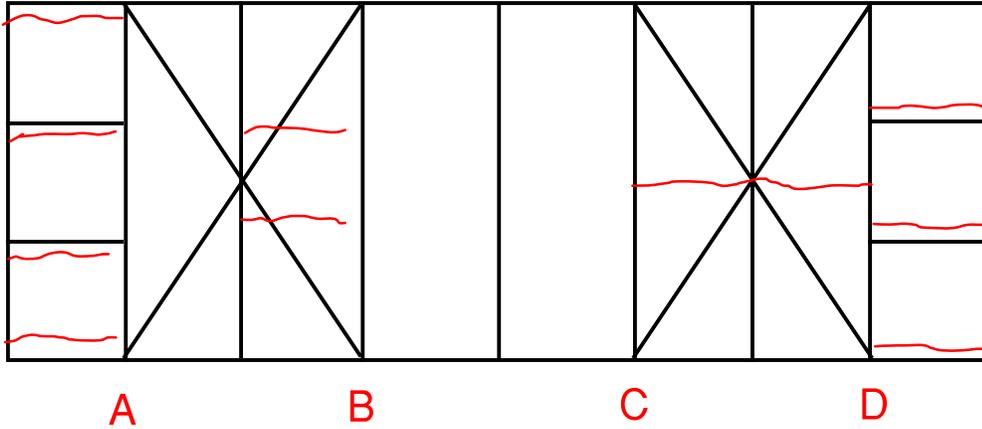
Panel # 7

DECK	Good	HL cracks
FLOOR BEAMS	Good	
GIRDERS	Good	
STRINGERS	Good	
LATERAL BRACING	Good	
SIDEWALK BRACKETS	Good

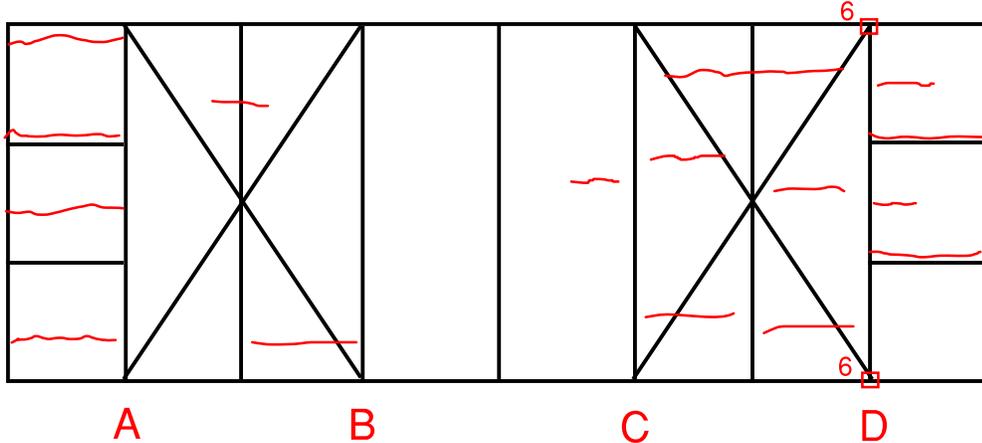
Panel # 8

6 - heavy corrosion and section loss of tie plate for overhang bracket.

DECK	Good	HL cracks
FLOOR BEAMS	Good	
GIRDERS	Good	
STRINGERS	Good	
LATERAL BRACING	Good	
SIDEWALK BRACKETS	Poor	Areas of heavy corrosion with up to 100% section loss See 6

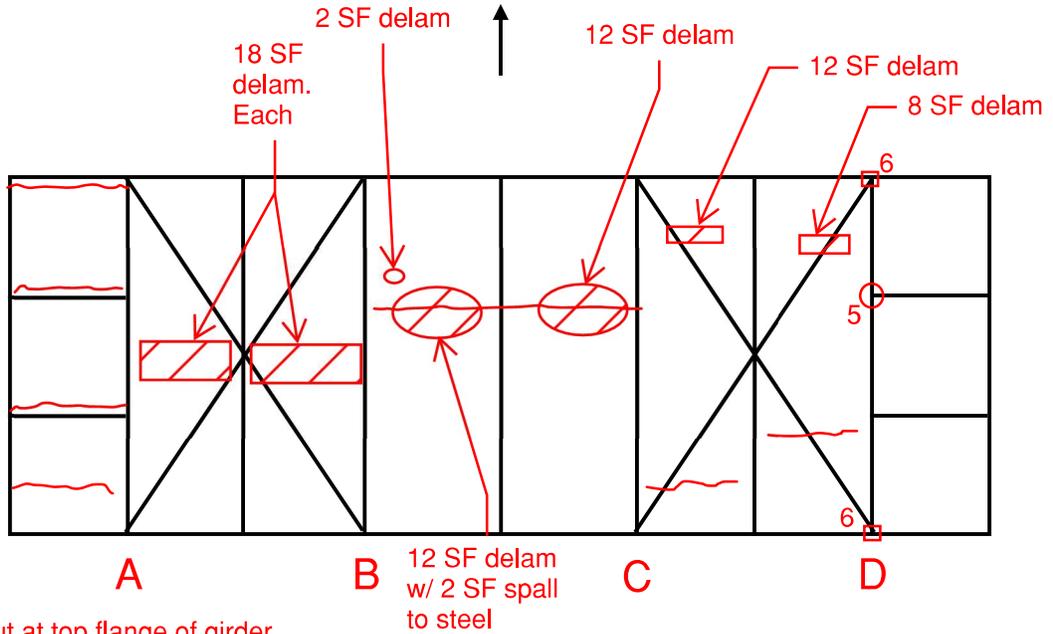
**Panel # 9**

- 5 - 100% SL of overhang strut at top flange of girder.
- 6 - heavy corrosion and section loss of tie plate for overhang bracket.

DECK	Fair	HL cracks, areas of delamination, and spalls to steel
FLOOR BEAMS	Good	
GIRDERS	Good	
STRINGERS	Good	
LATERAL BRACING	Good	
SIDEWALK BRACKETS	Poor	Areas of heavy corrosion with up to 100% section loss See 5 and 6

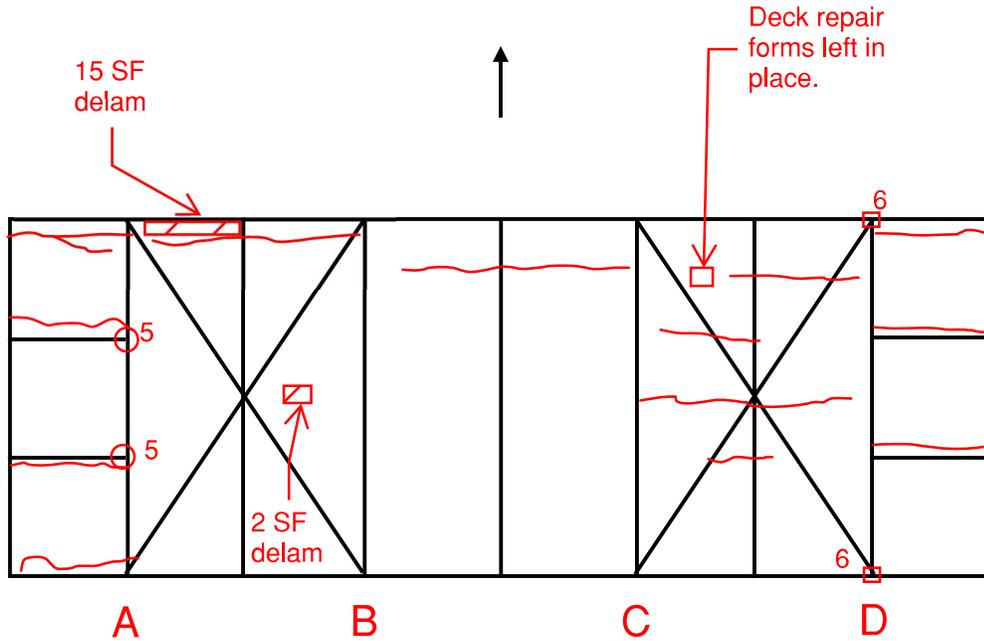
**Panel # 10**

5 - 100% SL of overhang strut at top flange of girder.  
 6 - heavy corrosion of tie plate for overhang bracket.

DECK	Fair	HL cracks, areas of delamination, leftover formwork
FLOOR BEAMS	Good	
GIRDERS	Good	
STRINGERS	Good	
LATERAL BRACING	Good	
SIDEWALK BRACKETS	Poor	Areas of heavy corrosion with up to 100% section loss. See 5 and 6

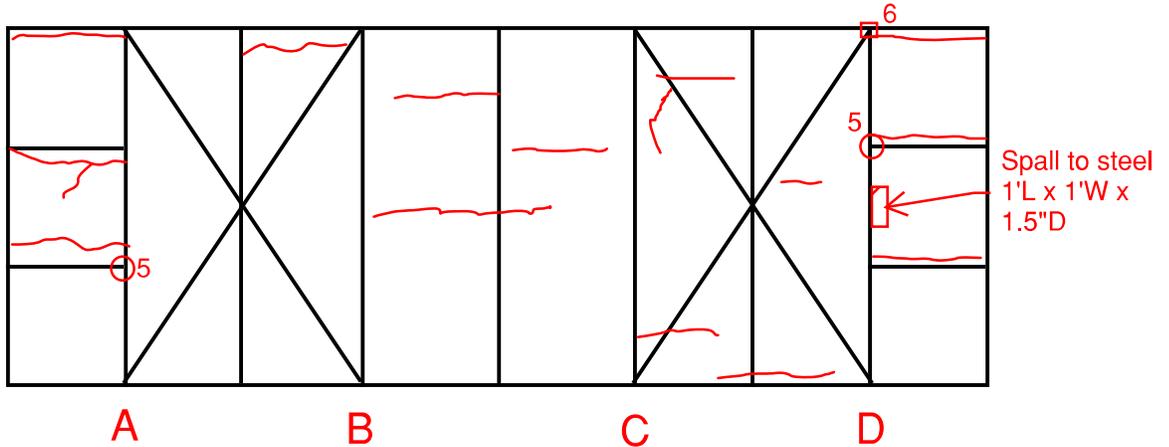
Panel # 11

- 5 - 100% SL of overhang strut at top flange of girder.
- 6 - heavy corrosion of tie plate for overhang bracket.

DECK	Good	HL cracks
FLOOR BEAMS	Good	
GIRDERS	Good	
STRINGERS	Good	
LATERAL BRACING	Good	
SIDEWALK BRACKETS	Poor	Areas of heavy corrosion with up to 100% section loss. See 5 and 6

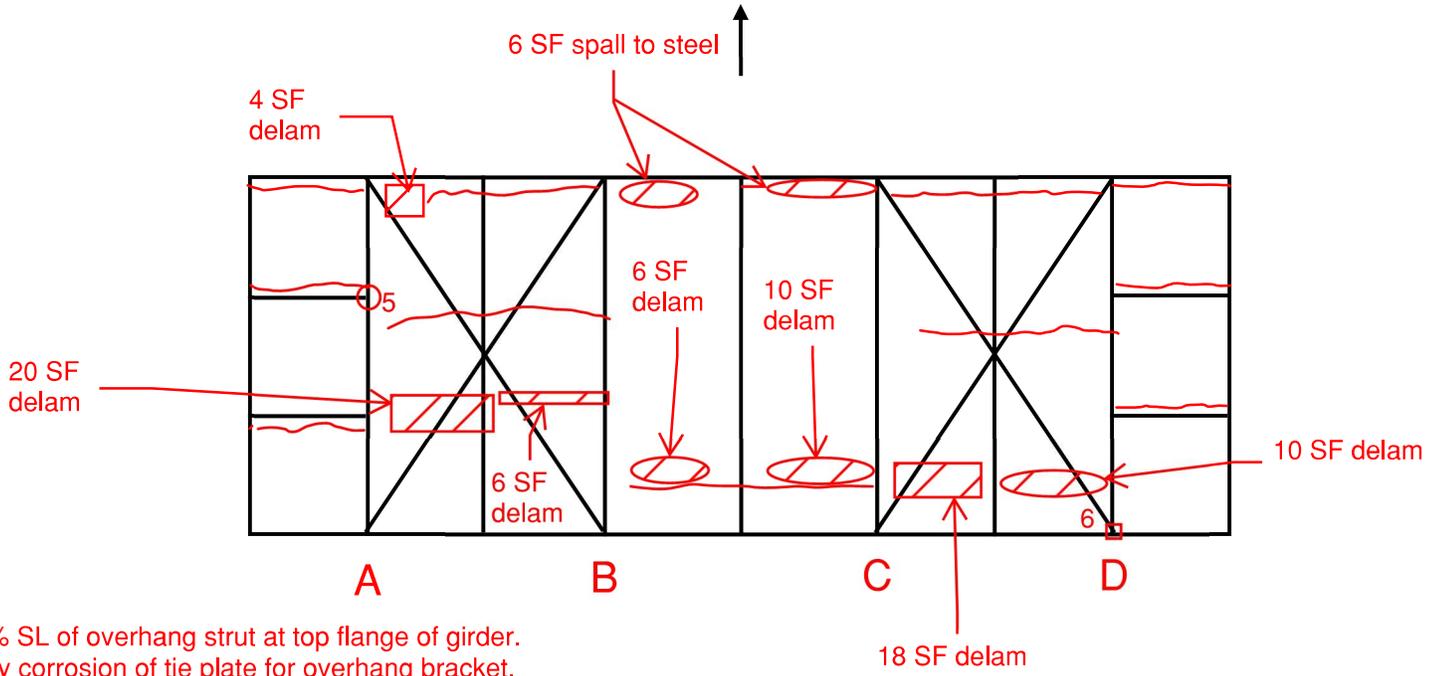
**Panel # 12**

5 - 100% SL of overhang strut at top flange of girder.  
 6 - heavy corrosion of tie plate for overhang bracket.

DECK	Good	HL cracks, areas of delamination, spalls to steel
FLOOR BEAMS	Good	
GIRDERS	Good	
STRINGERS	Good	
LATERAL BRACING	Good	
SIDEWALK BRACKETS	Poor	Areas of heavy corrosion with up to 100% section loss. See 5 and 6

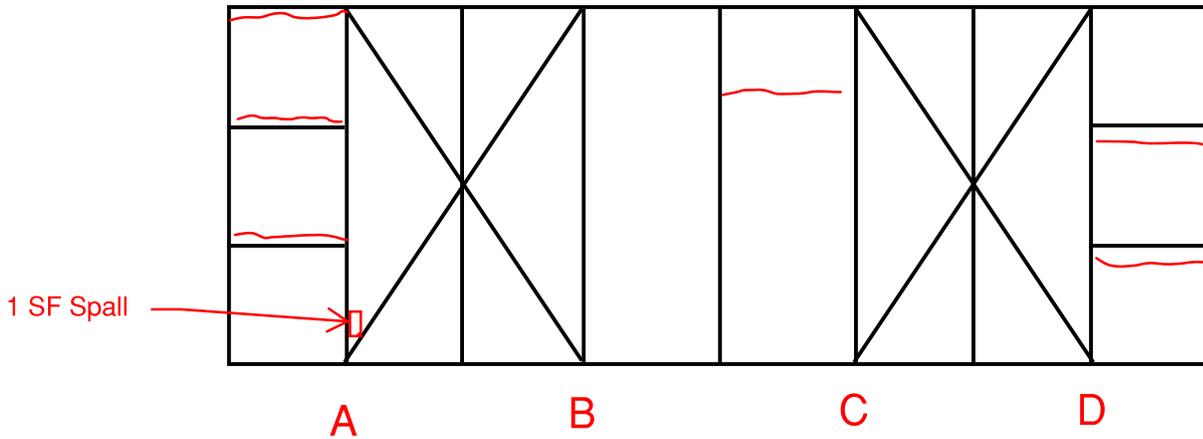
Panel # 13

DECK	Good	HL cracks, isolated spall
FLOOR BEAMS	Good	
GIRDERS	Good	
STRINGERS	Good	
LATERAL BRACING	Good	
SIDEWALK BRACKETS	Good

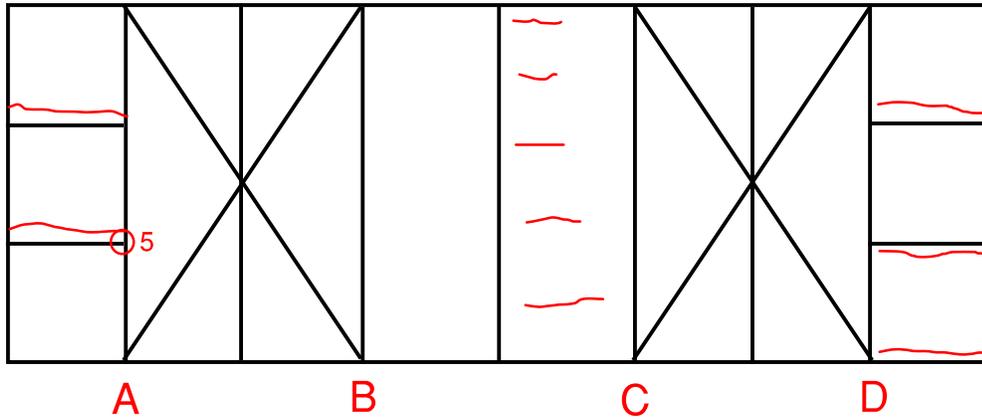
Panel # 14

5 - 100% SL of overhang strut at top flange of girder.

DECK	Good	HL cracks
FLOOR BEAMS	Good	
GIRDERS	Good	
STRINGERS	Good	
LATERAL BRACING	Good	
SIDEWALK BRACKETS	Poor	Areas of heavy corrosion with up to 100% section loss. See 5

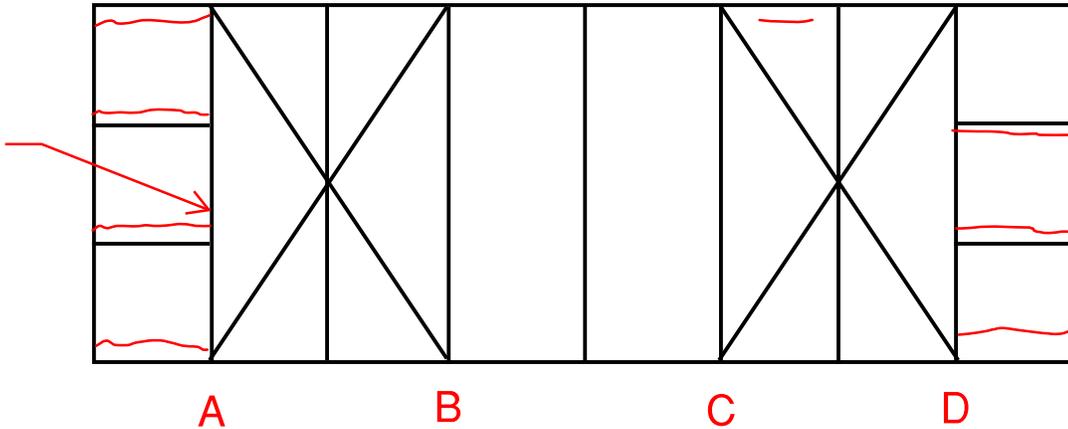
Girder A  
 Bottom  
 Flange up to  
 1/2" Thick  
 pack rust

DECK	Good	HL cracks
FLOOR BEAMS	Good	
GIRDERS	Fair	Girder A bottom flange pack rust
STRINGERS	Good	
LATERAL BRACING	Good	
SIDEWALK BRACKETS	Good

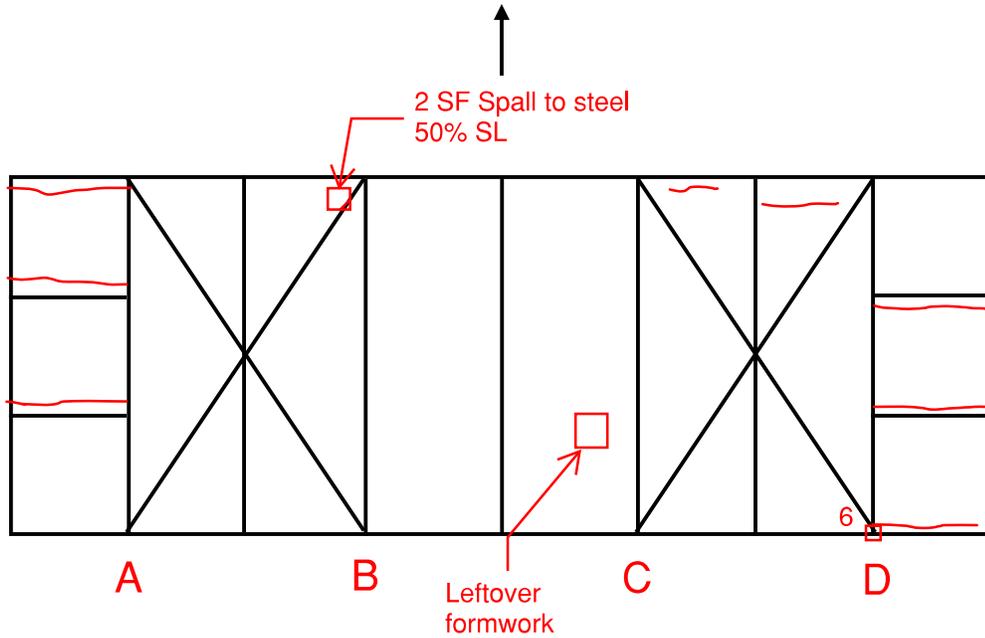
Panel # 2

6 - heavy corrosion of tie plate for overhang bracket.

DECK	Good	HL cracks, isolated spall to steel, leftover formwork
FLOOR BEAMS	Good	
GIRDERS	Good	
STRINGERS	Good	
LATERAL BRACING	Good	
SIDEWALK BRACKETS	Fair	Areas of heavy corrosion. See 6

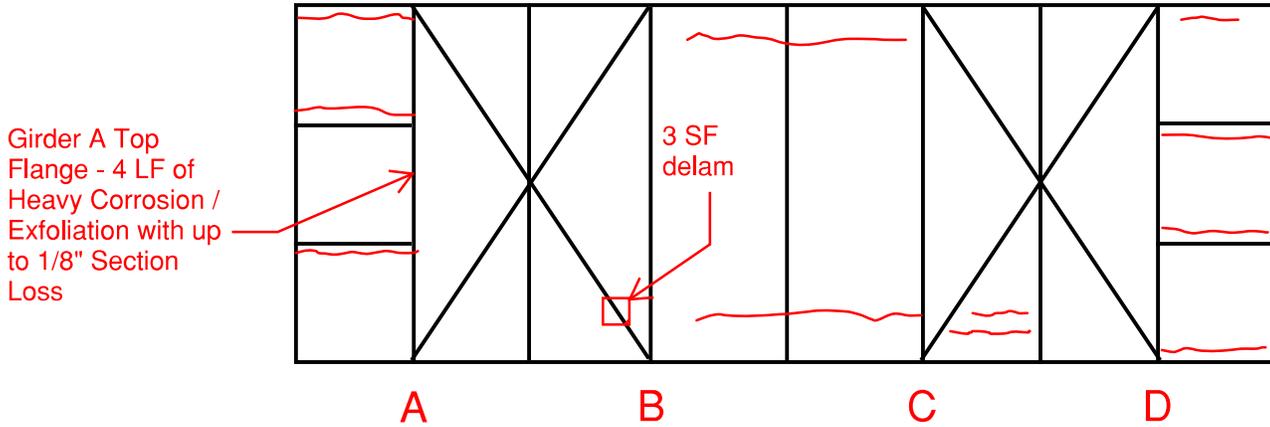
Panel # 3

DECK	Good	HL cracks, isolated area of delamination
FLOOR BEAMS	Good	
GIRDERS	Fair	Girder A Top Flange - 4 LF of Heavy Corrosion / Exfoliation with up to 1/8" Section Loss
STRINGERS	Good	
LATERAL BRACING	Good	
SIDEWALK BRACKETS	Good

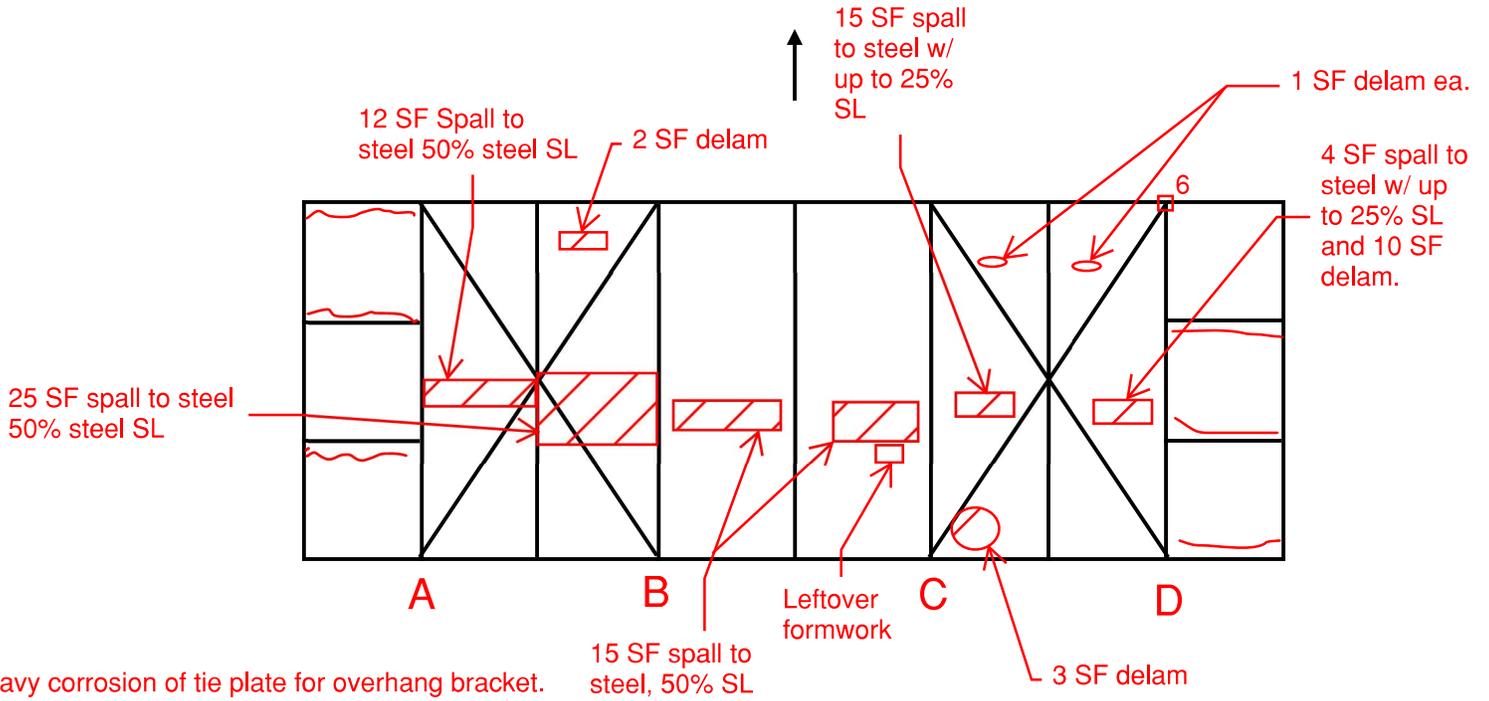
## Panel # 4

DECK	Fair	HL cracks, areas of delamination, spalls to steel with section loss, leftover formwork
FLOOR BEAMS	Good	
GIRDERS	Good	
STRINGERS	Good	
LATERAL BRACING	Good	
SIDEWALK BRACKETS	Fair	Heavy corrosion. See 6

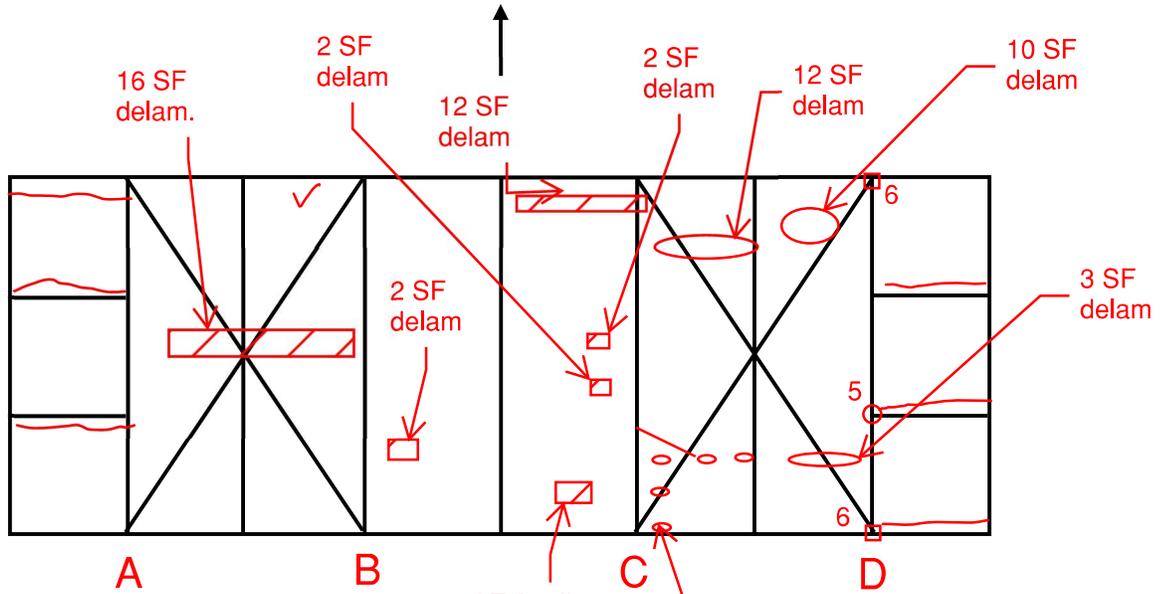
**Panel # 5**

5 - 100% SL of overhang strut at top flange of girder.  
 6 - heavy corrosion of tie plate for overhang bracket.

DECK	Fair	HL cracks, areas of delamination and spalls to steel
FLOOR BEAMS	Good	
GIRDERS	Good	
STRINGERS	Good	
LATERAL BRACING	Good	
SIDEWALK BRACKETS	Poor	Areas of heavy corrosion with up to 100% section loss. See 5 and 6

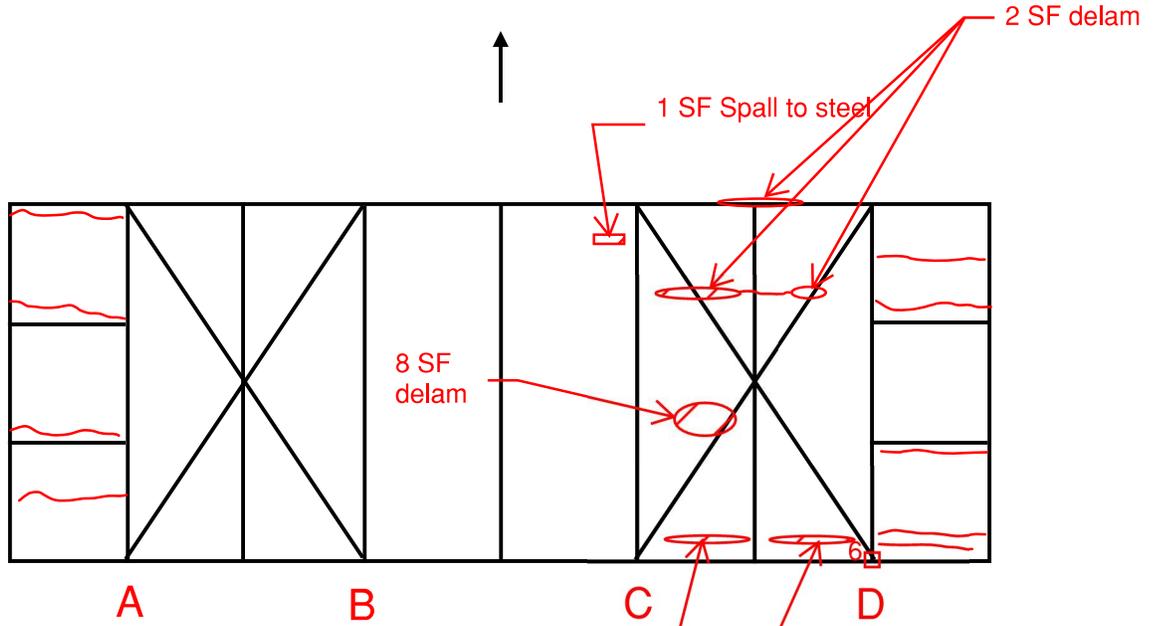
**Panel # 6**

6 - heavy corrosion of tie plate for overhang bracket.

2 SF spall to steel 2 SF delam

DECK	Fair	HL cracks, areas of delamination, and spalls to steel
FLOOR BEAMS	Good	
GIRDERS	Good	
STRINGERS	Good	
LATERAL BRACING	Good	
SIDEWALK BRACKETS	Fair	Areas of heavy corrosion. See 6

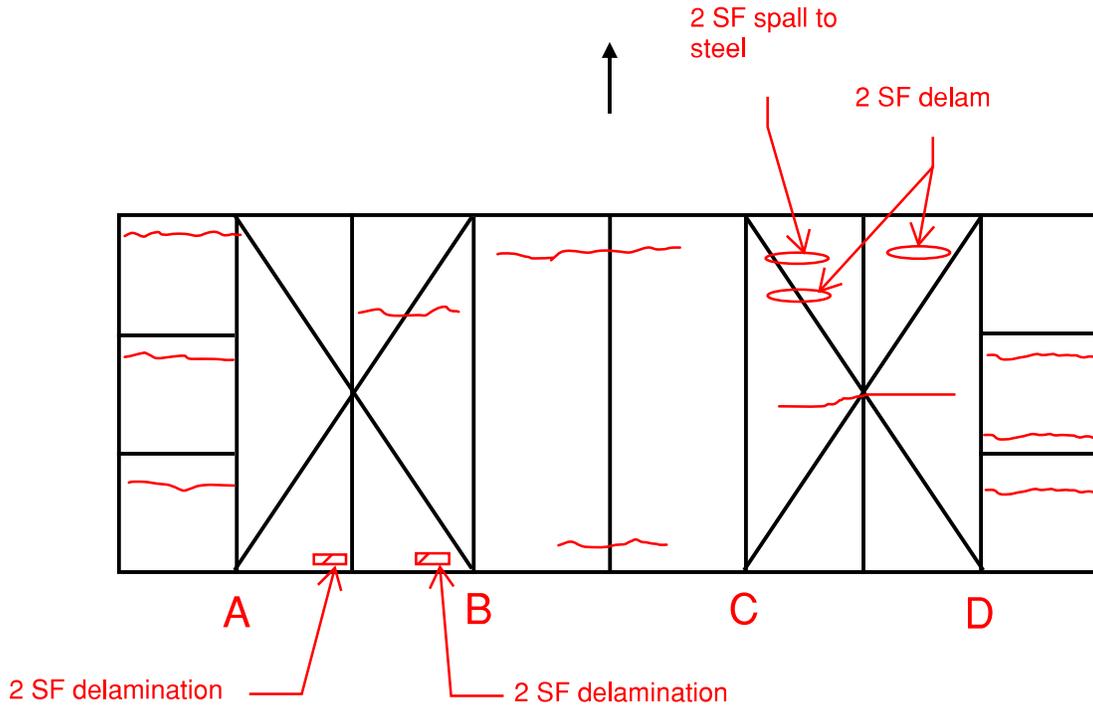
Panel # 7

DECK	Fair	HL cracks, areas of delamination, and spalls to steel
FLOOR BEAMS	Good	
GIRDERS	Good	
STRINGERS	Good	
LATERAL BRACING	Good	
SIDEWALK BRACKETS	Good

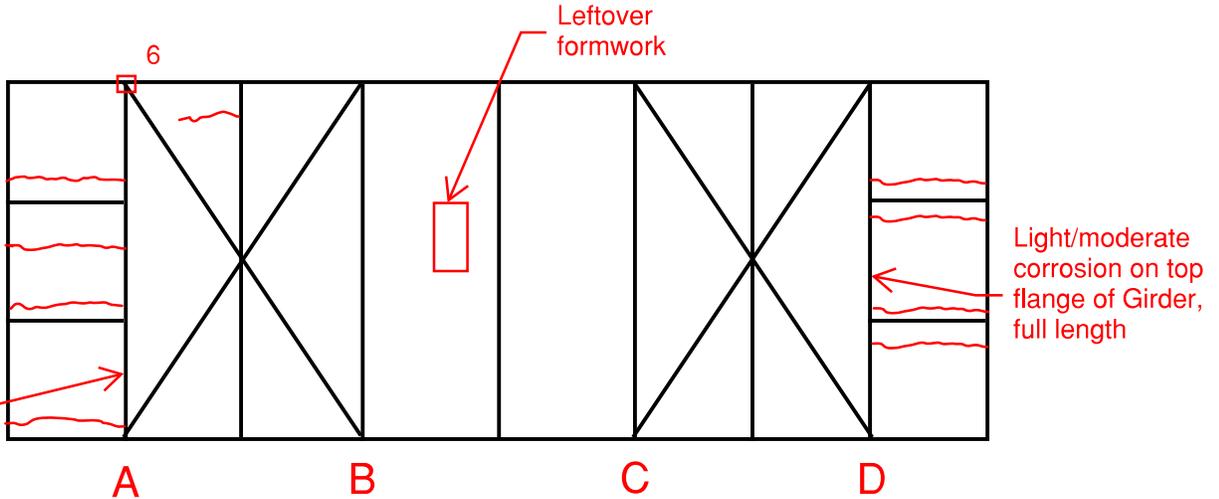
Panel # 8

Light/moderate corrosion on top flange of Girder, full length

6 - heavy corrosion of tie plate for overhang bracket.

DECK	Good	HL cracks, and leftover formwork
FLOOR BEAMS	Good	
GIRDERS	Fair	Light to moderate corrosion along exterior top FL of Girders A & D.
STRINGERS	Good	
LATERAL BRACING	Good	
SIDEWALK BRACKETS	Fair	Areas of heavy corrosion. See 6

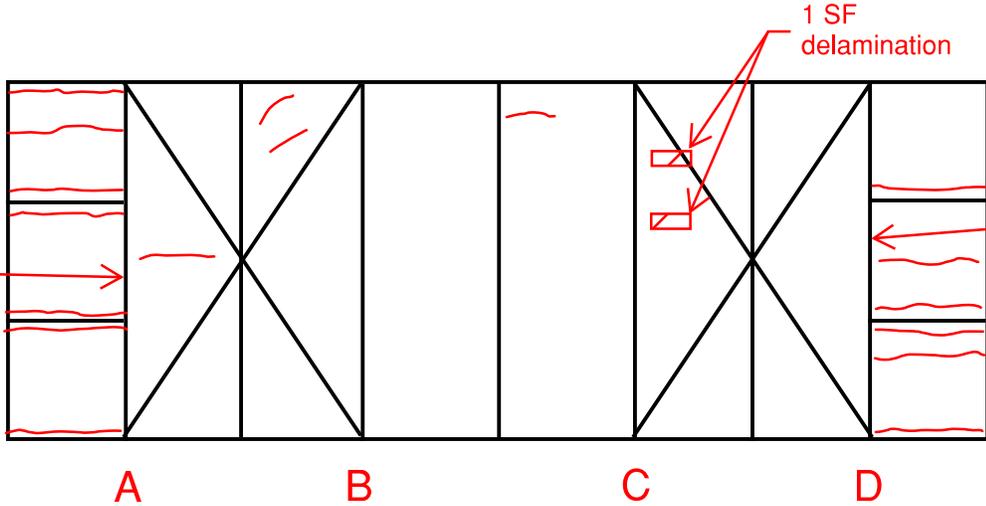
Panel # 9

DECK	Fair	HL cracks, and areas of delamination
FLOOR BEAMS	Good	
GIRDERS	Fair	Light to moderate corrosion along exterior top FL of Girders A & D.
STRINGERS	Good	
LATERAL BRACING	Good	
SIDEWALK BRACKETS	Good

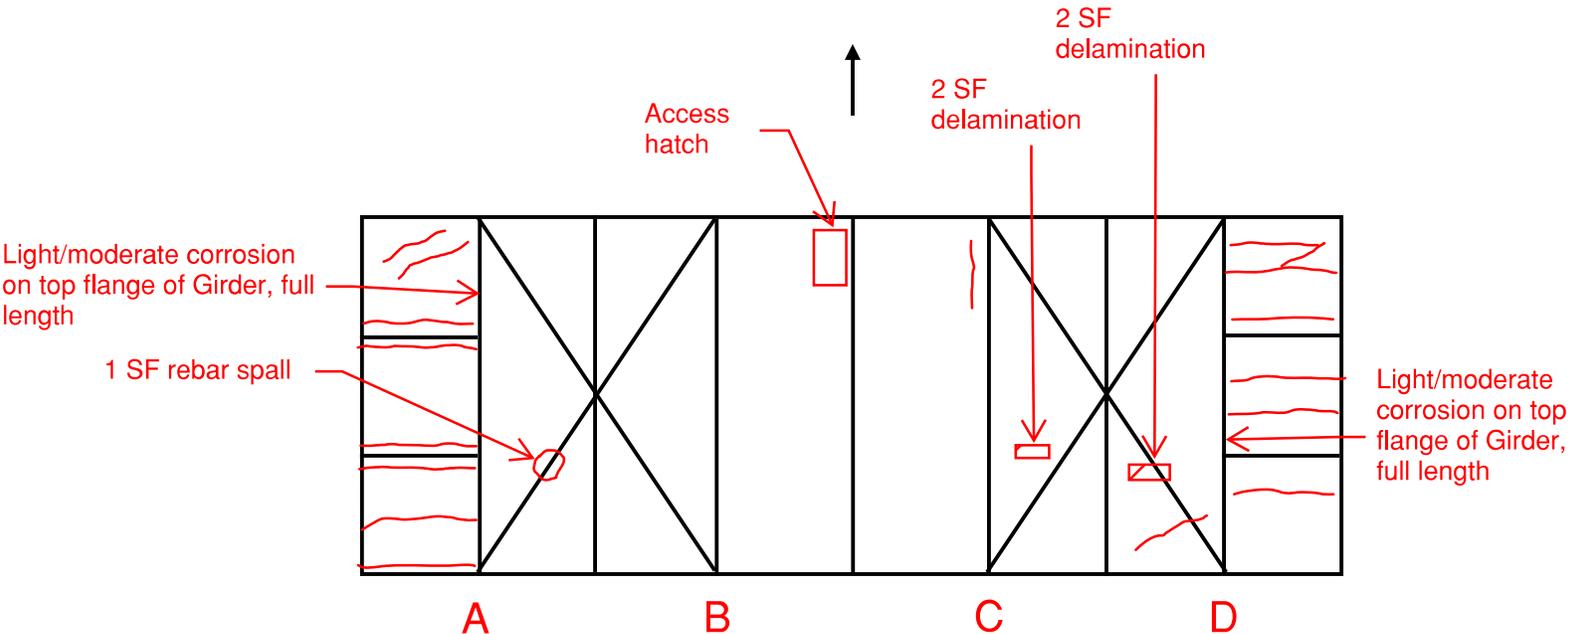
## Panel # 10

DECK	Fair	HL cracks, areas of delamination, and spalls to steel
FLOOR BEAMS	Good	
GIRDERS	Fair	Light to moderate corrosion along exterior top FL of Girders A & D.
STRINGERS	Good	
LATERAL BRACING	Good	
SIDEWALK BRACKETS	Good

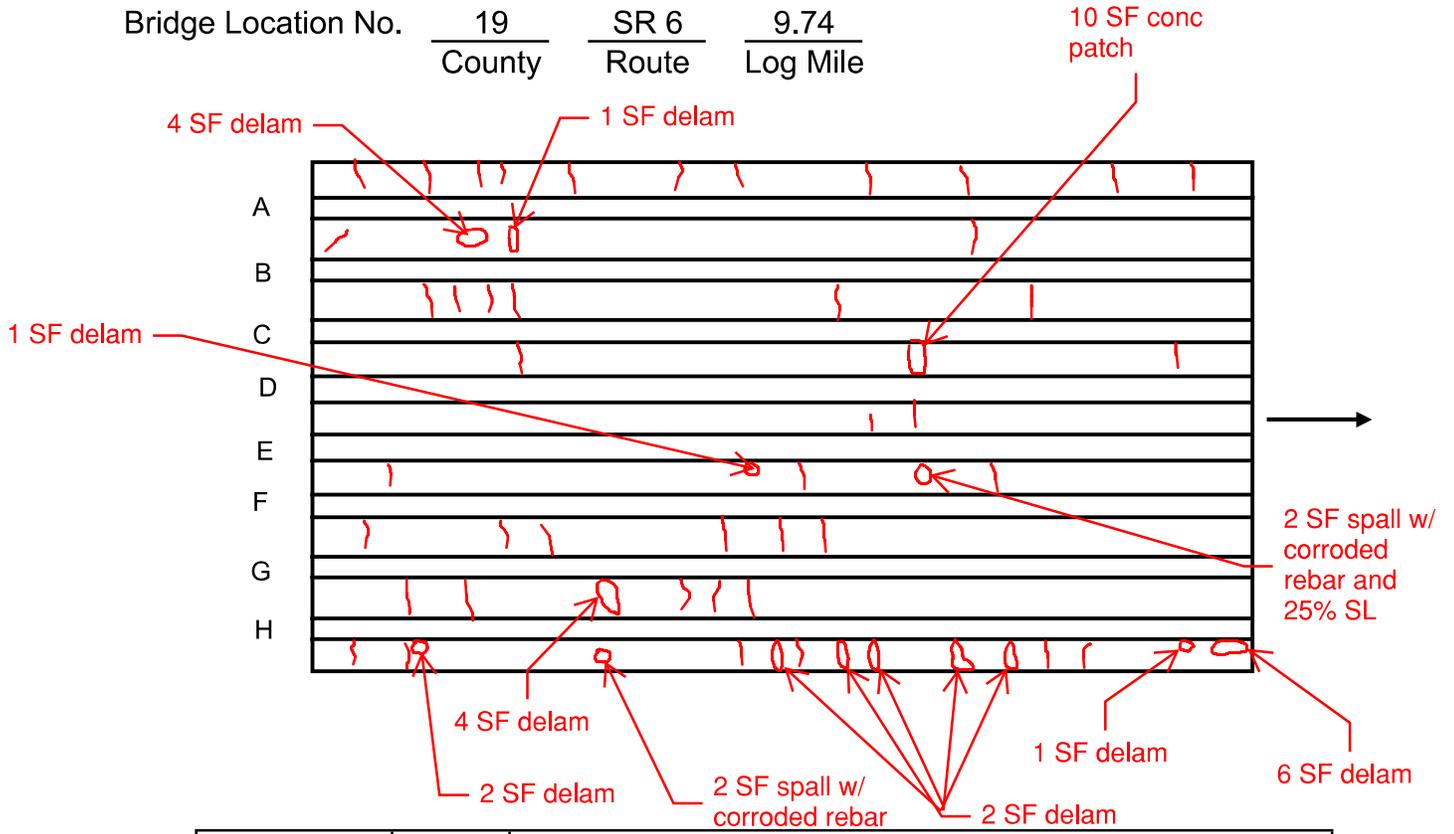
# Bottom of Slab Span No. 4

DECK	Fair	Areas of delamination, spalls to steel with section loss, and HL cracks
		Overhangs: spalls to steel with rebar corrosion, areas of delamination, and HL cracks
DIAPHRAGMS	Good	
BEAMS	Good

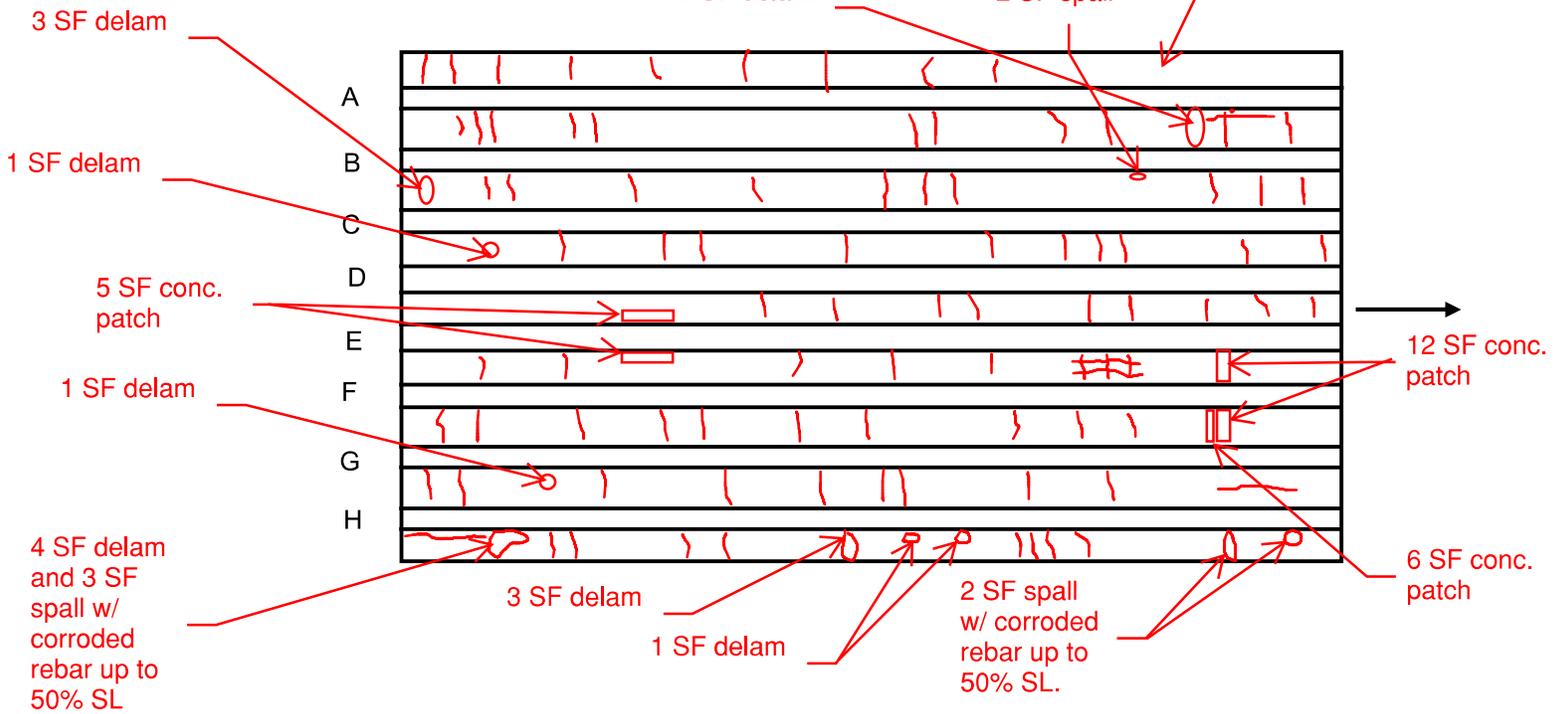
# Bottom of Slab Span No. 5

Light to moderate corrosion on top & bottom FLs, full length.

DECK	Fair	Areas of patching and delamination, spalling, and HL cracks
		Overhangs: spalls to steel with section loss, areas of delamination, and HL cracks
DIAPHRAGMS	Good	
BEAMS	Fair	Light to moderate corrosion on top & bottom flanges, full length
		Beam A
