JAMES ROBERTSON PKWY. Crossing CUMBERLAND RIVER

Inspection Date(s): 05/15/2025 - 05/15/2025

IDENTIFICATION	
(1) State Names	47 - Tennessee
(8) Structure Number	19SR0060015
(5) Inventory Route	1
(2) Highway Agency District	Region 3
(3) County Code	19 - Davidson

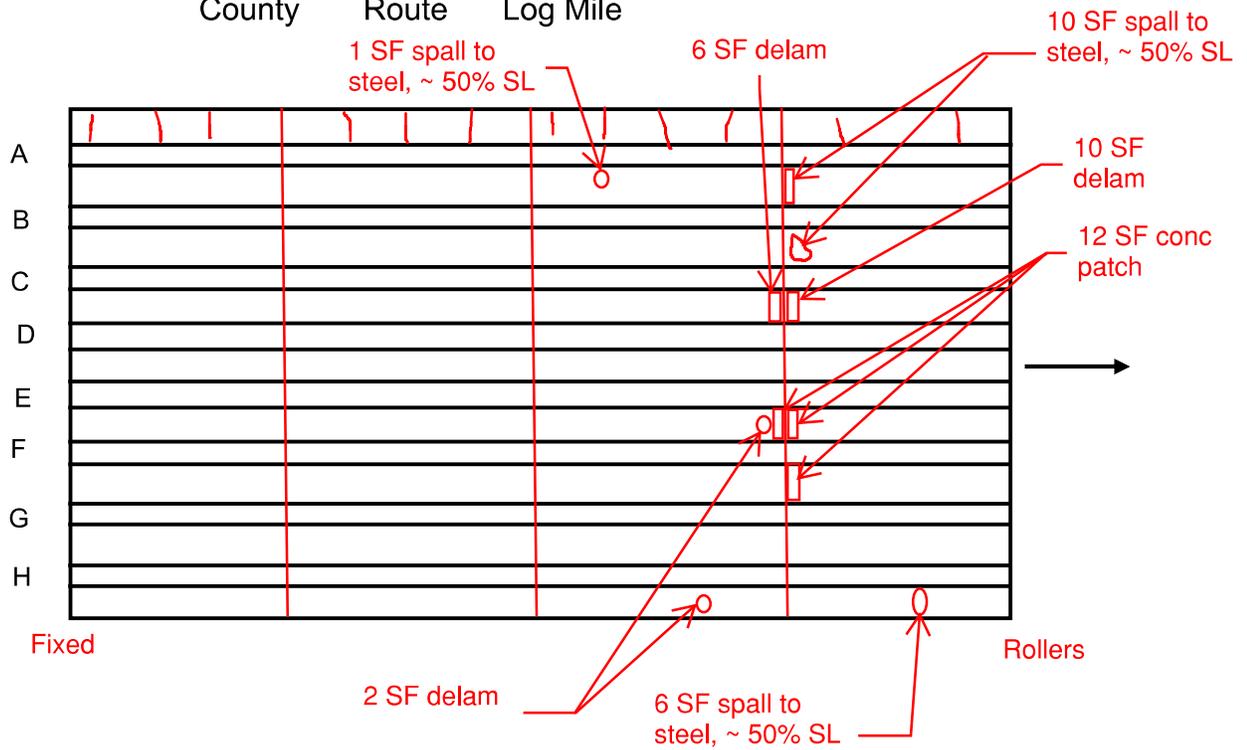
# Bottom of Slab Span No. 6

DECK	Fair	Areas of patching and delamination, spalls to steel
		Overhangs: spalls to steel with section loss, areas of delamination, and HL cracks
DIAPHRAGMS	Good	Isolated spalls on concrete diaphragms in overhangs
BEAMS	Good

All bays and both overhangs have fine transverse cracks that represent ~ 6% of the under deck area

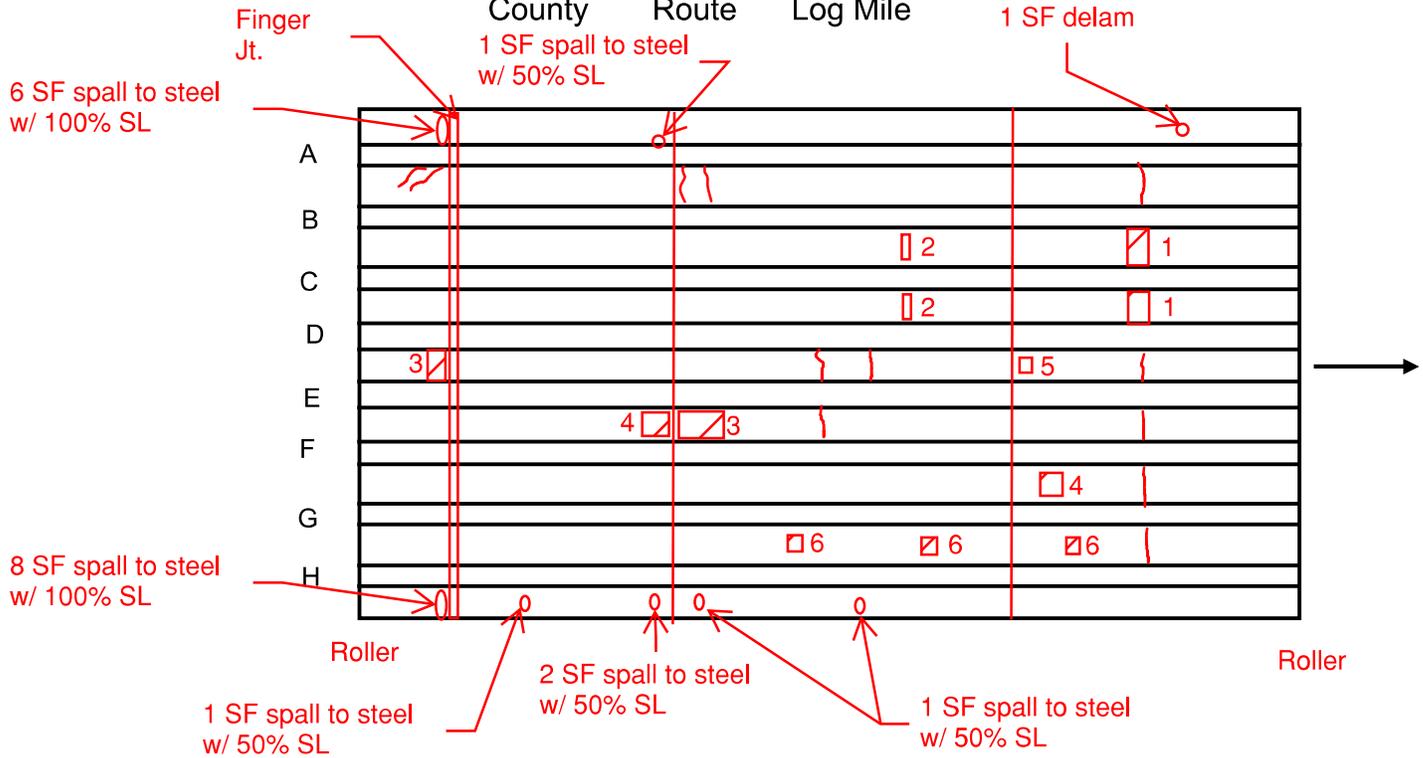
DECK	Fair	See 1-5, cracks up to 1/32" throughout, spalling to steel with section loss and areas of delamination in overhangs
DIAPHRAGMS	Fair	Moderate corrosion at the steel overhang brackets with tie plates and steel intermediate diaphragms under the joint due to leakage
BEAMS	Good	
BEARINGS	Fair	Rockers under finger joint have light to moderate corrosion that are moderately expanded

- 1: denotes concrete patch 10 SF
- 2: denotes 2 SF of delamination
- 3: denotes 4 SF of delamination
- 4: denotes 2 SF of spall to steel
- 5: denotes 1 SF of spall to steel
- 6: denotes 1 SF of delamination

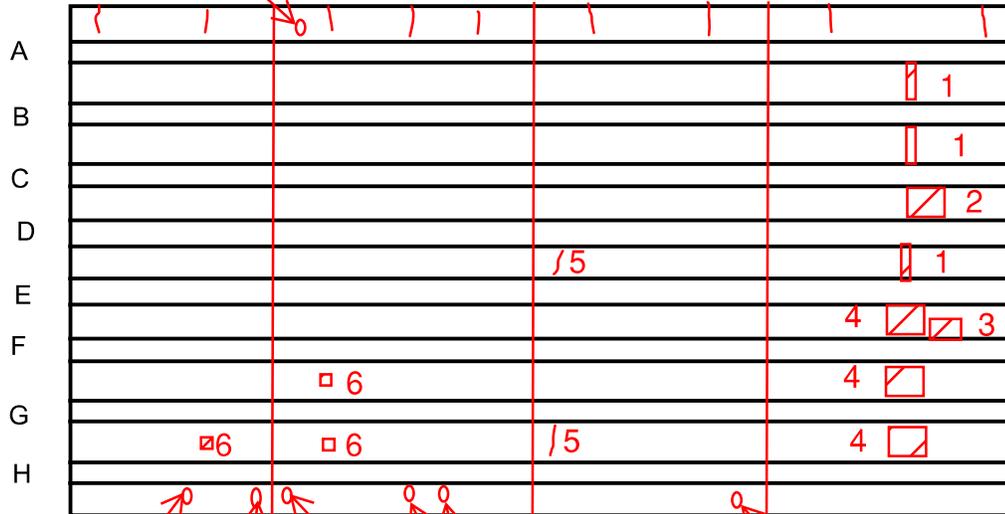
1 SF spall

1 SF spall to steel w/ 50% SL

2 SF spall to steel w/ 50% SL

3 SF spall to steel w/ 50% SL

DECK	Fair	See 1-6, spalling to steel with section loss, areas of delamination, spalling, cracks up to 1/32" in overhangs
DIAPHRAGMS	Good	
BEAMS	Good

- 1 - denotes; 10 SF spall
- 2 - denotes; 20 SF spall to steel
- 3 - denotes; 12 SF spall to steel
- 4 - denotes; 20 SF delam
- 5 - denotes; 5 LF HL crack
- 6 - denotes; 1 SF delam

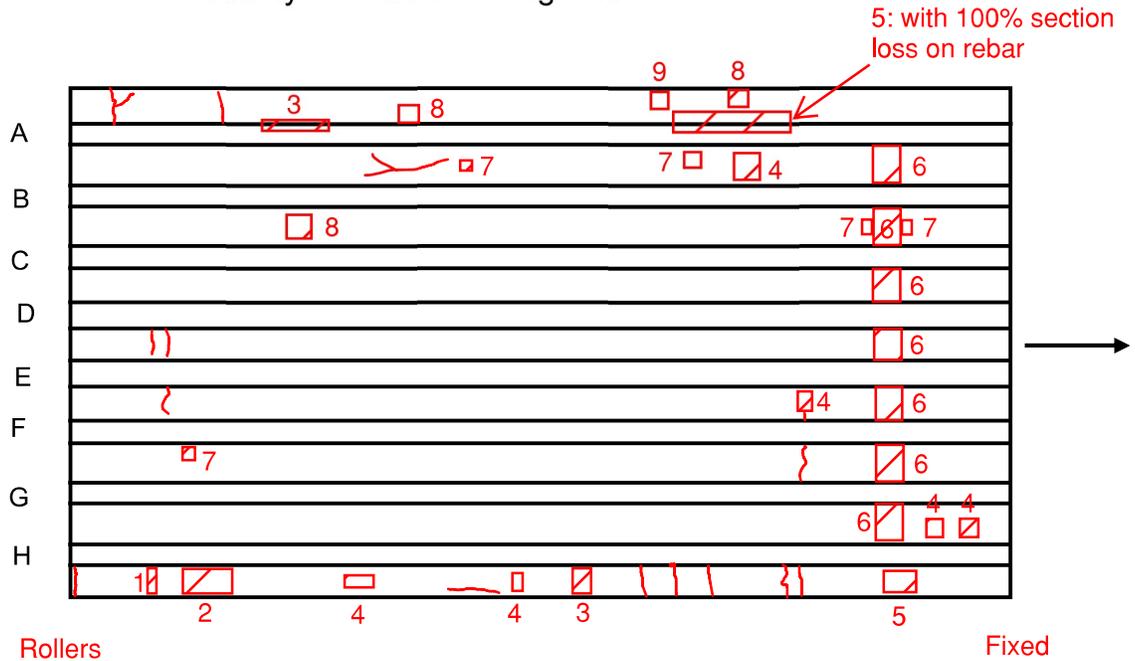
DECK	Fair	See 2-9, cracks up to 1/32" throughout
DIAPHRAGMS	Fair	See 1
BEAMS	Good

- 1: denotes 2 SF of spall to steel in concrete diaphragm in the overhang
- 2: denotes 8 SF of spall to steel
- 3: denotes 3 SF of spall to steel
- 4: denotes 2 SF of delamination
- 5: denotes 4 SF of spall to steel
- 6: denotes concrete patch 10 SF
- 7: denotes 1 SF of delamination
- 8: denotes 2 SF of spall to steel
- 9: denotes 1 SF of spall to steel

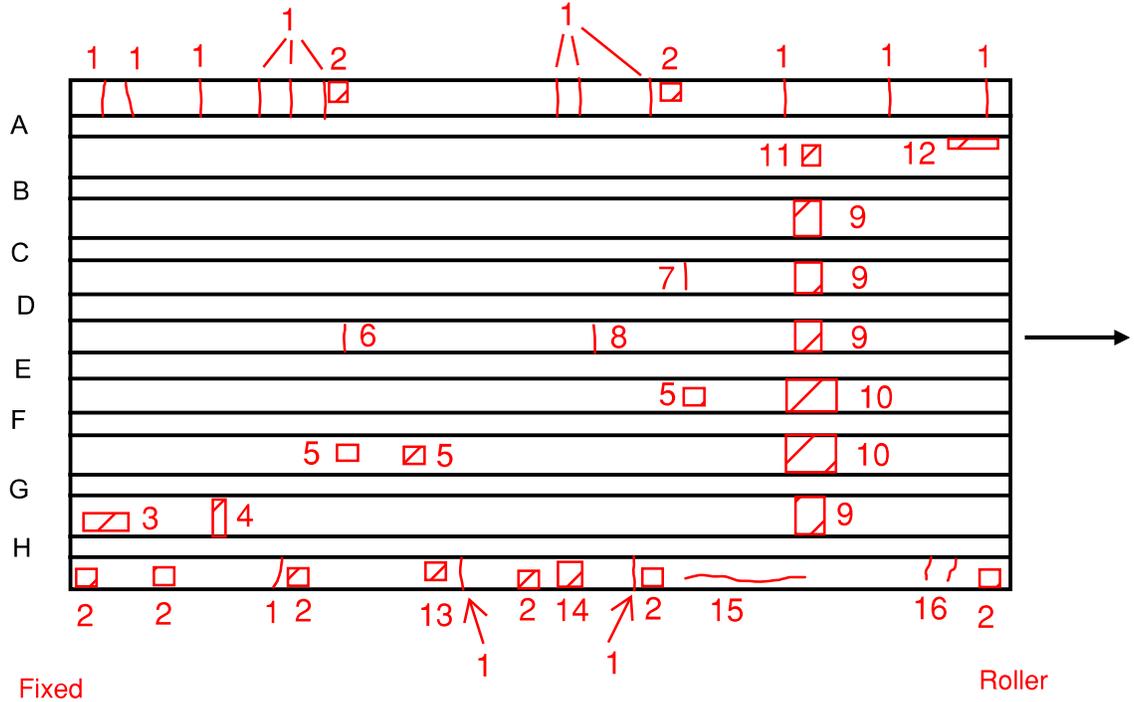
DECK	Fair	See 1-16
DIAPHRAGMS	Good	
BEAMS	Good

- 1 - denotes: 6 LF HL crack
- 2 - denotes: 1 SF spall w/exp. Rebar
- 3 - denotes: 6 SF Deck repair
- 4 - denotes: 2 SF Delamination
- 5 - denotes: 2 SF Deck repair
- 6 - denotes: 4 LF HL crack w/eff
- 7 - denotes: 1 LF HL crack w/eff
- 8 - denotes: 6 LF HL crack w/eff

- 9 - denotes: 20 SF Deck repair
- 10 - denotes: 36 SF Deck repair
- 11 - denotes: 8 SF Spall w/ exp. Rebar
- 12 - denotes: 6 SF Deck repair
- 13 - denotes: 4 SF Spall w/ exp. Rebar
- 14 - denotes: 9 SF Spall w/ exp. Rebar
- 15 - denotes: 8 SF HL crack
- 16 - denotes: 2 x 4 LF HL crack

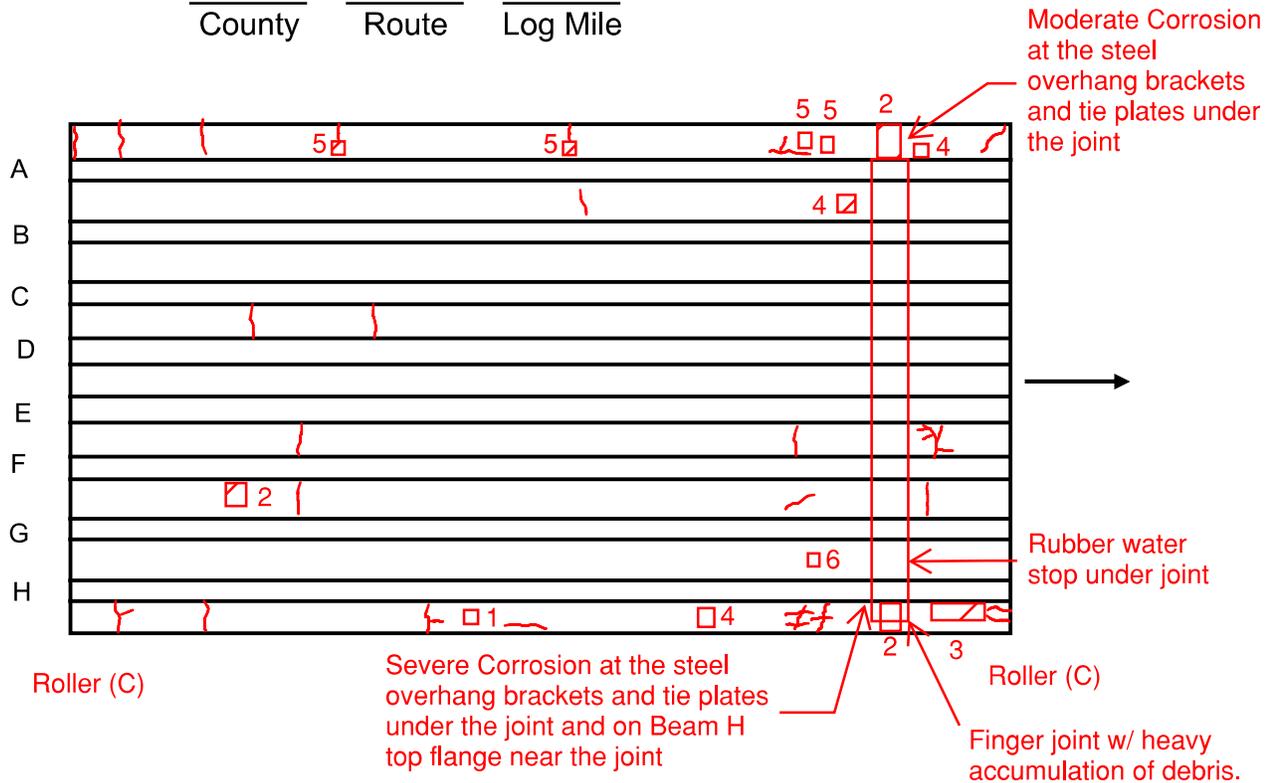
DECK	Fair	See 1-6, cracks up to 1/32" throughout
DIAPHRAGMS	Fair	Moderate to severe corrosion at the steel overhang brackets with tie plates and steel intermediate diaphragms under the joint due to leakage
BEAMS	Fair	Moderate to severe corrosion on exterior face top flange of Beams A and H near the joint due to leakage
BEARINGS	Fair	Rockers under finger joint have light to moderate corrosion that are moderately expanded

- 1: denotes 2 SF of spall to steel
- 2: denotes 4 SF of spall to steel
- 3: denotes 3 SF of spall to steel
- 4: denotes 2 SF of delamination
- 5: denotes 1 SF of spall to steel
- 6: denotes 1 SF of delamination

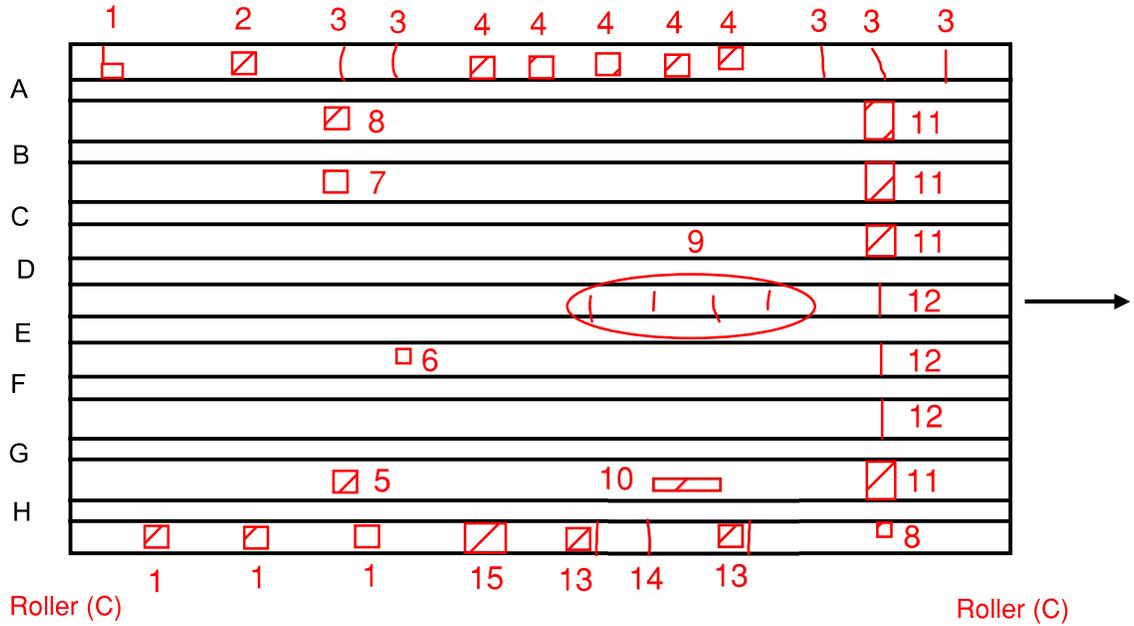
DECK	Fair	See 1-15
DIAPHRAGMS	Good	
BEAMS	Good

- 1 - denotes: 2 SF spall; 4 LF HL crack
- 2 - denotes: 1 SF spall; 3 LF HL crack
- 3 - denotes: 4 LF HL crack
- 4 - denotes: 4 LF HL crack
- 5 - denotes: 2 SF Deck repair
- 6 - denotes: 12 SF Deck repair
- 7 - denotes: 3 SF Spall
- 8 - denotes: 1 SF Spall

- 9 - denotes : 7 LF HL crack w/eff
- 10 - denotes: 10 SF Deck repair
- 11- denotes: 24 SF Deck repair
- 12 - denotes: 6 LF HL crack w/eff
- 13 - denotes: 2 SF Spall; 6 LF HL crack
- 14 - denotes: 6 LF HL crack
- 15 - denotes: 6 SF Spall w/ exp.rebar

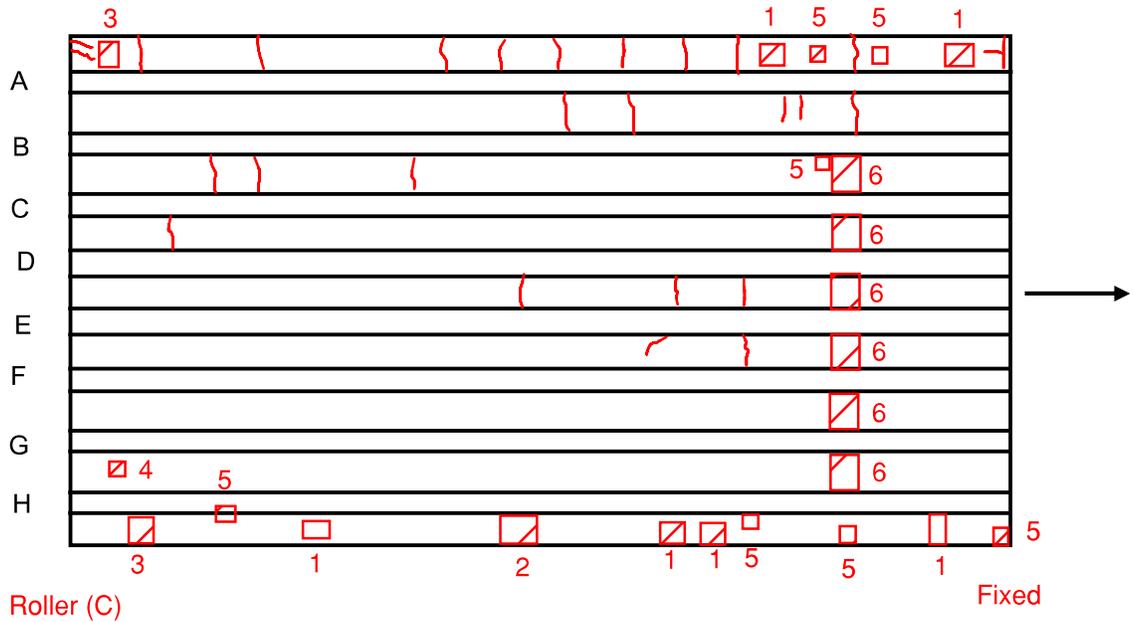
DECK	Fair	See 1-6, cracks up to 1/32" throughout
DIAPHRAGMS	Good	Isolated spalls on concrete diaphragms in overhangs
BEAMS	Good	
BEARINGS	Fair	Rollers are fully contracted to the point where sole plate bolts are in contact with the roller.

- 1: denotes 2 SF of spall to steel
- 2: denotes 4 SF of spall to steel
- 3: denotes 3 SF of spall to steel
- 4: denotes 1 SF of delamination
- 5: denotes 1 SF of spall to steel
- 6: denotes concrete patch 10 SF

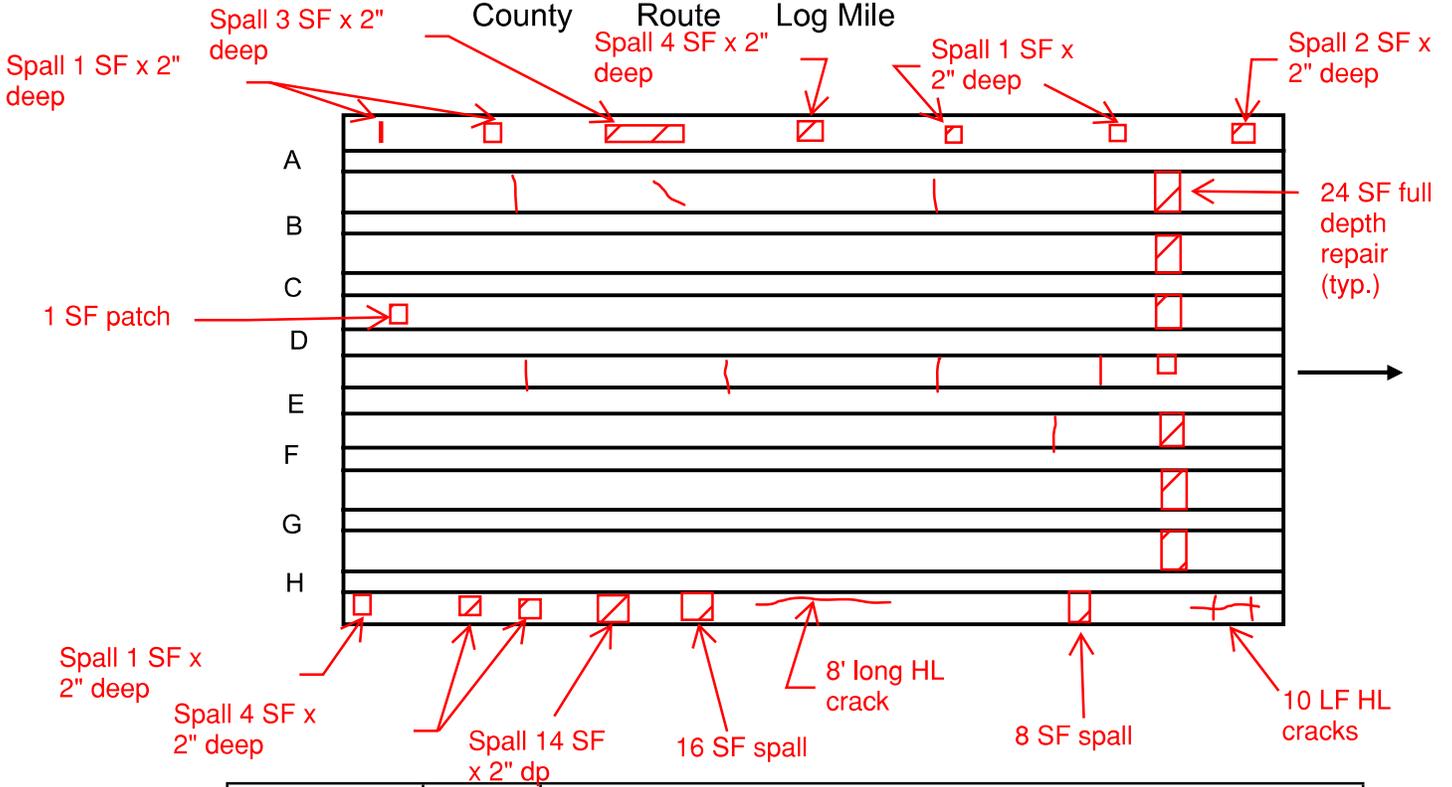
# Bottom of Slab Span No. 15

DECK	Fair	Areas of patching, full depth repair, and HL cracks with eff.
		Overhangs: spalls to steel with section loss, areas of delamination, and HL cracks
DIAPHRAGMS	Good	Isolated spalls on concrete diaphragms in overhangs
BEAMS	Good

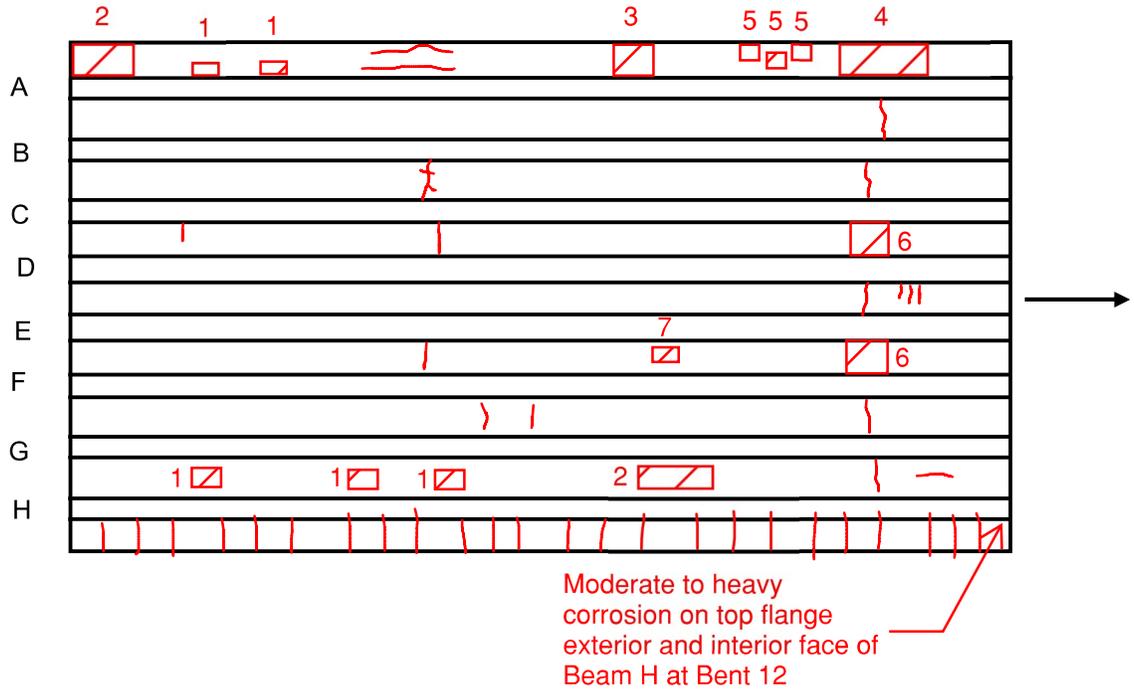
DECK	Fair	See 1-7, cracks up to 1/32" throughout
DIAPHRAGMS	Good	
BEAMS	Fair	Moderate to heavy corrosion on top flange exterior and interior face of Beam H at Bent 12

- 1: denotes 2 SF of delamination
- 2: denotes 4 SF of delamination
- 3: denotes 3 SF of spall to steel
- 4: denotes 5 SF of spall to steel
- 5: denotes 1 SF of spall to steel
- 6: denotes concrete patch 10 SF
- 7: denotes 1 SF of delamination

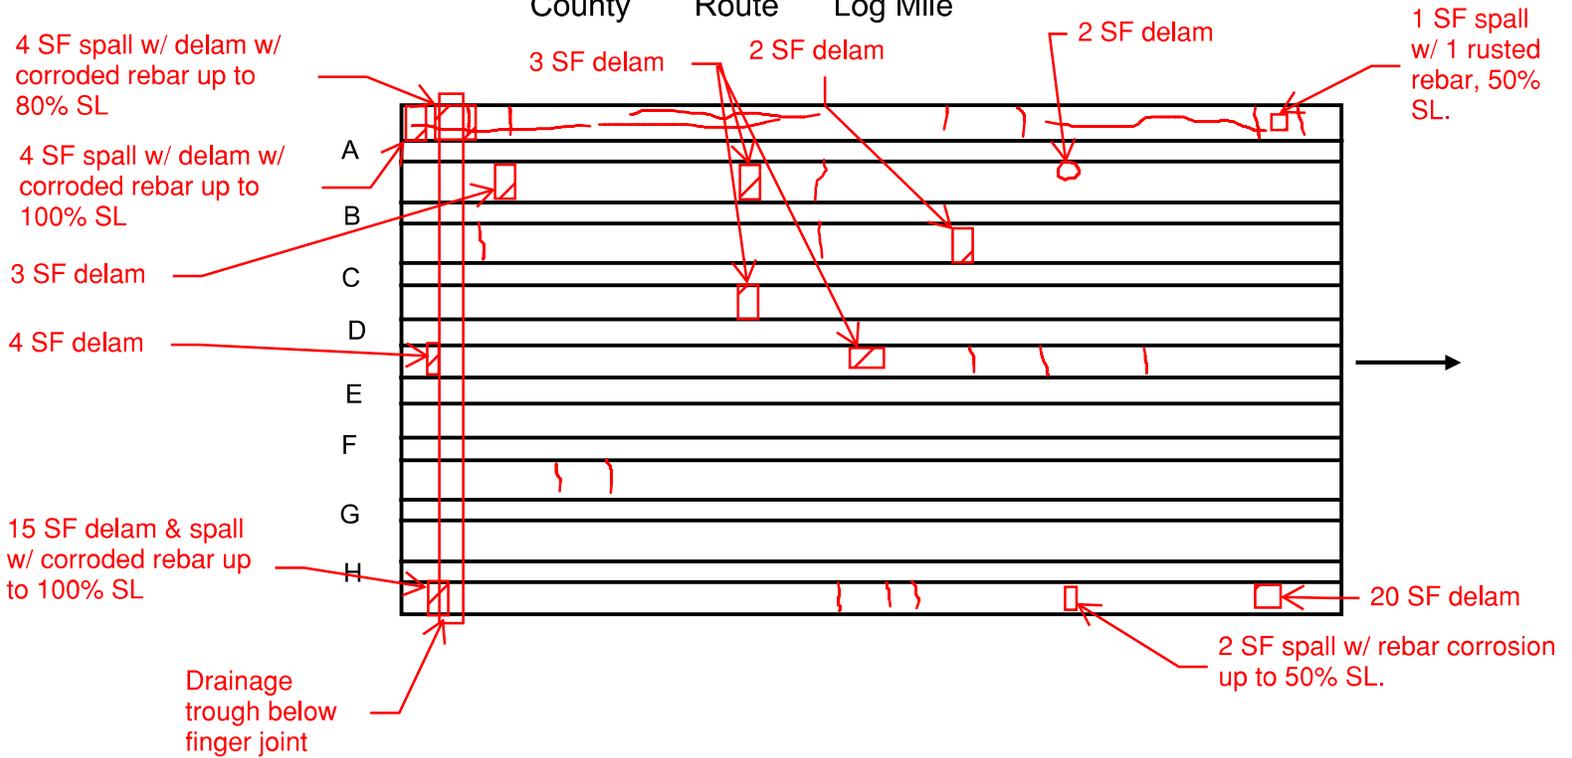
# Bottom of Slab Span No. 17

DECK	Fair	Areas of delamination, spalling, and HL cracks with eff.
		Overhangs: spalls to steel with section loss, areas of delamination, cracks up to 1/16"
DIAPHRAGMS	Good	
BEAMS	Good	
BEARINGS	Poor	Rockers under finger joint have moderate to heavy corrosion that are fully expanded

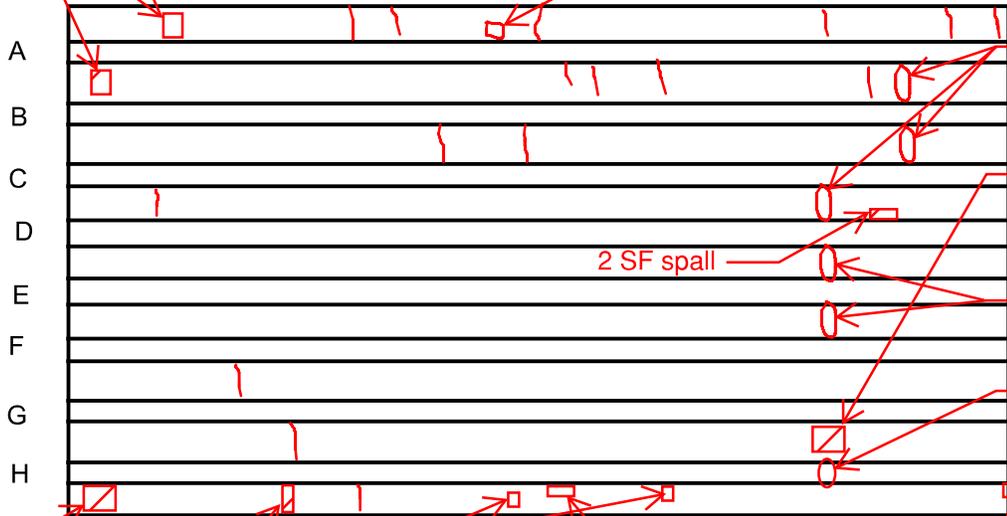
4 SF Delam

1 SF Spall with exposed rebar 1.5" deep with section loss up to 1/16"

3 SF Delam

8 SF spall w/ corroded rebar up to 50% SL

2 SF spall

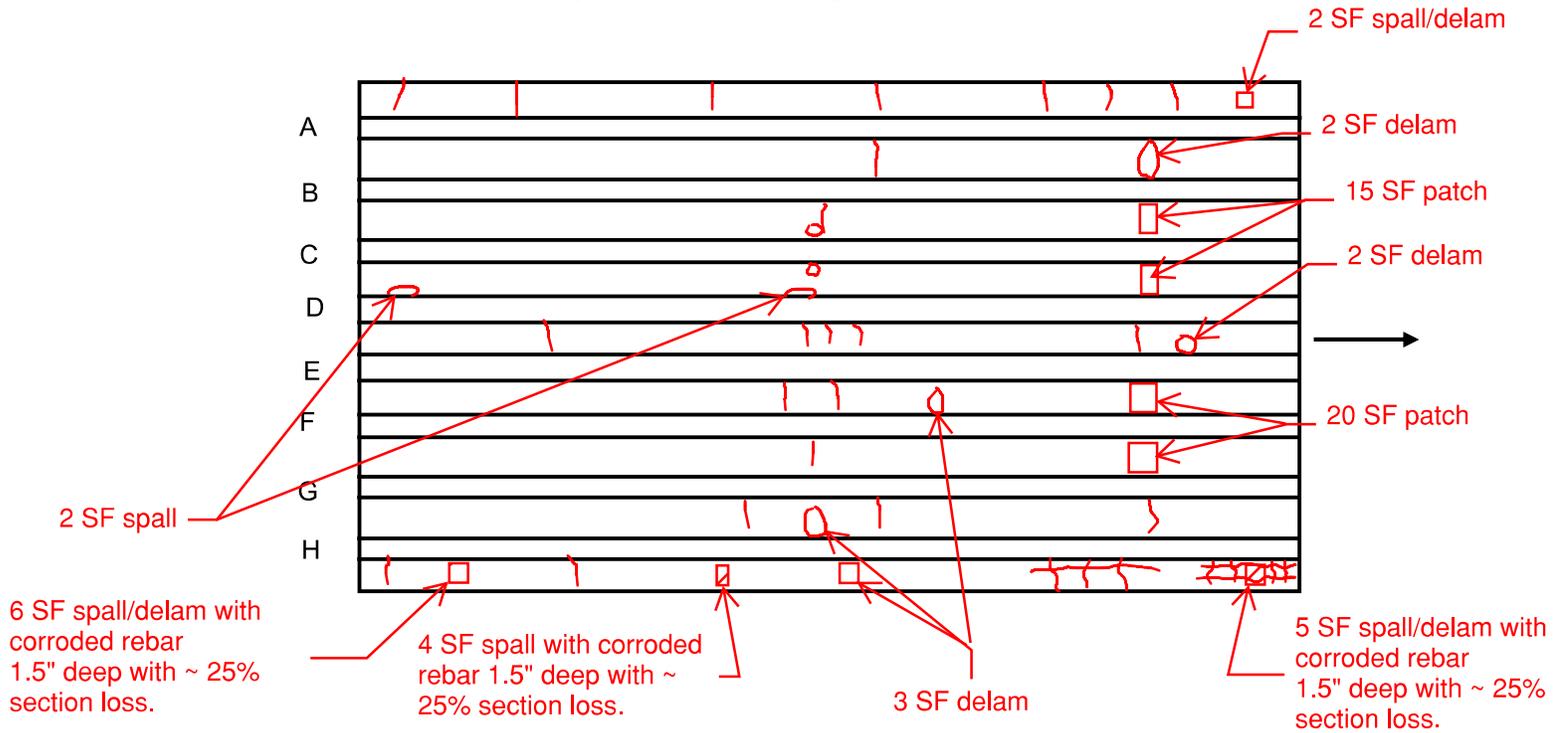
# Bottom of Slab Span No. 19

DECK	Fair	Areas of patching and delamination, spalling, and HL cracks with eff.
		Overhangs: spalls to steel with section loss, areas of delamination, cracks up to 1/16"
DIAPHRAGMS	Good	Initiation of small areas of minor surface corrosion
BEAMS	Good	Initiation of small areas of minor surface corrosion

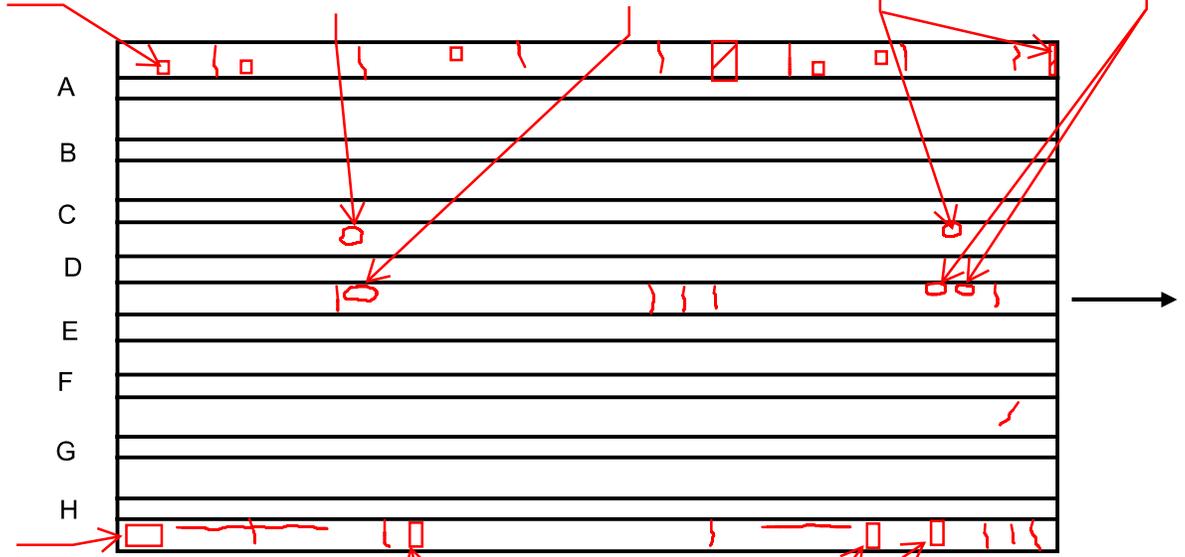
1 SF spall with corroded rebar with ~ 25% section loss. (Typ.)

6 SF conc patch

1 SF conc delam 1 SF conc patch ea.

Spall with corroded rebar 8' long, 3' wide 1.5" deep with ~ 25% section loss.

Spalls with corroded rebar up to 1.5" deep with ~ 25% section loss.

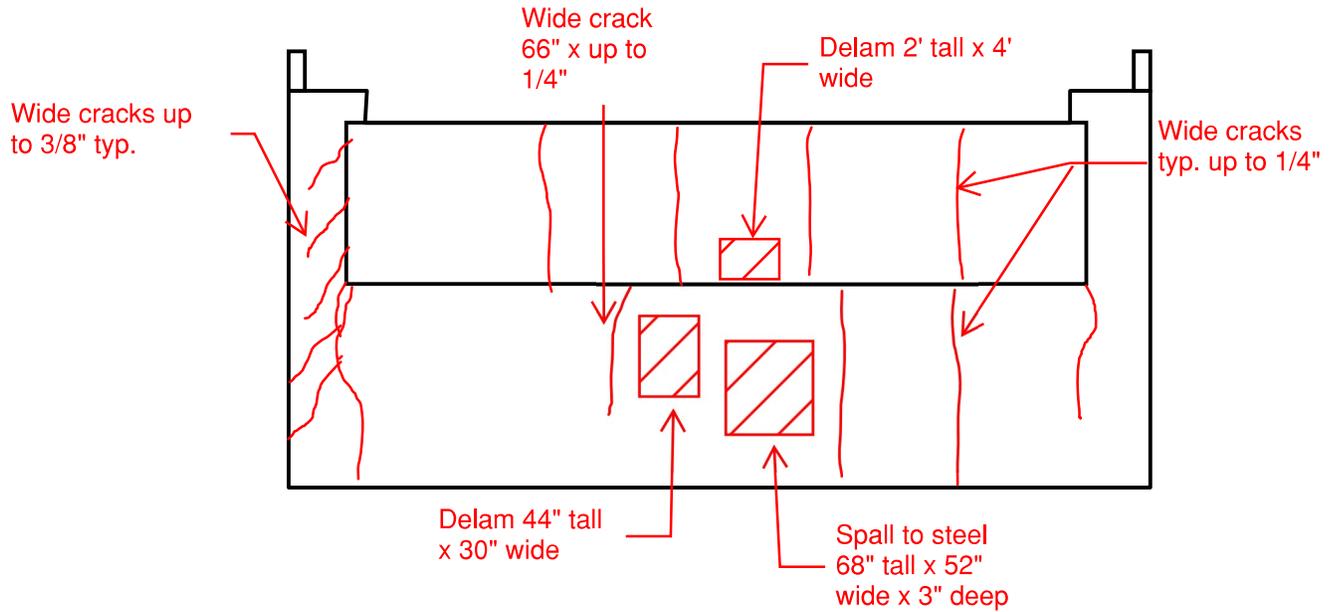
CAP	Fair	Cracks up to 1/4", delaminated areas, spalls to steel
WALL	Fair	Cap and wall are synonymous at this abutment
BACKWALL	Fair	Cracks up to 1/4", delaminated areas
WINGS	Fair	Cracks up to 3/8"
BEARINGS	Good	
FOOTING	N/V

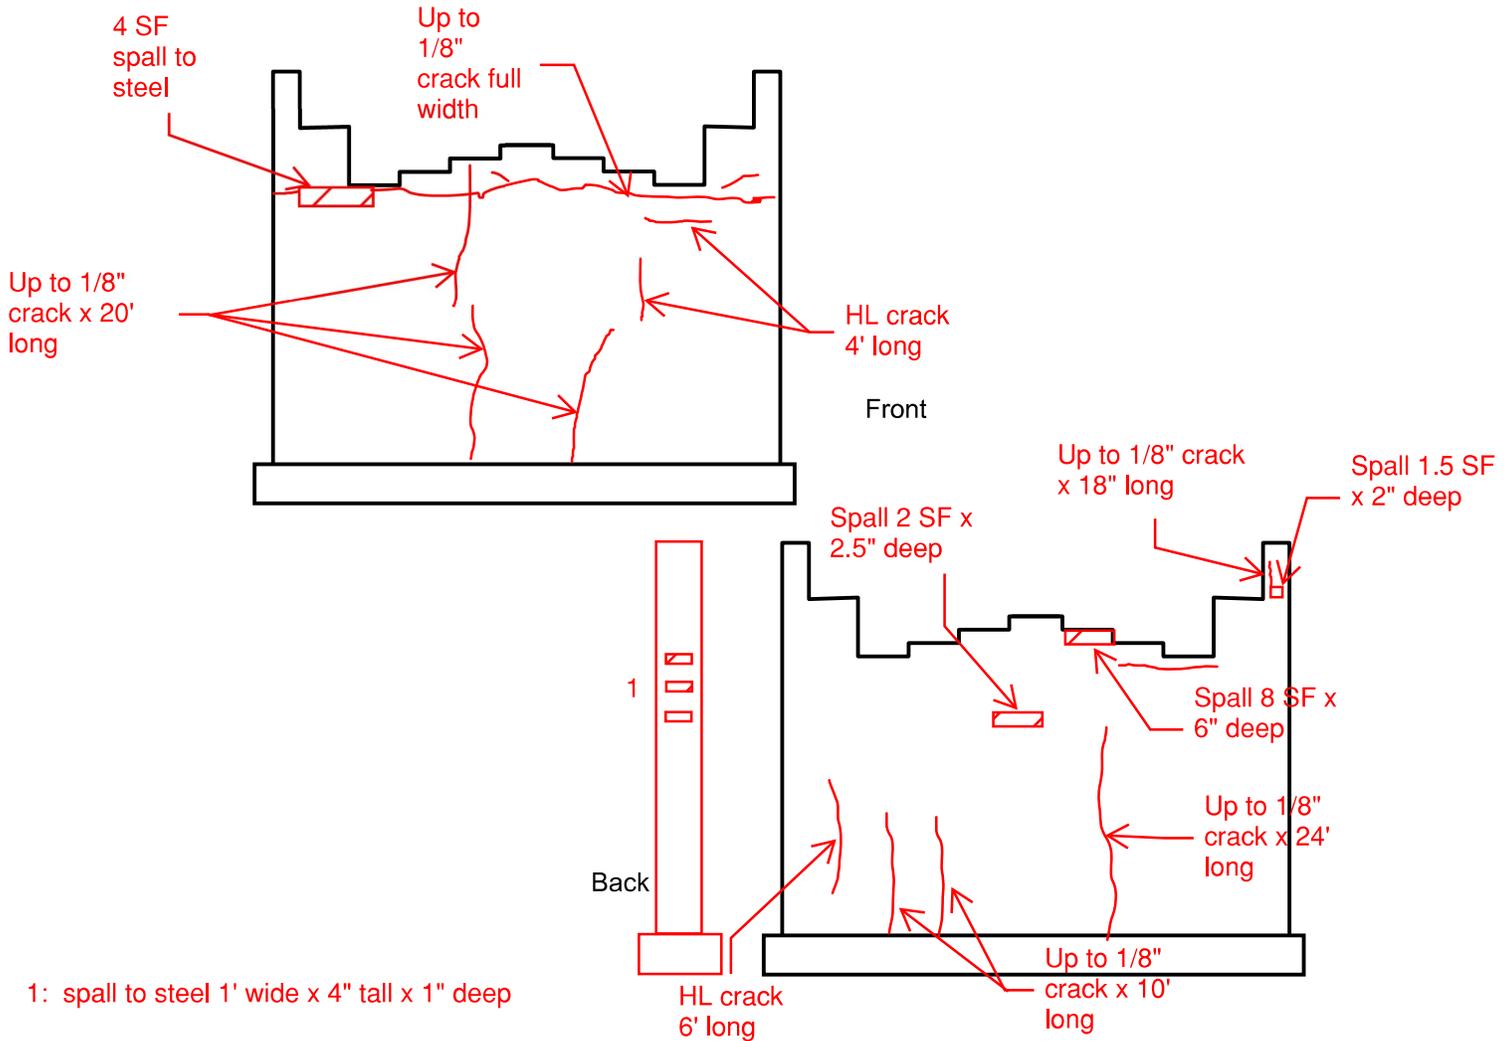
# BENT # 1

CAP	Fair	Cracks up to 1/8", deep spalls to steel
WALL	Fair	Cracks up to 1/8", spalls to steel
FOOTING	N/V	
BEARINGS	Fair	Moderate corrosion present

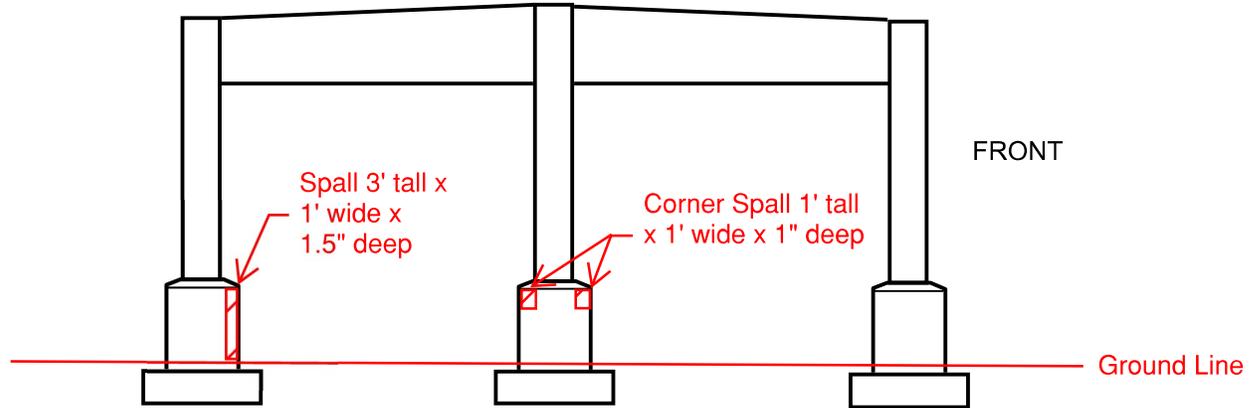
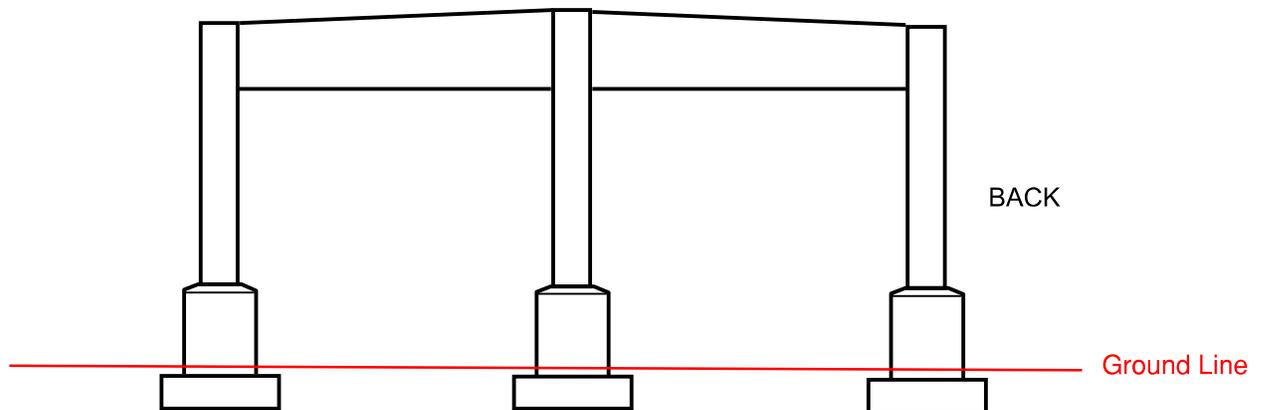
# BENT # 2

CAP	Good	
COLUMNS	Good	
FOOTING	Fair	Spalling
BEARINGS	Good

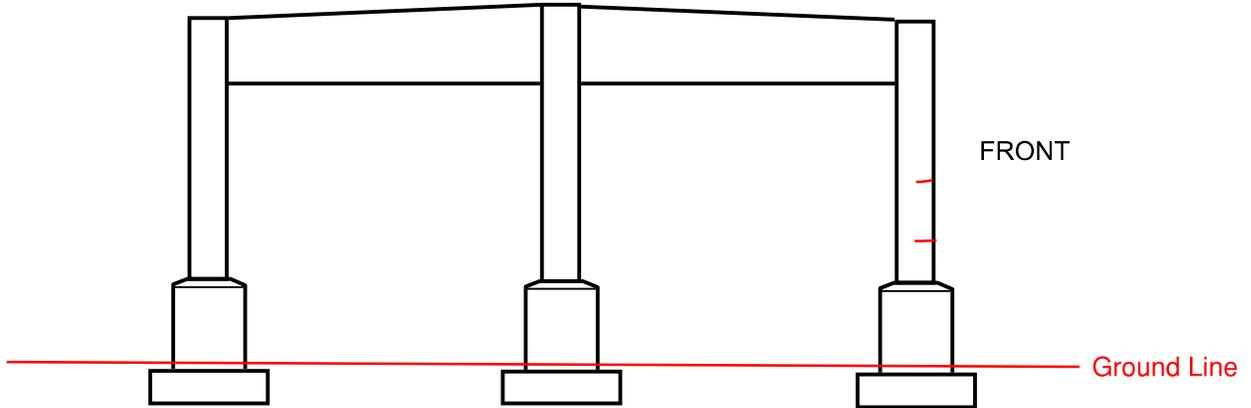
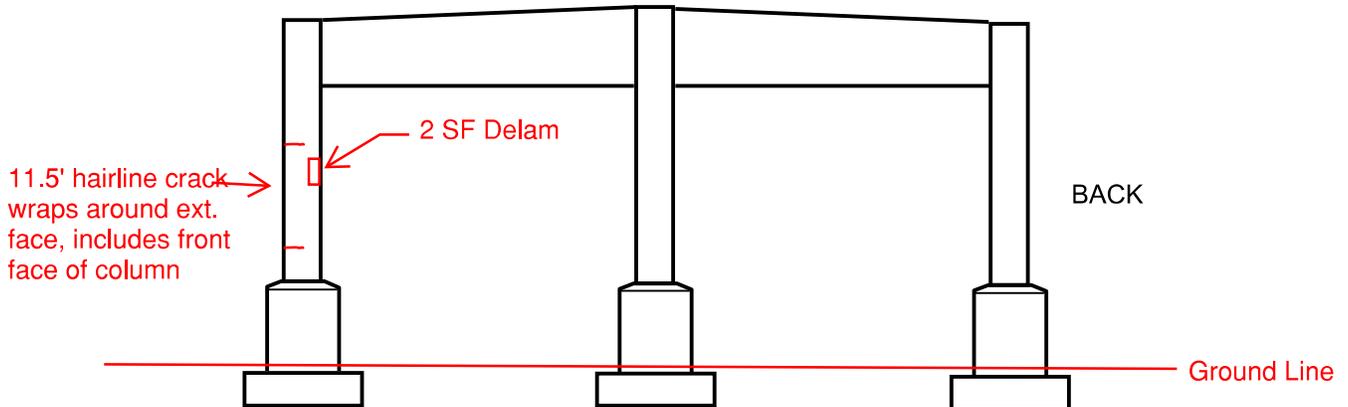
# BENT # 3

CAP	Good	
COLUMNS	Good	Delaminated area and HL cracks
FOOTING	Fair	
BEARINGS	Good

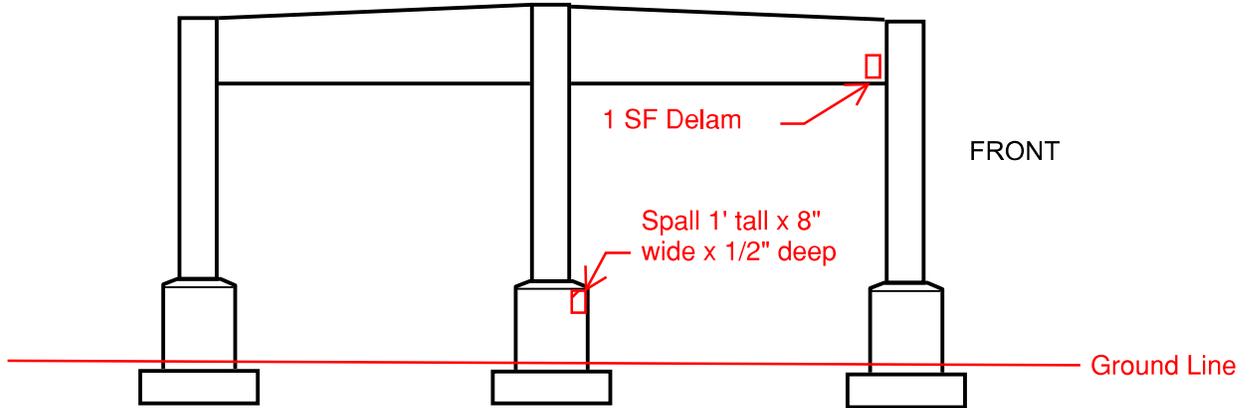
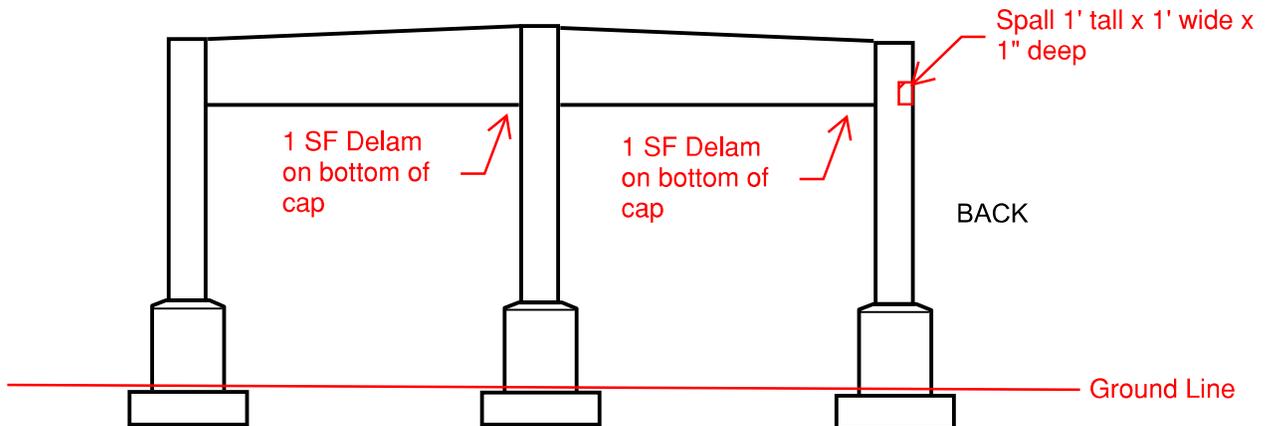
# BENT # 4

CAP	Fair	Spalling and delaminated areas
COLUMNS	Good	Isolated spalling
FOOTING	Fair	
BEARINGS	Good

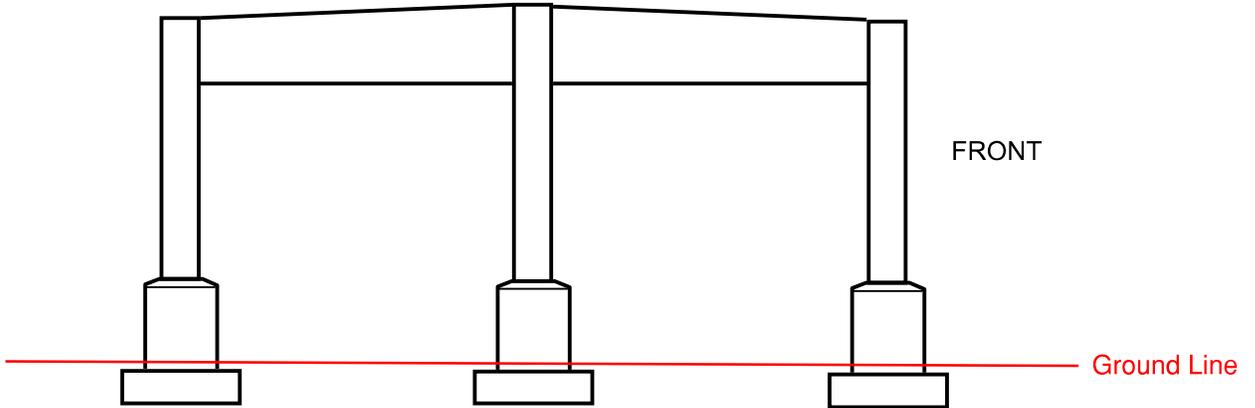
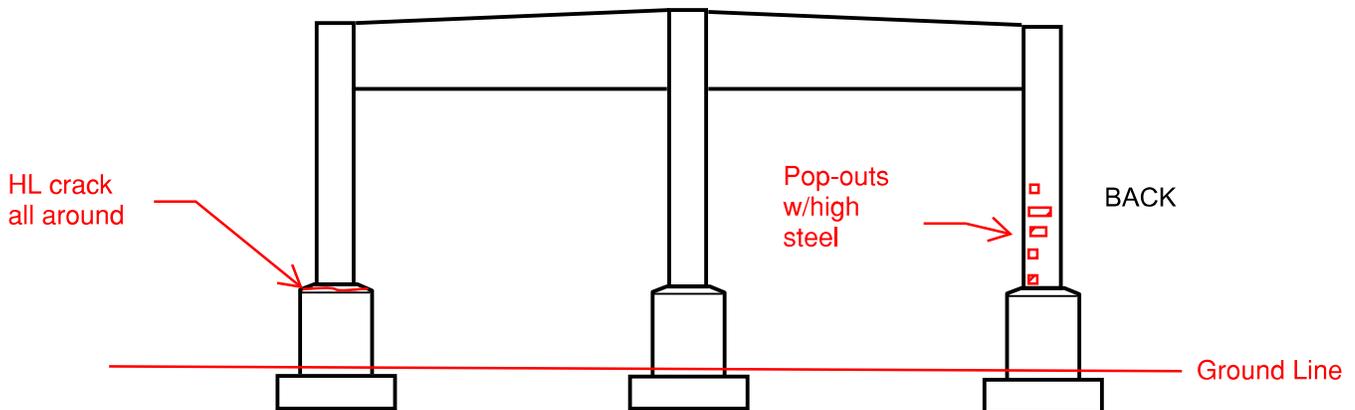
# BENT # 5

CAP	Good	
COLUMNS	Fair	High-steel popouts and HL crack
FOOTING	N/V	
BEARINGS	Good	Slightly expanded at 65 degrees

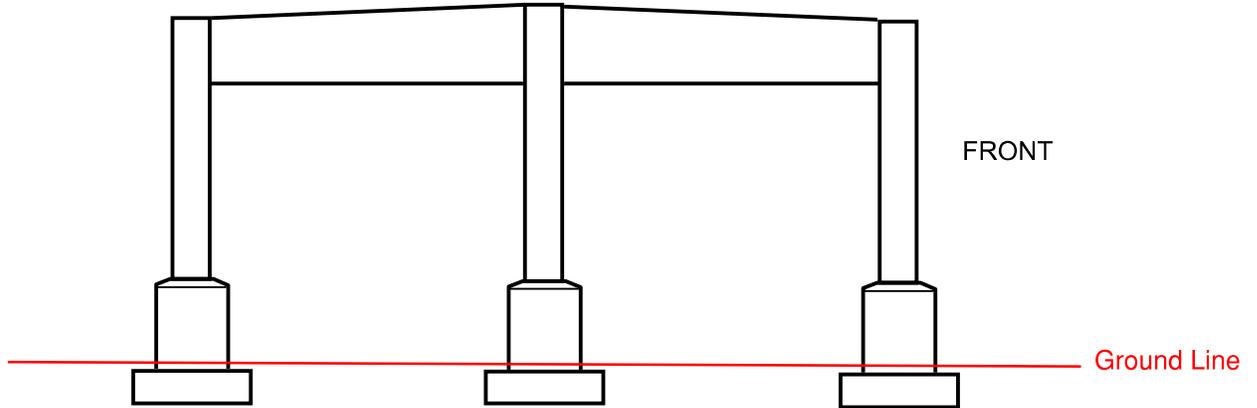
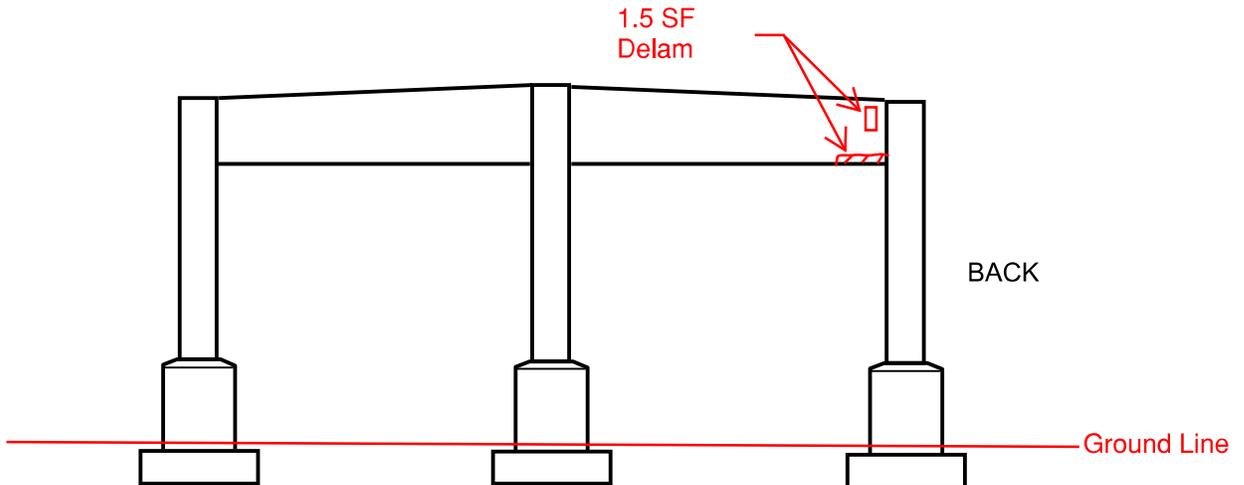
# BENT # 6

CAP	Fair	Delaminated areas
COLUMNS	Good	
FOOTING	N/V	
BEARINGS	Good	Slightly expanded at 65 degrees

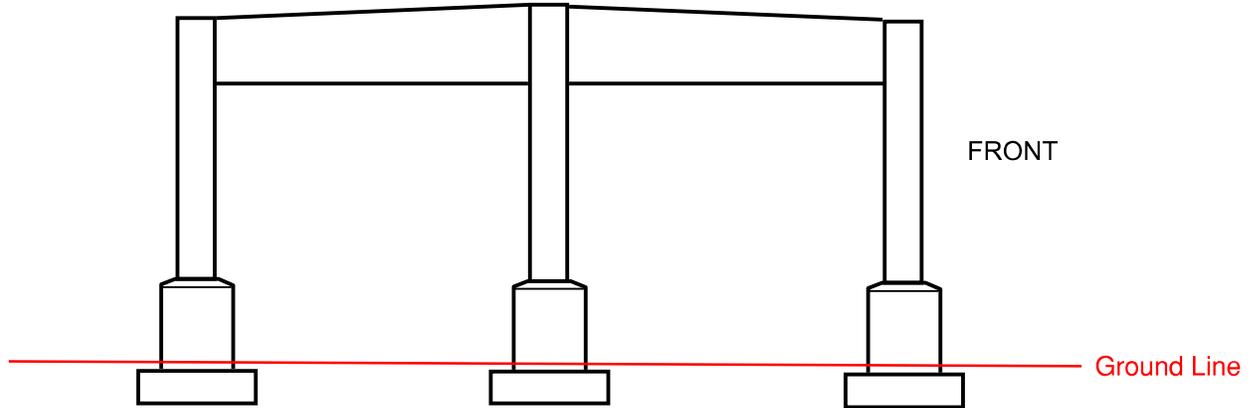
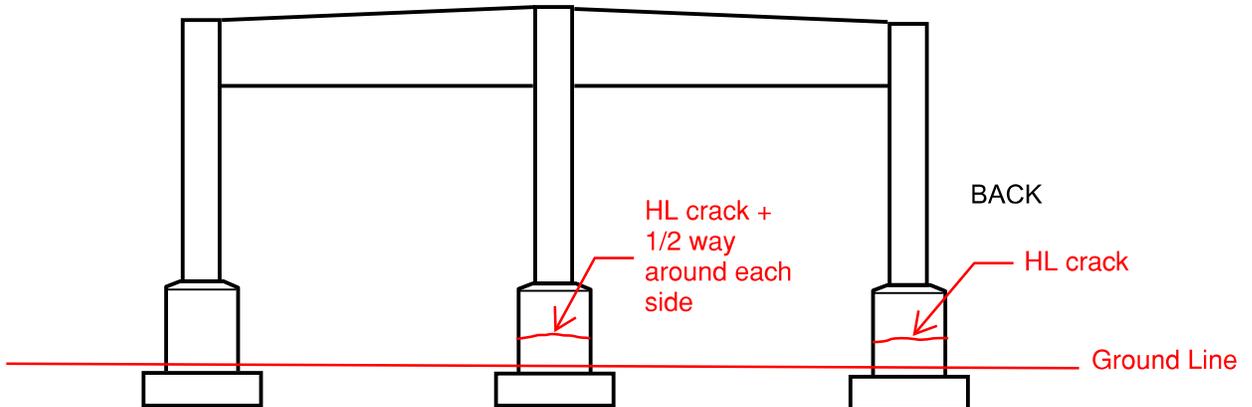
# BENT # 7

CAP	Good	
COLUMNS	Good	Isolated HL cracks
FOOTING	N/V	
BEARINGS	Good
