JAMES ROBERTSON PKWY. Crossing CUMBERLAND RIVER

Inspection Date(s): 05/15/2025 - 05/15/2025

IDENTIFICATION	
(1) State Names	47 - Tennessee
(8) Structure Number	19SR0060015
(5) Inventory Route	1
(2) Highway Agency District	Region 3
(3) County Code	19 - Davidson

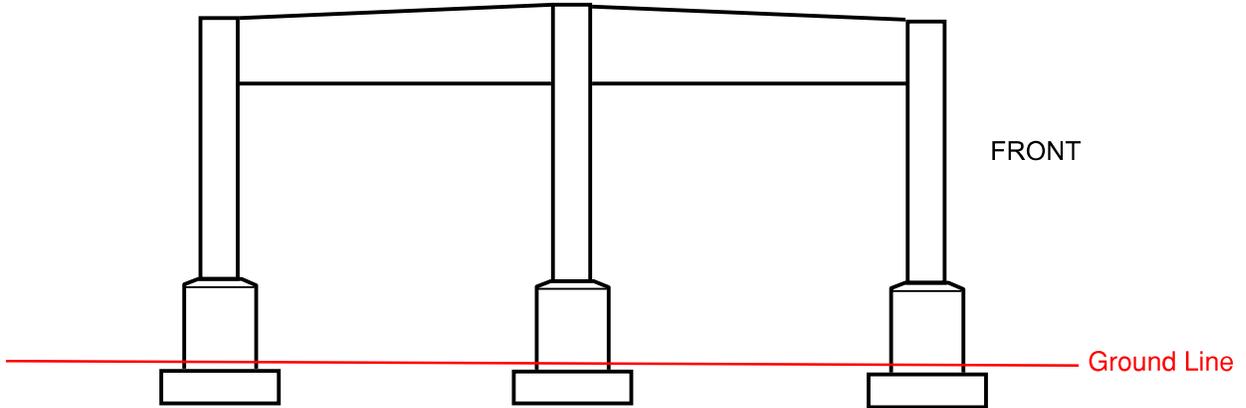
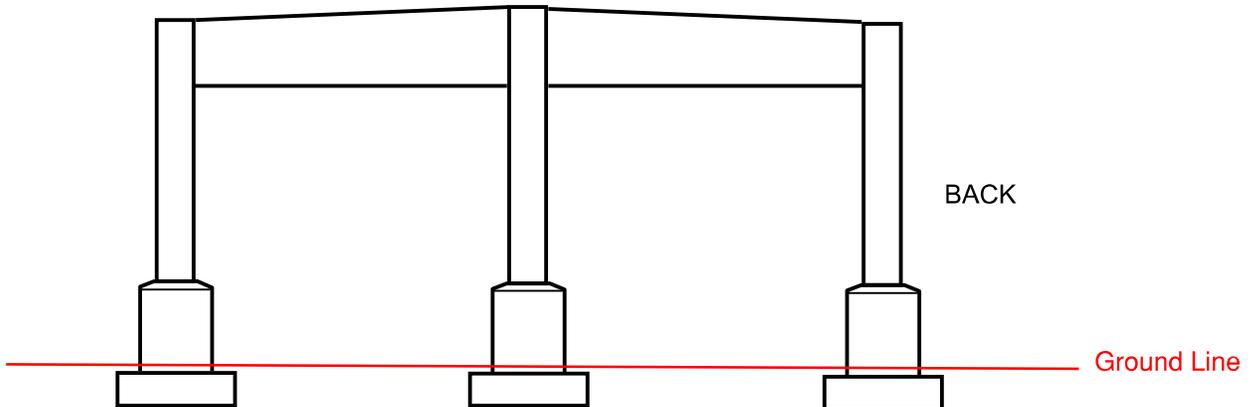
# BENT # 8

CAP	Good	
COLUMNS	Good	
FOOTING	N/V	
BEARINGS	Fair	Rollers are fully contracted to the point where sole plate bolts are in contact with the roller.

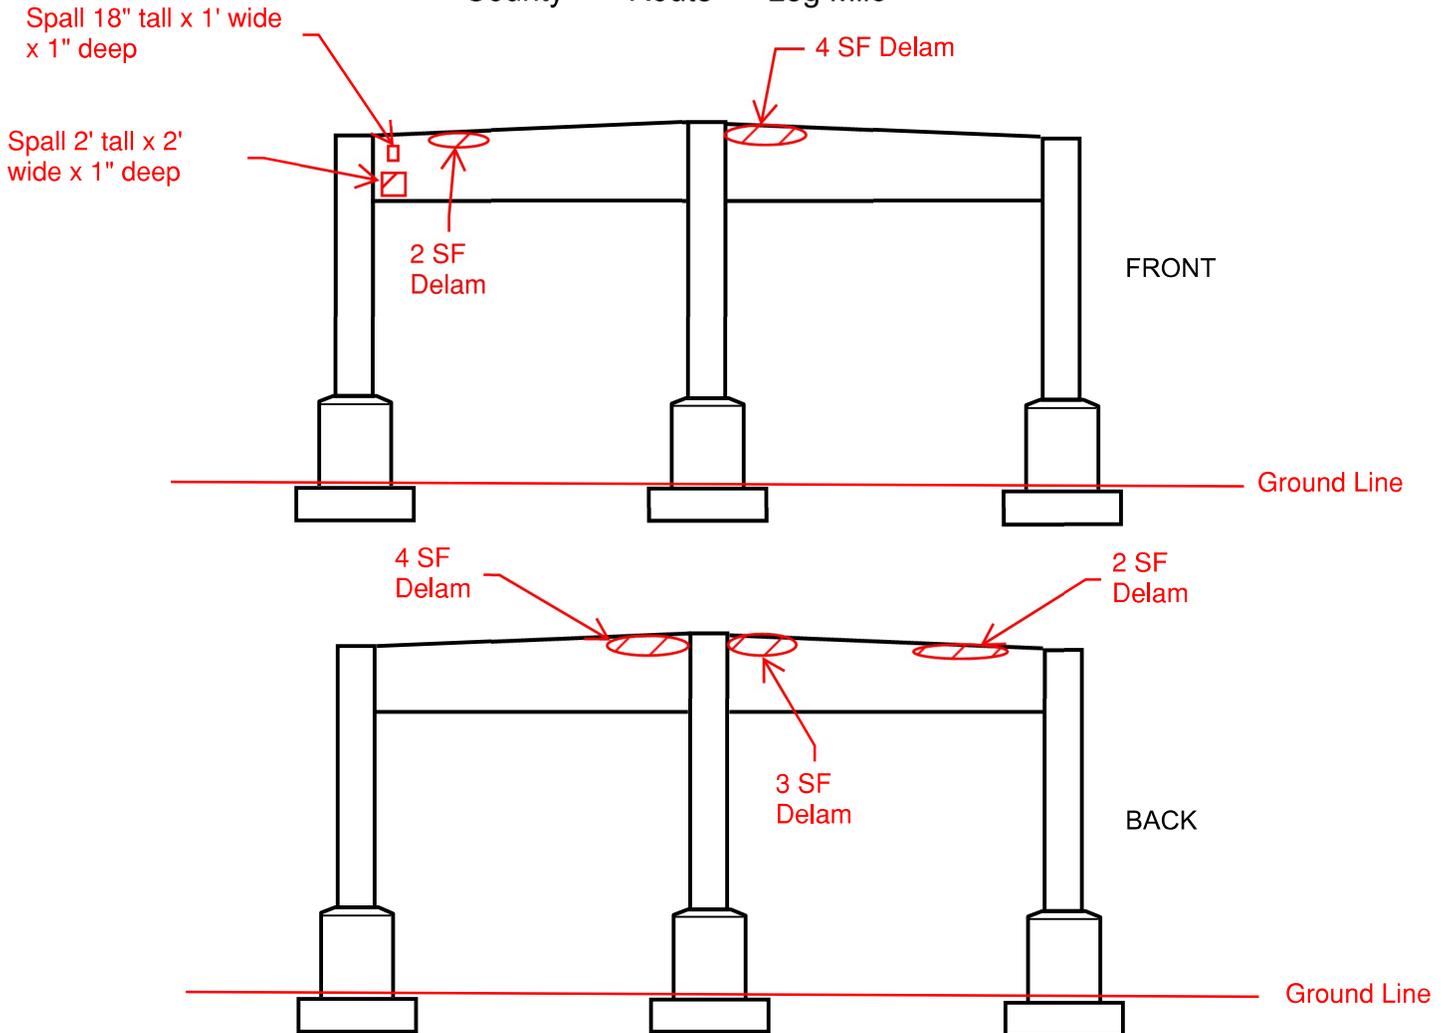
# BENT # 9

CAP	Fair	Spalling and delaminated areas
COLUMNS	Good	
FOOTING	N/V	
BEARINGS	Fair	Rollers are fully contracted to the point where sole plate bolts are in contact with the roller.

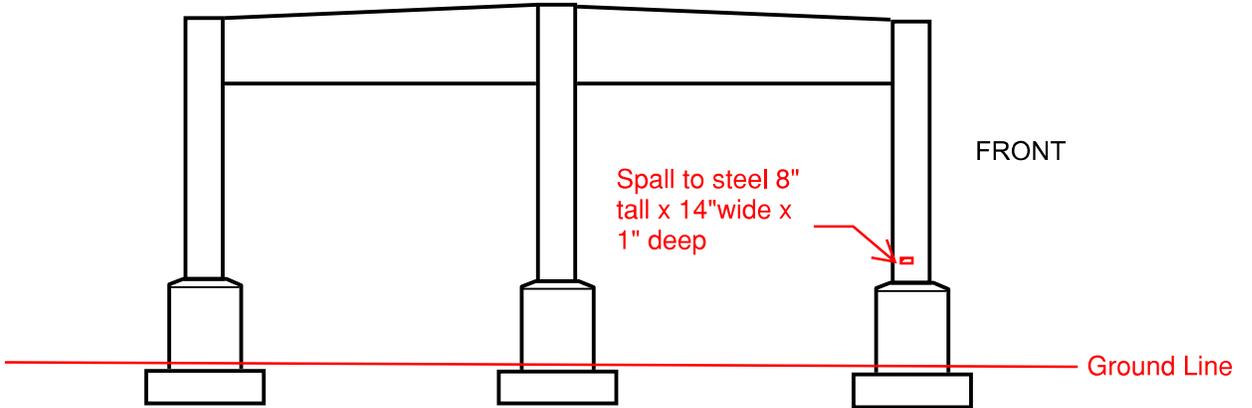
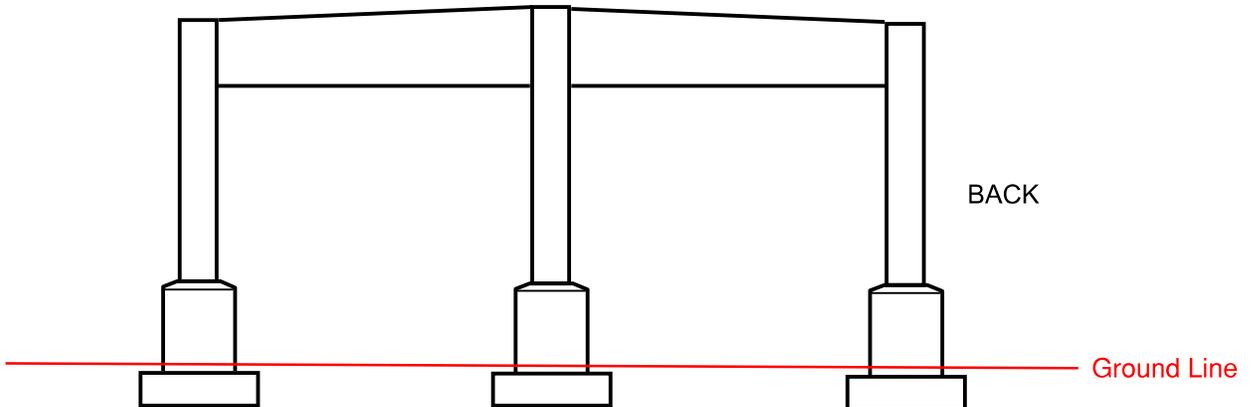
# BENT # 10

CAP	Good	
COLUMNS	Good	Minor spall
FOOTING	N/V	
BEARINGS	FAIR	Rollers are fully contracted to the point where sole plate bolts are in contact with the roller.

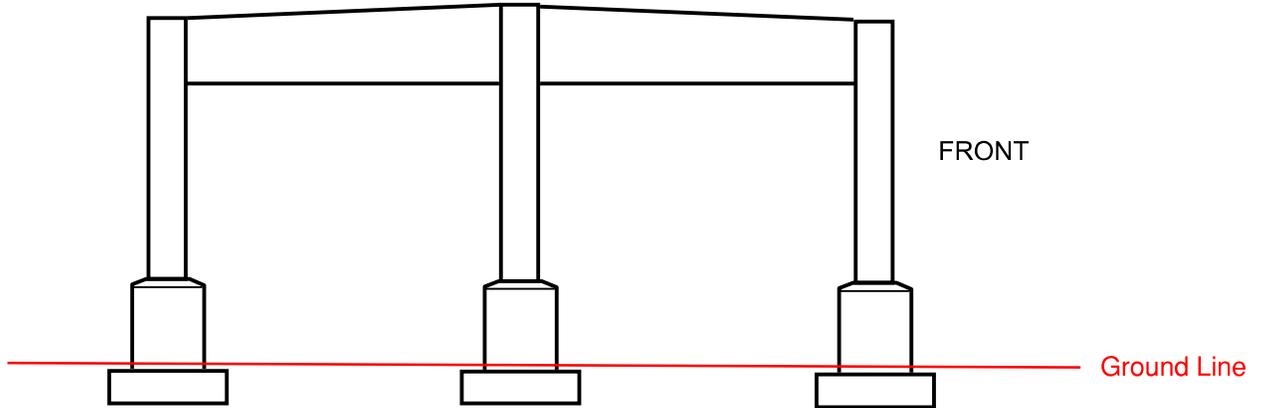
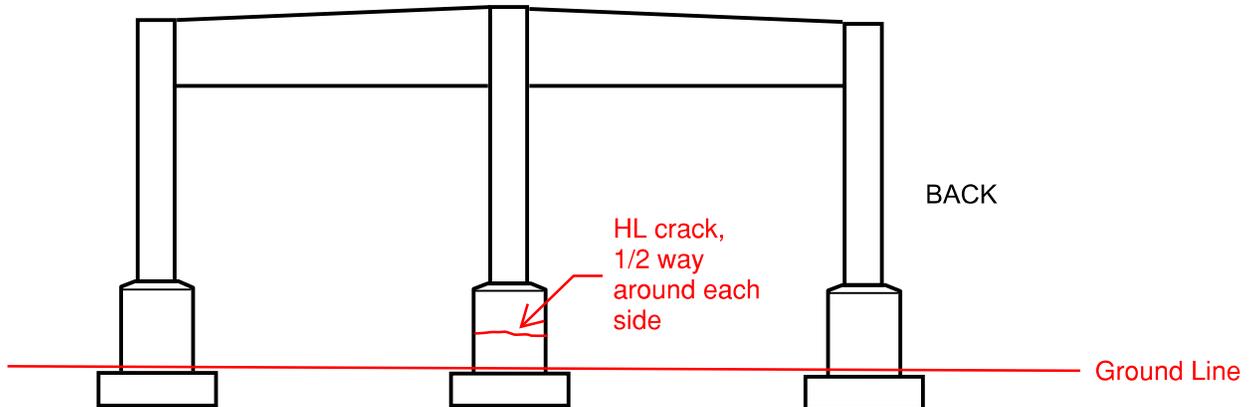
# BENT # 11

CAP	Good	
COLUMNS	Good	HL crack
FOOTING	N/V	
BEARINGS	Good

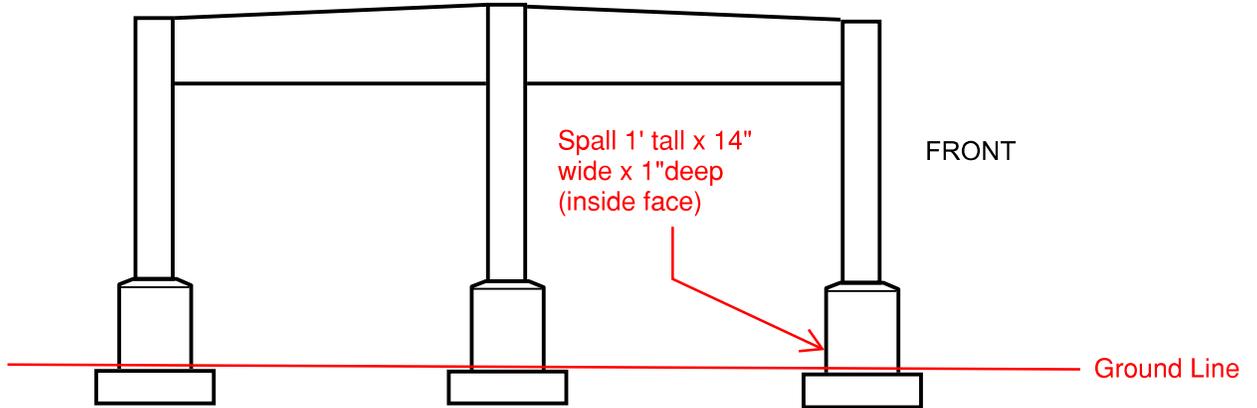
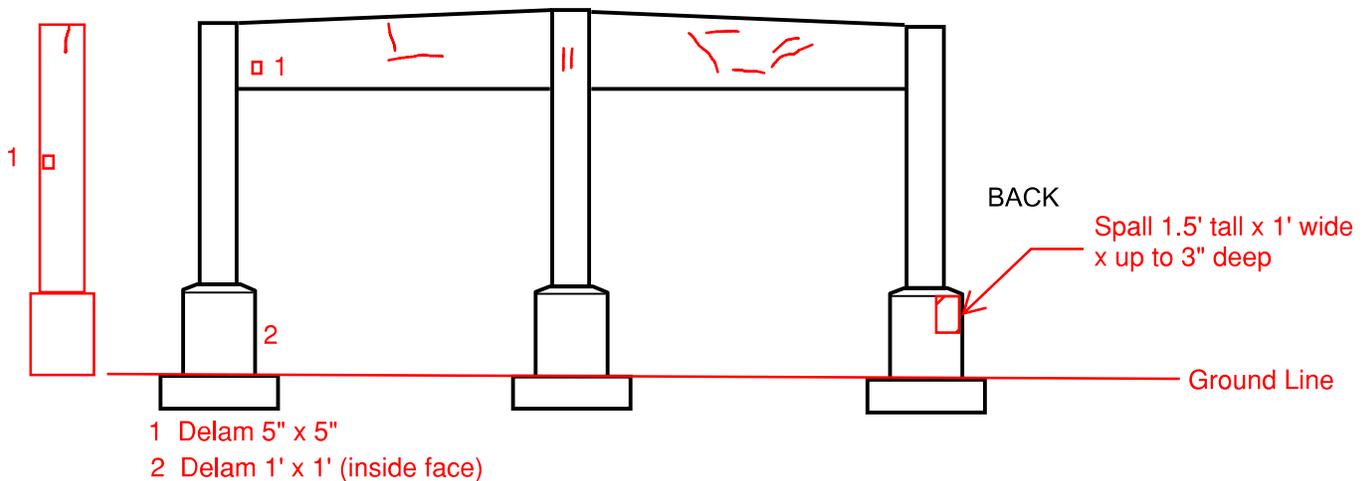
# BENT # 12

CAP	Fair	See 1, and cracking up to 1/32"
COLUMNS	Fair	See 2, and cracking up to 1/32"
FOOTING	N/V	
BEARINGS	Fair	Rollers are fully contracted to the point where sole plate bolts are in contact with the roller.

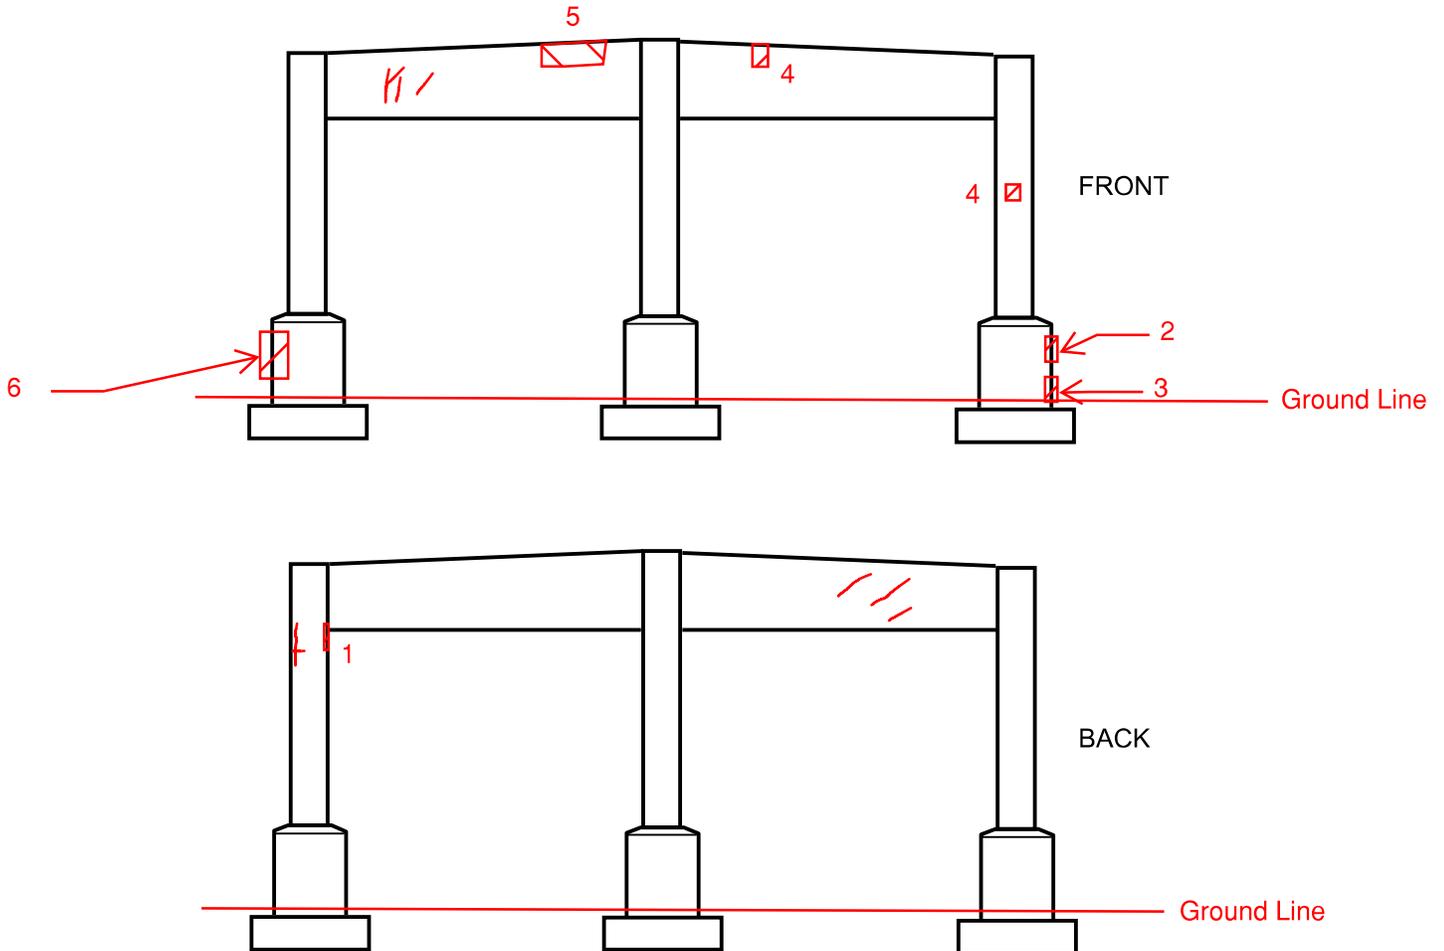
CAP	Fair	See 4 & 5, and cracking up to 1/32"; texture coat peeling on back right side
COLUMNS	Fair	See 1, 2, 3, 4 & 6, and cracking up to 1/32"
FOOTING	N/V	
BEARINGS	Fair	Rollers are fully contracted to the point where sole plate bolts are in contact with the roller.

- 1 Spall 1' tall x 3" wide x up to 2" deep
- 2 Spall 1' tall x 2' wide x up to 3" deep
- 3 Spall 1' tall x 6" wide x up to 2.5" deep
- 4 Delam 5" x 5"
- 5 Delam 2.5' long x 5" tall
- 6 Spall 2' tall x 1.5' wide x up to 2" deep

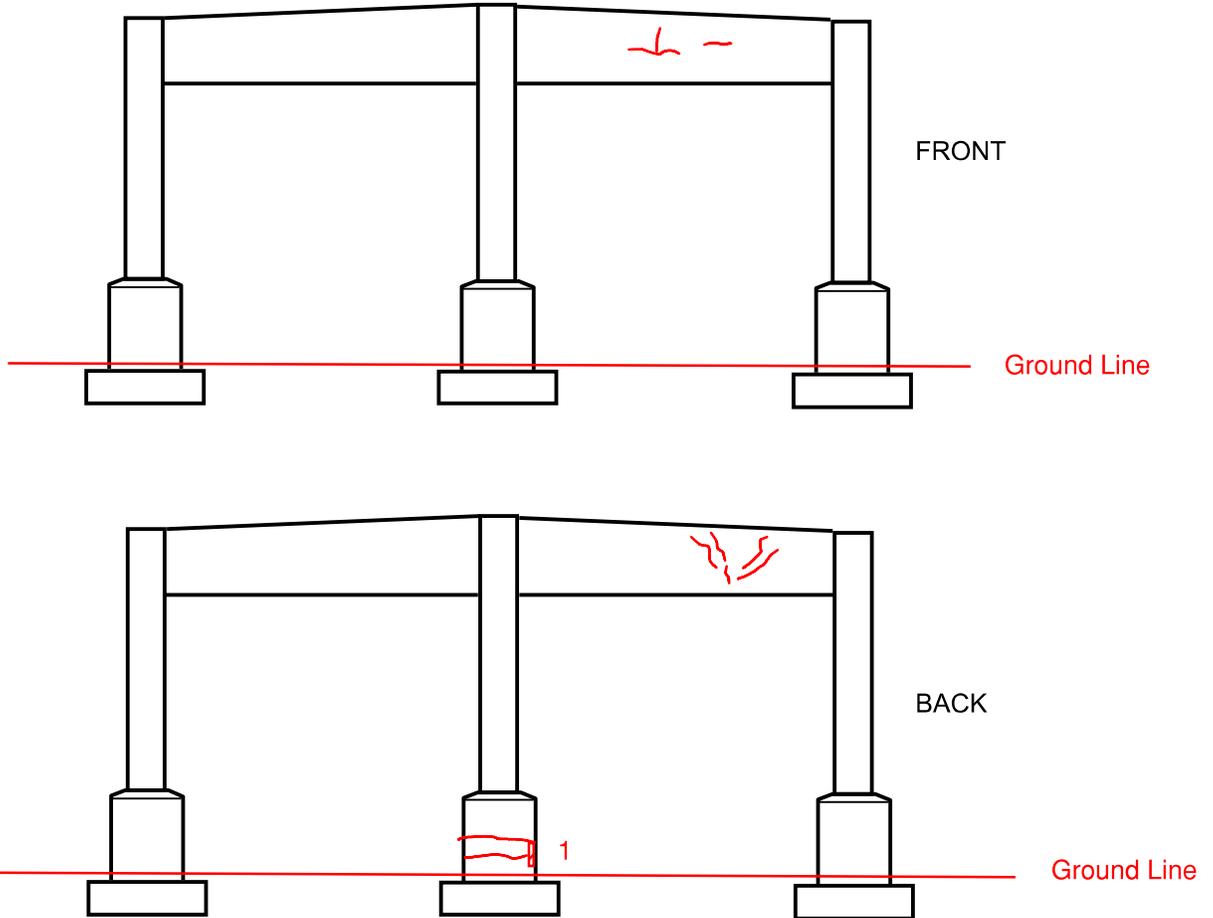
1. Spall 1.5' high x 4" wide x 2" deep

CAP	Good	HL Cracks
COLUMNS	Good	HL Cracks and see 1
FOOTING	N/V	
BEARINGS	Fair	Rollers are fully contracted to the point where sole plate bolts are in contact with the roller.

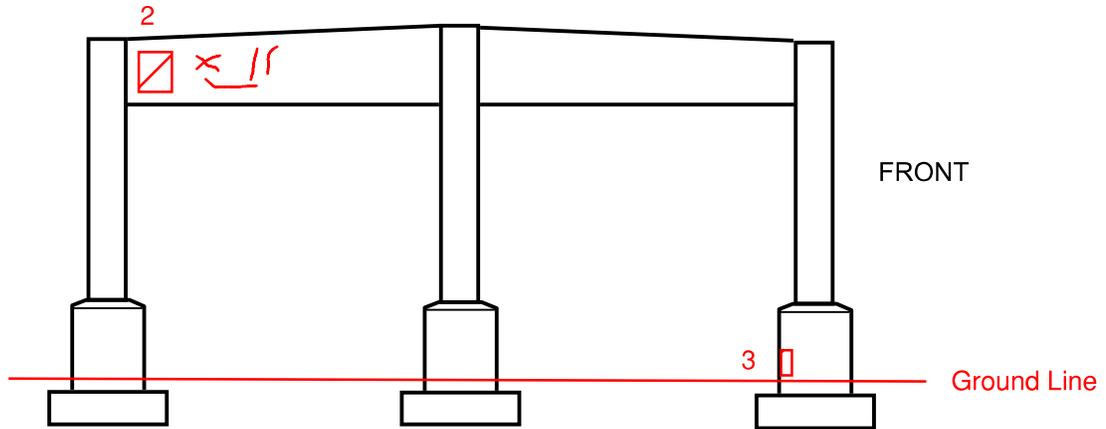
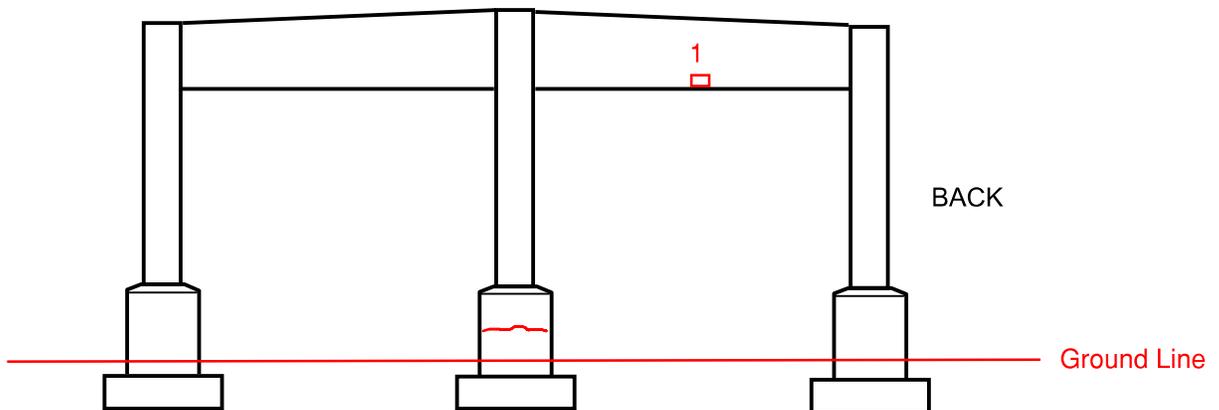
CAP	Fair	See 1 & 2, and cracks up to 1/32"
COLUMNS	Good	Cracks up to 1/32" and see 3
FOOTING	N/V	
BEARINGS	Fair	Rollers are fully contracted to the point where sole plate bolts are in contact with the roller.

- 1 Spall 4" tall x 4" wide x 2" deep
- 2 Spall to steel 2' tall x 2' wide x 1" deep
- 3 Spall 1' tall x 9" wide x 1.5" deep

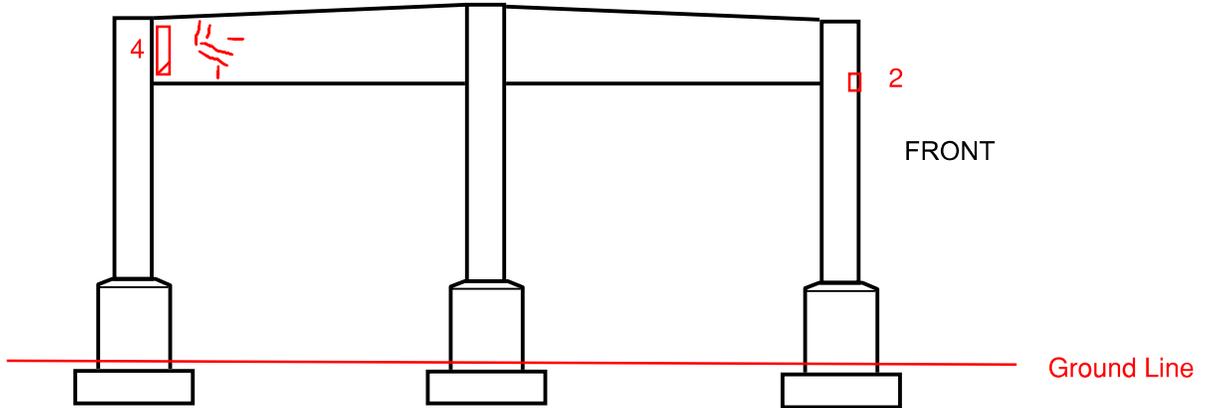
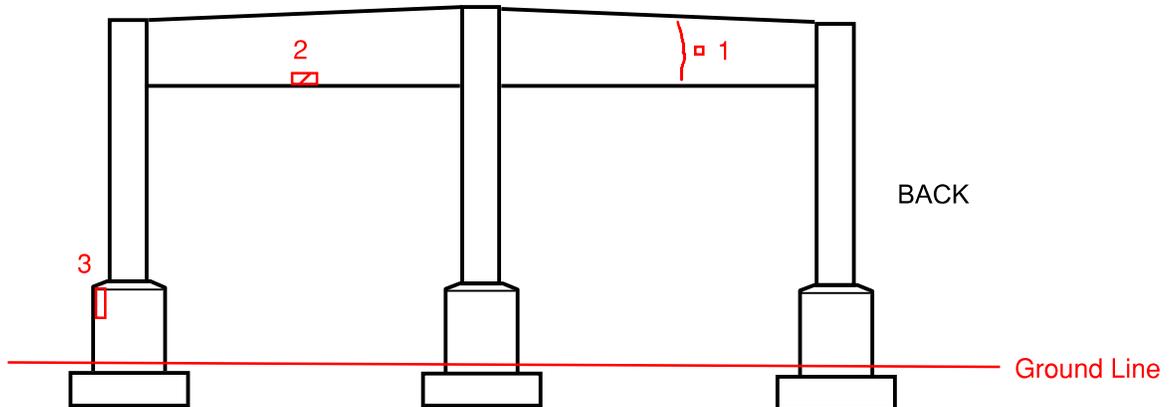
CAP	Fair	See 1 , 2 & 4 , and cracks up to 1/32"
COLUMNS	Good	See 2 & 3
FOOTING	N/V	
BEARINGS	Good

- 1 Minor rebar pop-out 2" x 2"
- 2 Spall 4" tall x 4" wide x 2" deep
- 3 Spall 1' tall x 4" wide x 1.5" deep
- 4 Delam 2.5' tall x 8" wide

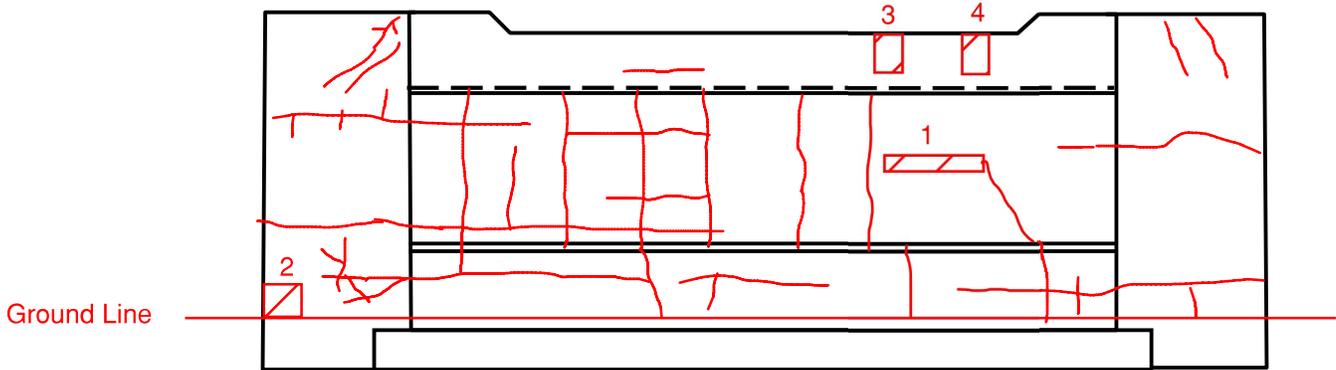
CAP	Fair	Cracks up to 1/16"
WALL	Fair	See 1 and 2 , cracks up to 1/16"
BACKWALL	Fair	See 3 and 4 , cracks up to 1/32"
WINGS	Fair	Cracks up to 1/16"
BEARINGS	Good	
FOOTING	N/V

- 1 Spall 3' long x 6" high x 1/2" deep
- 2 Spall 1' tall x 1' wide x up to 3" deep
- 3 Delam 2' tall x 1' wide
- 4 Spall to steel 2' tall x 1' wide x up to 3" deep
