BOULDER AND LOG RIFFLE

PLAN VIEW

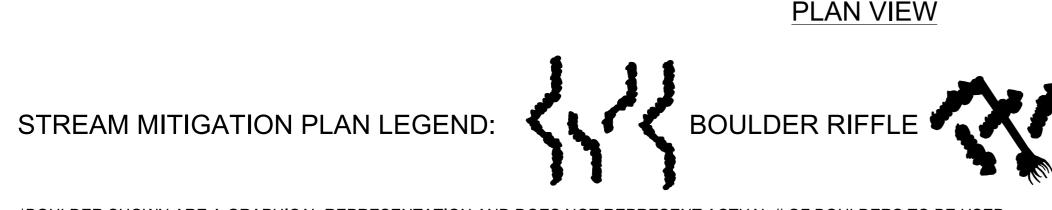
POINT OF TANGENCY

SILL - 1 BOULDER PAST BANKFULL

L SILL - 2 BOULDERS

10 FT. SILL PAST BANKFULL

POINT OF CURVATURE
