Concept Report Form

Project Name	SR-179 - Bridge over Little Muddy Creek (TMA)									
PIN	134881.00									
Route Information	Route	NHS (Y/N)	Functional Class			City		County		
	SR-179	Yes	Rural Major Collector			Stanton		Haywood		
Project Information	Begin Log Mile	End Log Mile	AADT¹	Design Hour Vol. (DHV)¹	Truck %¹	Design Speed (MPH)	Posted Speed (MPH)	Base Year	Design Year

AREA MAP
SR-179 BRIDGE [38S80520003]
BRIDGE OVER LITTLE MUDDY CREEK
L.M. 1.24
HAYWOOD COUNTY

R4 TIMBER BRIDGE PROGRAM
STATE ROUTE 179
BRIDGE OVER LITTLE MUDDY CREEK, L.M. 1.24
HAYWOOD COUNTY

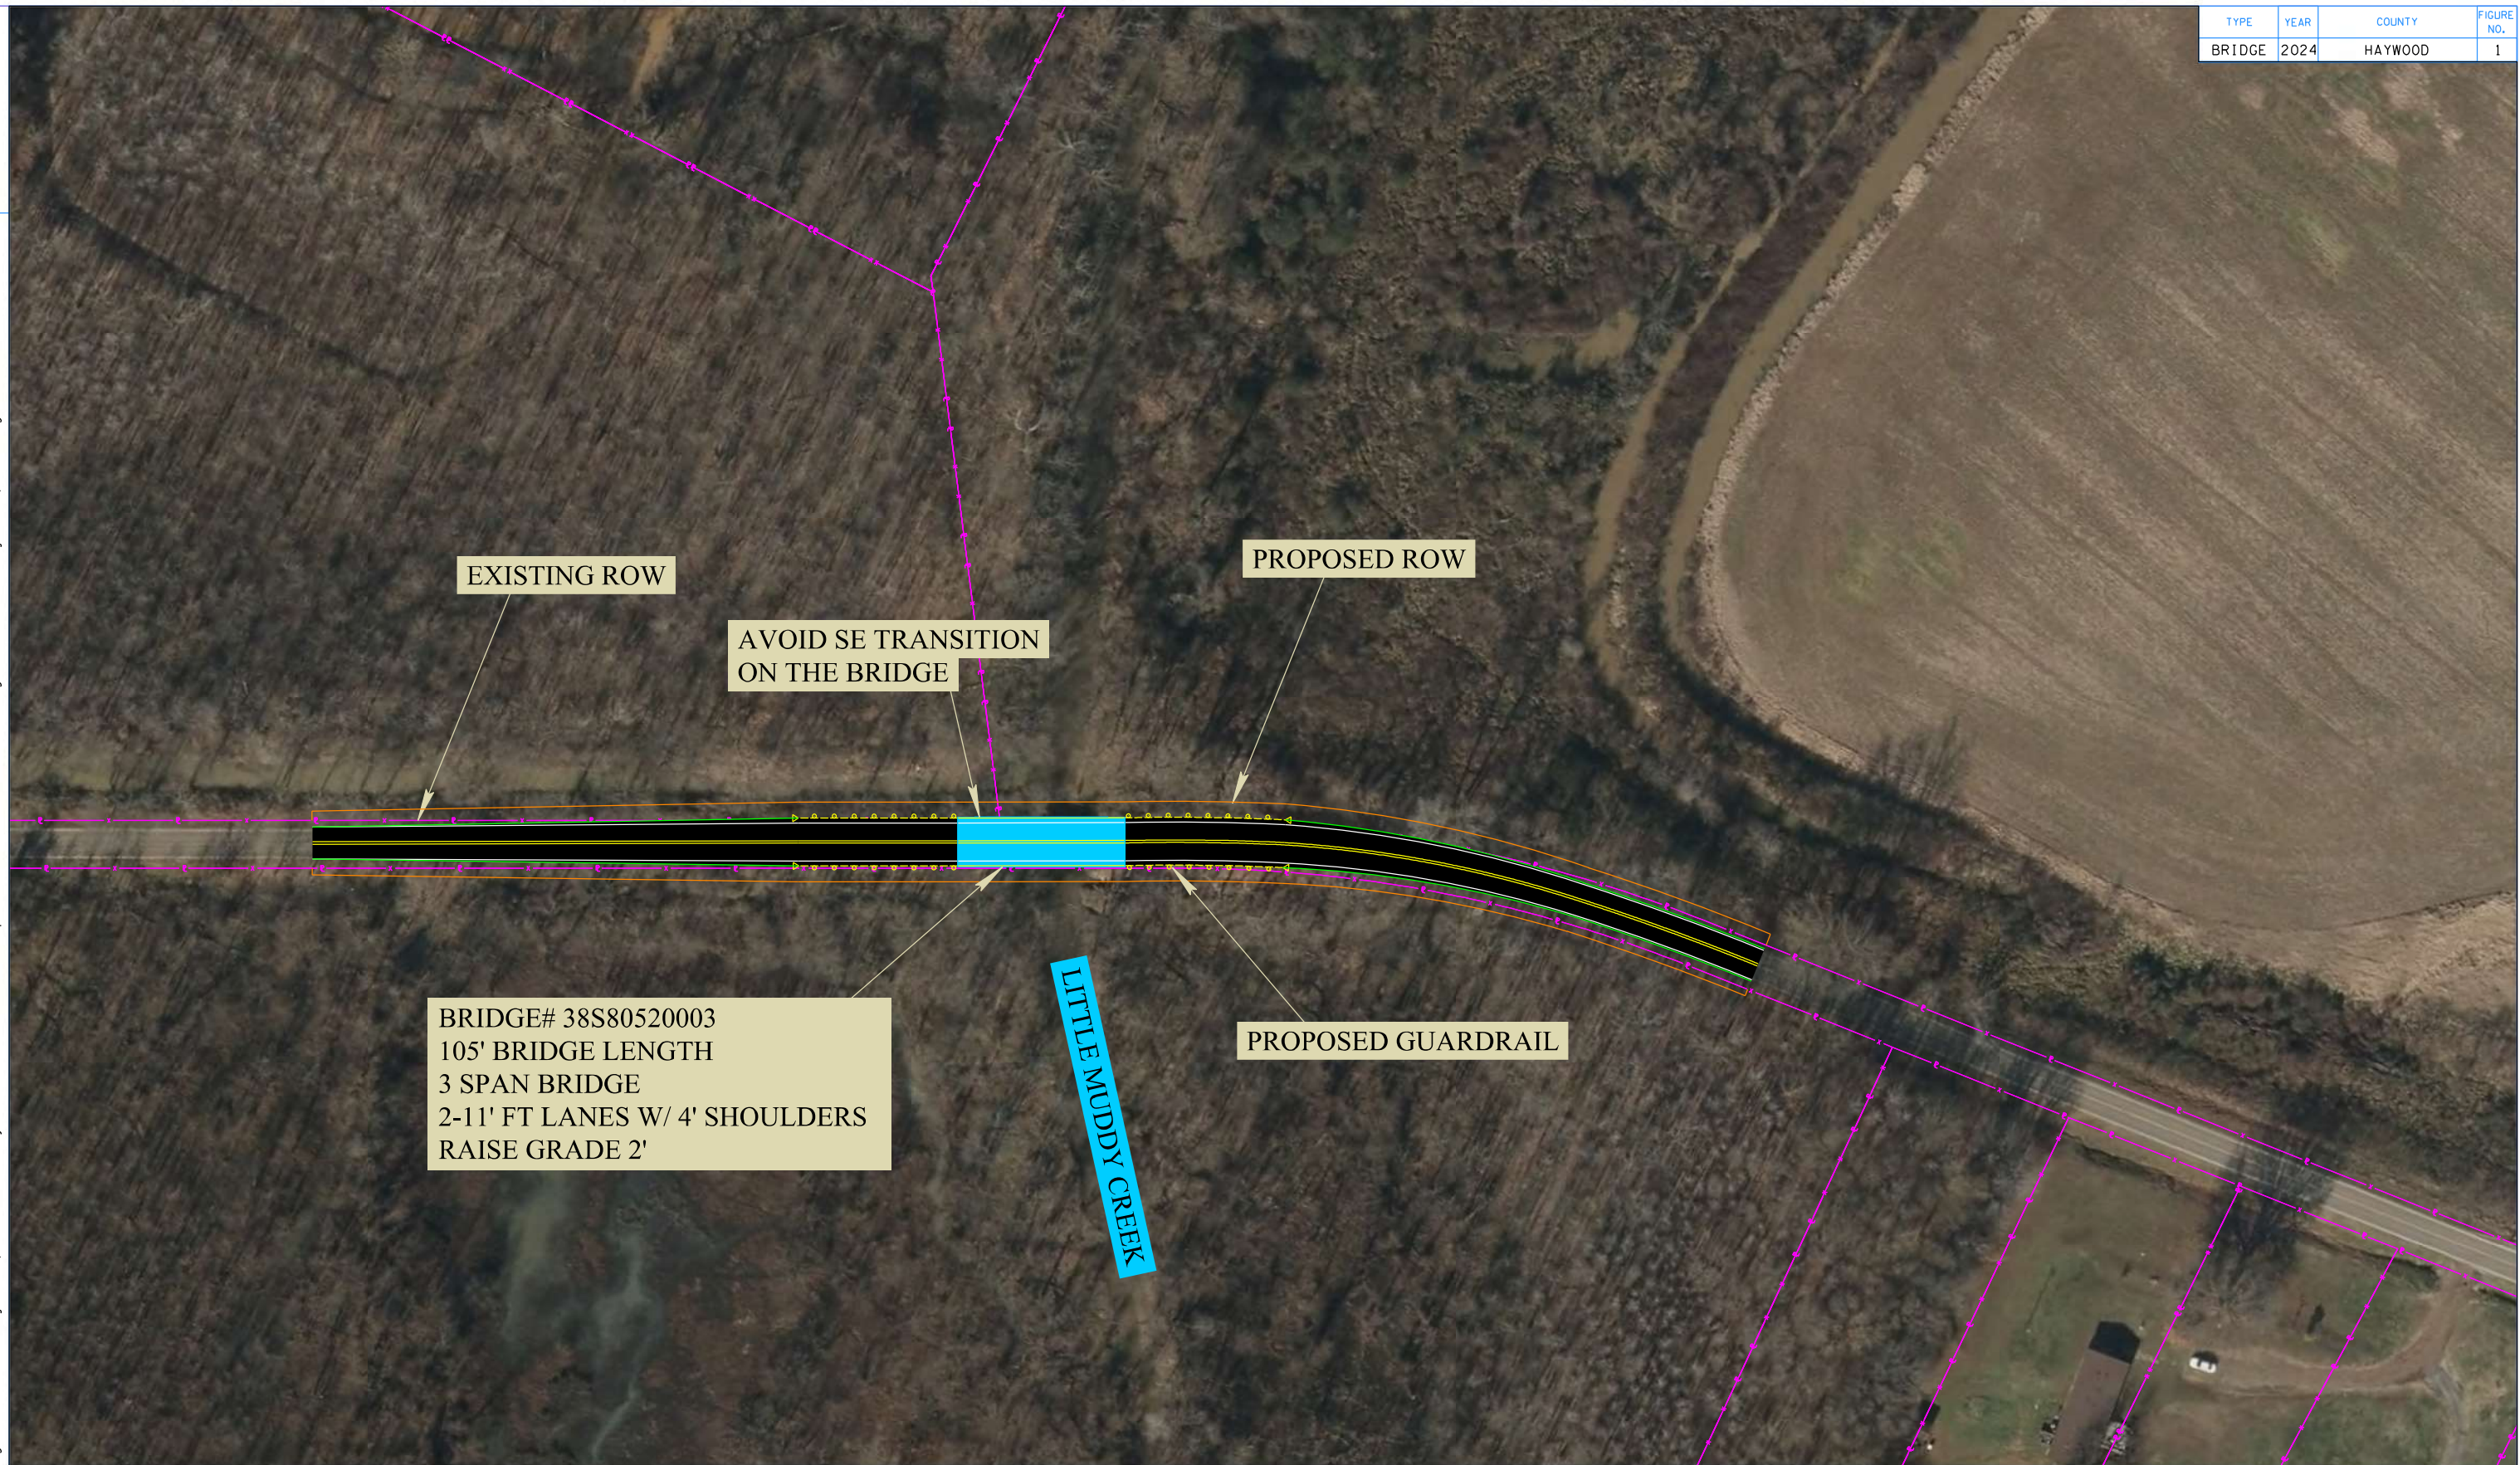
BRIDGE# 38S80520003
105' BRIDGE LENGTH
3 SPAN BRIDGE
2-11' FT LANES W/ 4' SHOULDERS
RAISE GRADE 2'

1.24		2,450	294	4.00	55	55	2029	2049	
Project Description & Standard Drawings Used	<p>The proposed bridge is to be a 3 span 105' bridge using Type 1 I beam. The typical section for the approach and bridge will be 2-11' foot travel lanes with 4' shoulders (Design Exception Required). The out-to-out width based on the above recommendations will be 31'3". The proposed grade and vertical clearance will be raised 2'. A detour is recommended but is a potential ABC candidate. The state route detour is 32 minutes (26.6 miles); the local route detour is 15 minutes (11.2 miles). Superstructure depth is 41.75" = 28 (beam) + 10" (deck) + 3.75" (width (in inches) x0.02/2).</p> <p>RD11-TS-2</p>									
Important Project History or Related Projects	<p>Existing structure, built in 1959, is a 4 span timber bridge, 76' long with an out-to-out width of 25'. The existing structure has 2-10' travel lanes with no shoulders. The listed weight limit on the inspection report is 40 tons (8/16/2023). The discharges for the drainage basin (StreamStats Version 4.19.4) for drainage area of 13.46 square miles: Q10 is 3100 cfs, Q50 is 4320 cfs, and Q100 is 4820 cfs.</p> <p>This project is NOT expected to utilize federal funding.</p>

134881.00	Haywood	SR179	1	Bridge over Little Muddy Creek (TMA)	1.24	38S80520003	105', 3 span, type 1 I beam, raise grade 2 ft. Existing bridge is scour critical. Main channel bridge is 134881.00 and hydraulic design should be done together. Existing bridge is scour critical. Both are undersized and will probably be low design storm.

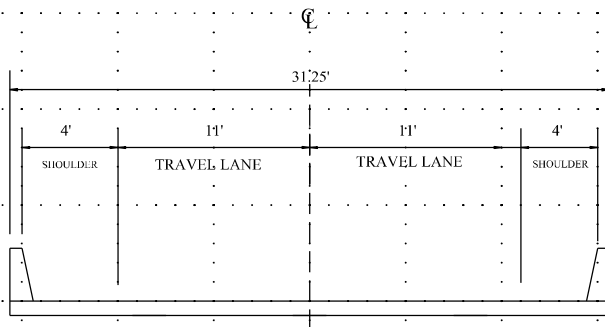
CROSS-SECTION DETAIL

PROPOSED COMPLETED

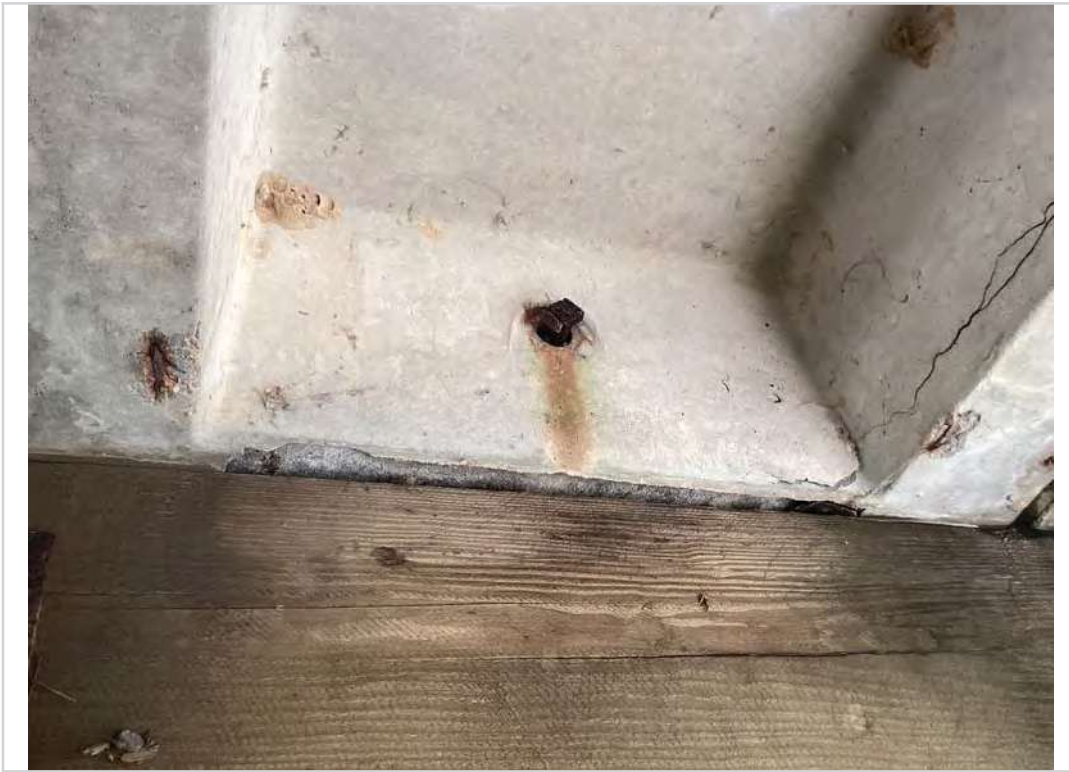
Span 2 span connectors corroded. 7 nuts missing

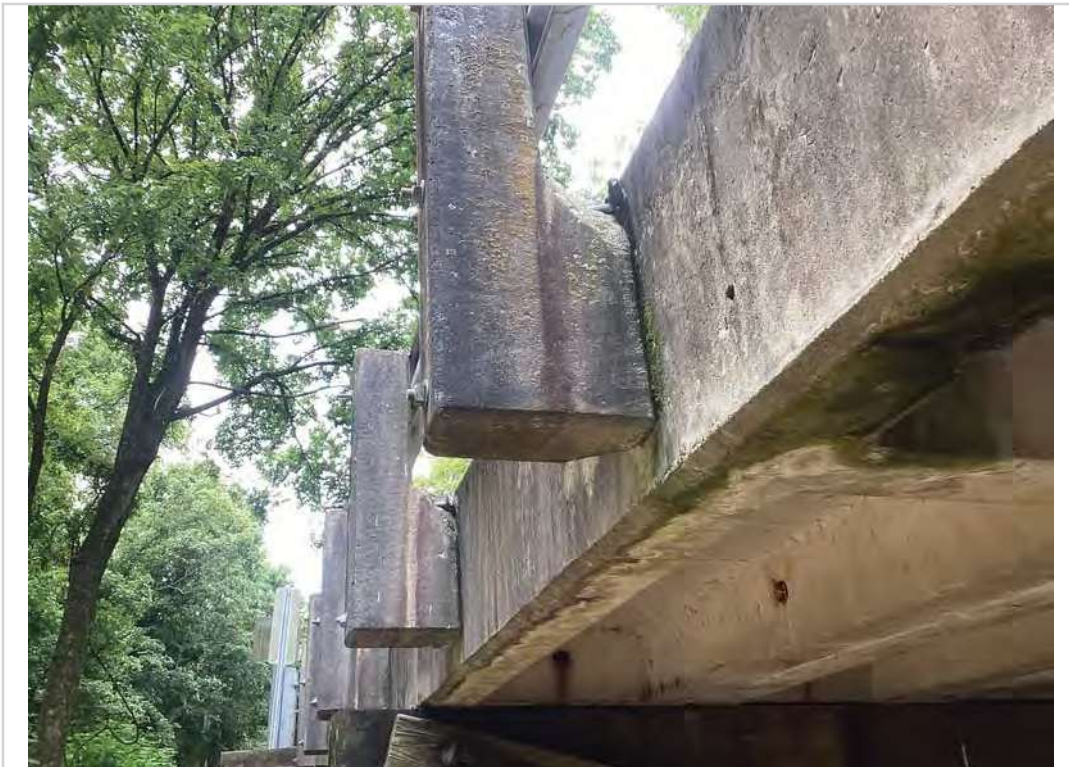
Span 2 right side posts damaged

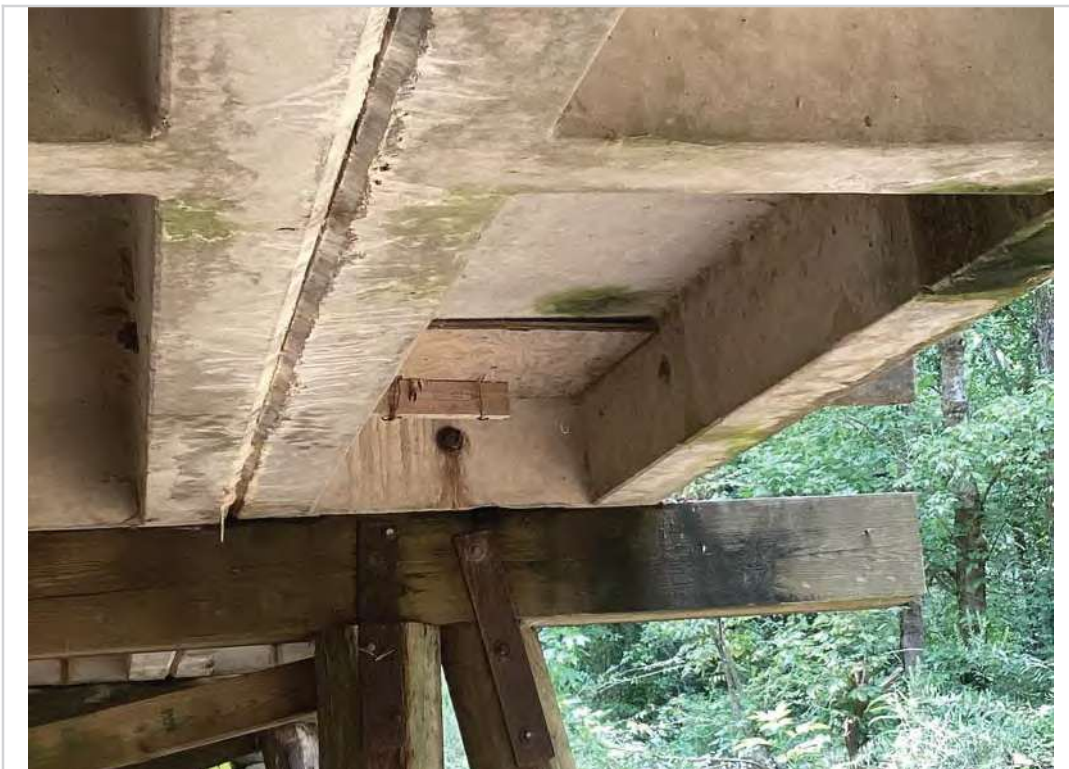
Span 2 slab G patched area

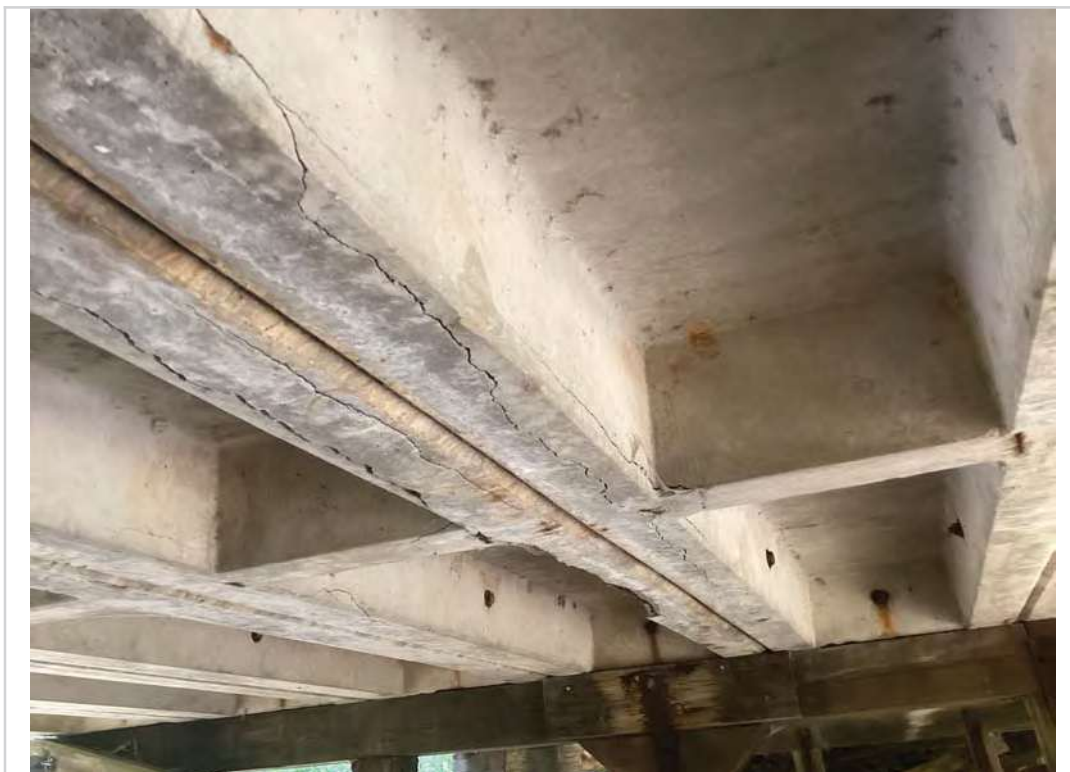
Span 2 slab E impending spall

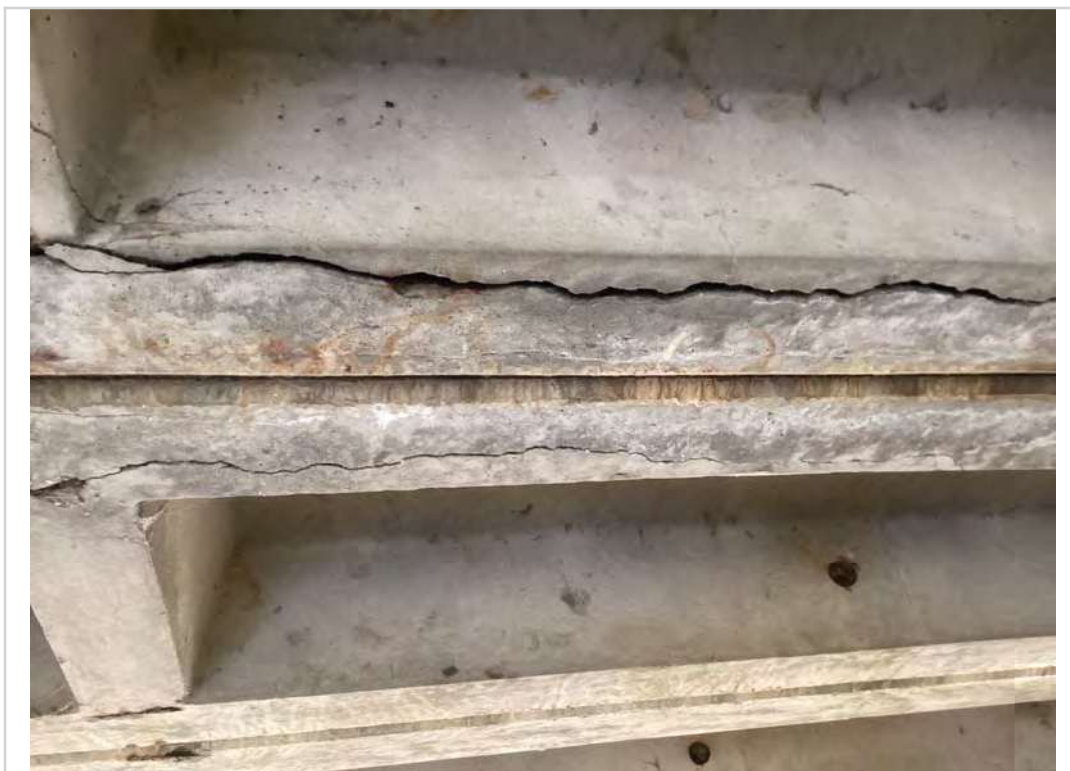
Span 2 slab D impending spall

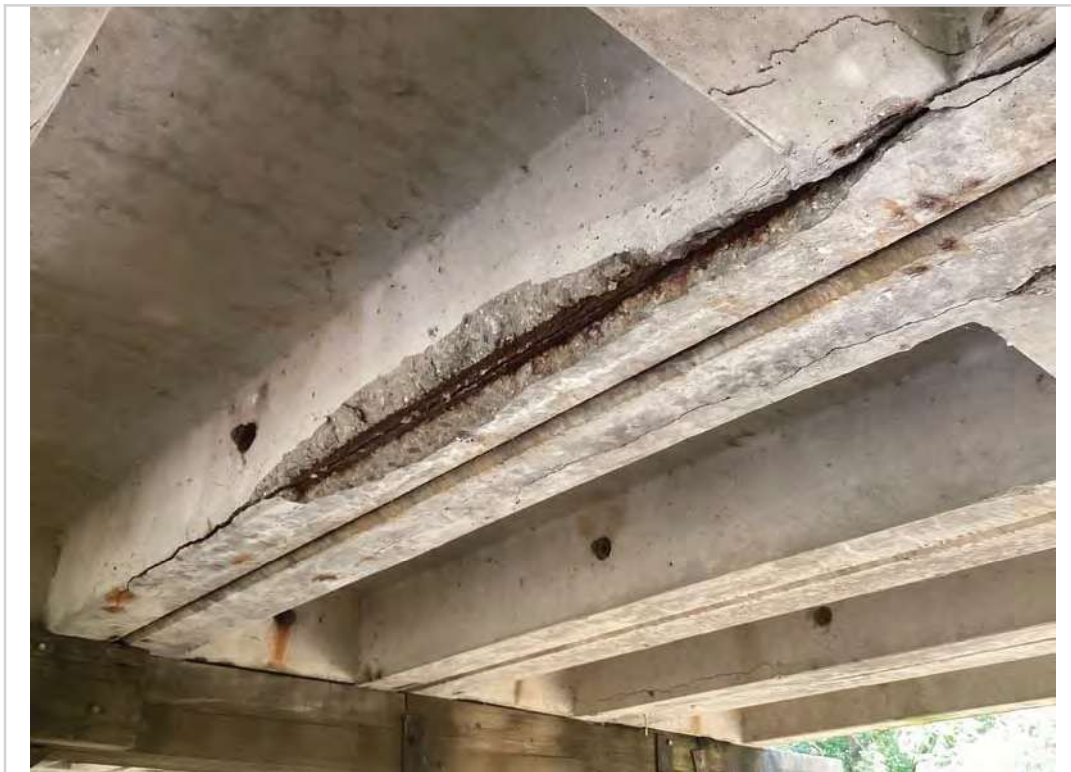
Span 2 slab D spall to steel

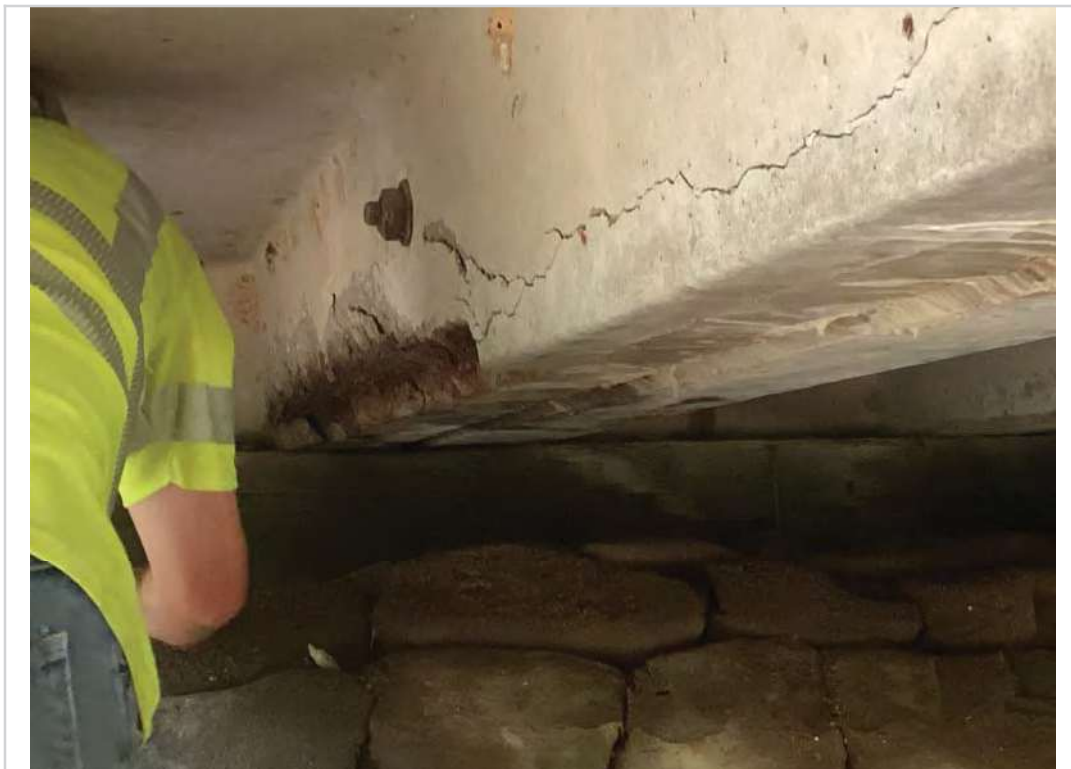
Span 1 slab G spall to steel

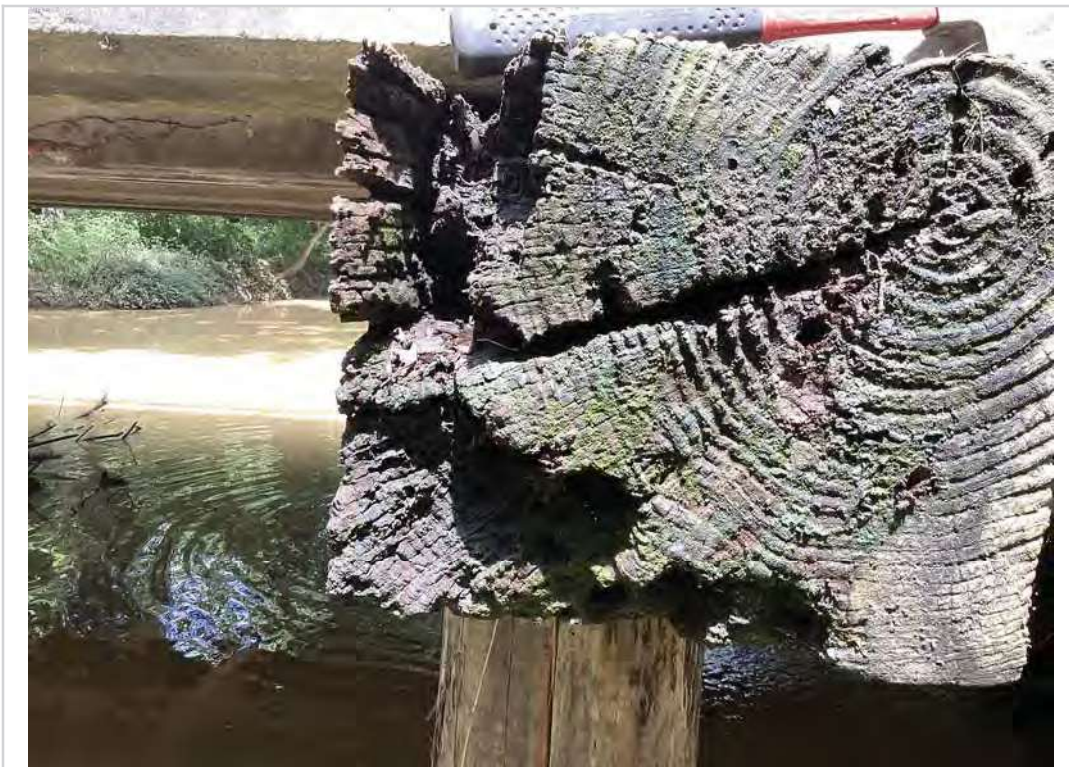
Decay, bent 3 cap

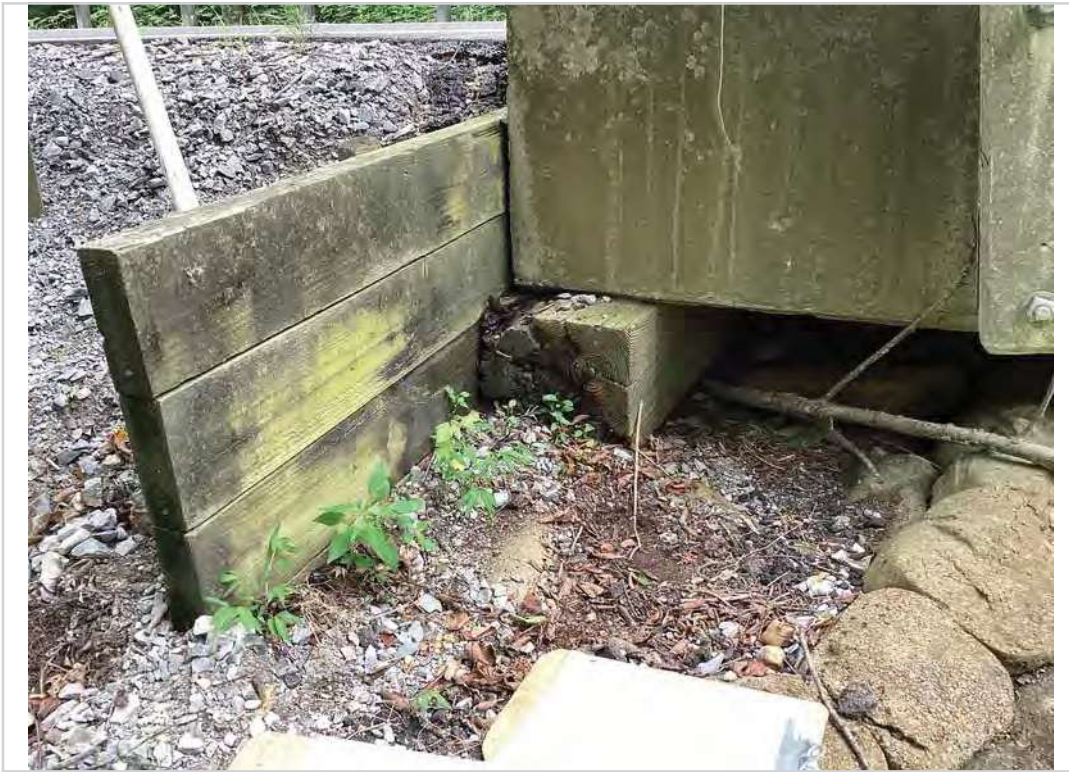
Abutment #1 right end cap decay

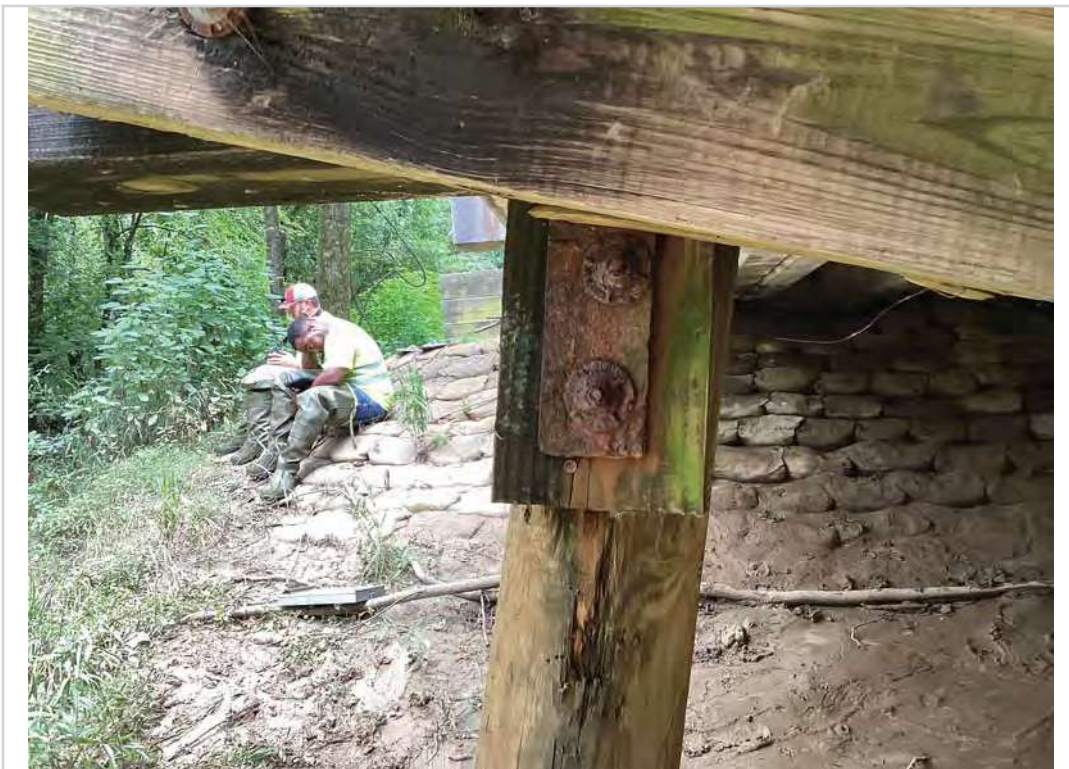
Bent #1 splice plates corroded

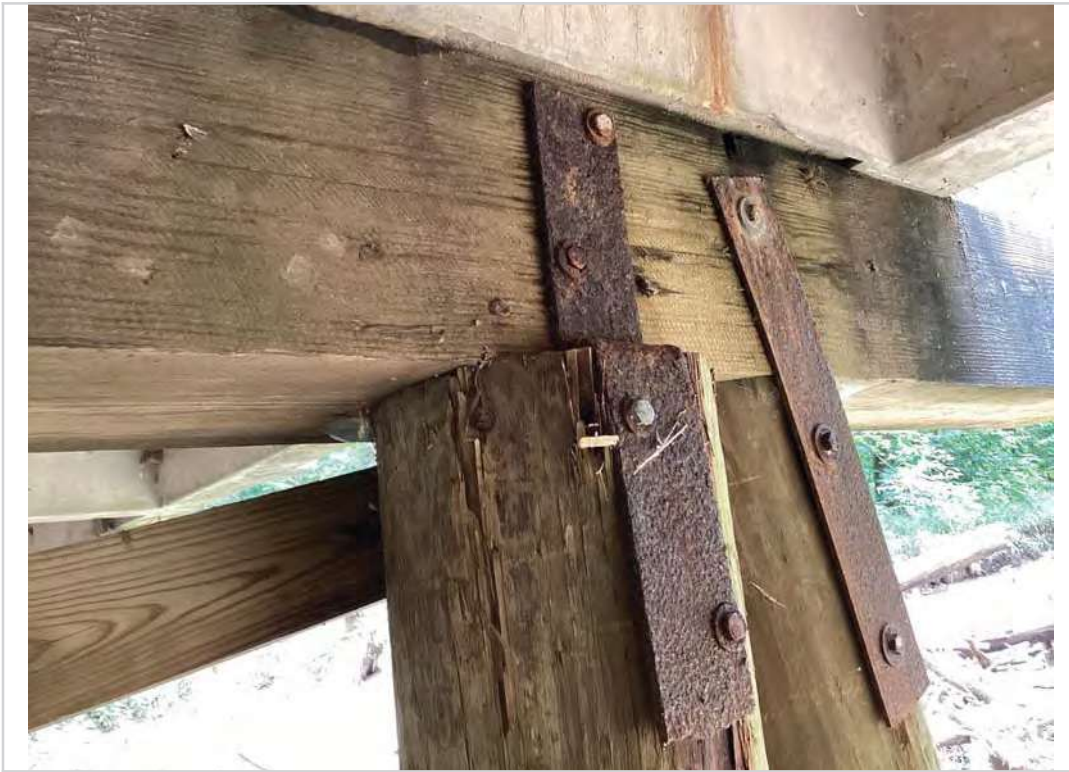
Bent #2 splice plates corrosion (typical for bents #1 and #2)

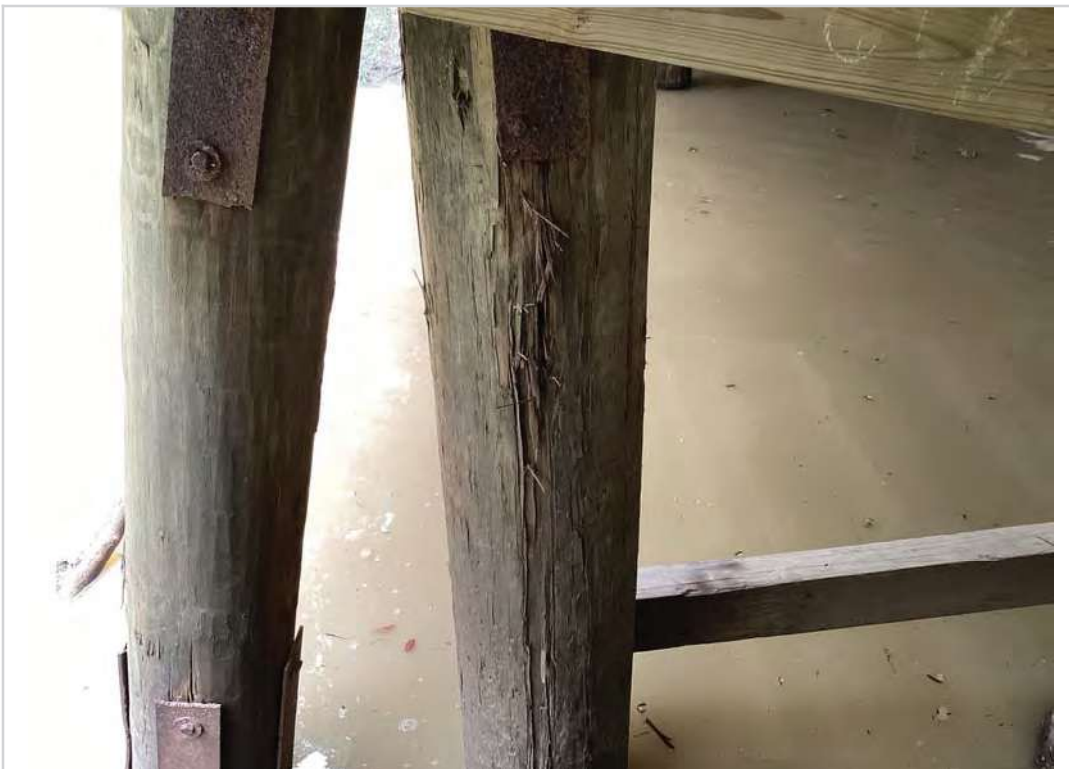
Bent #2 pile E splintering

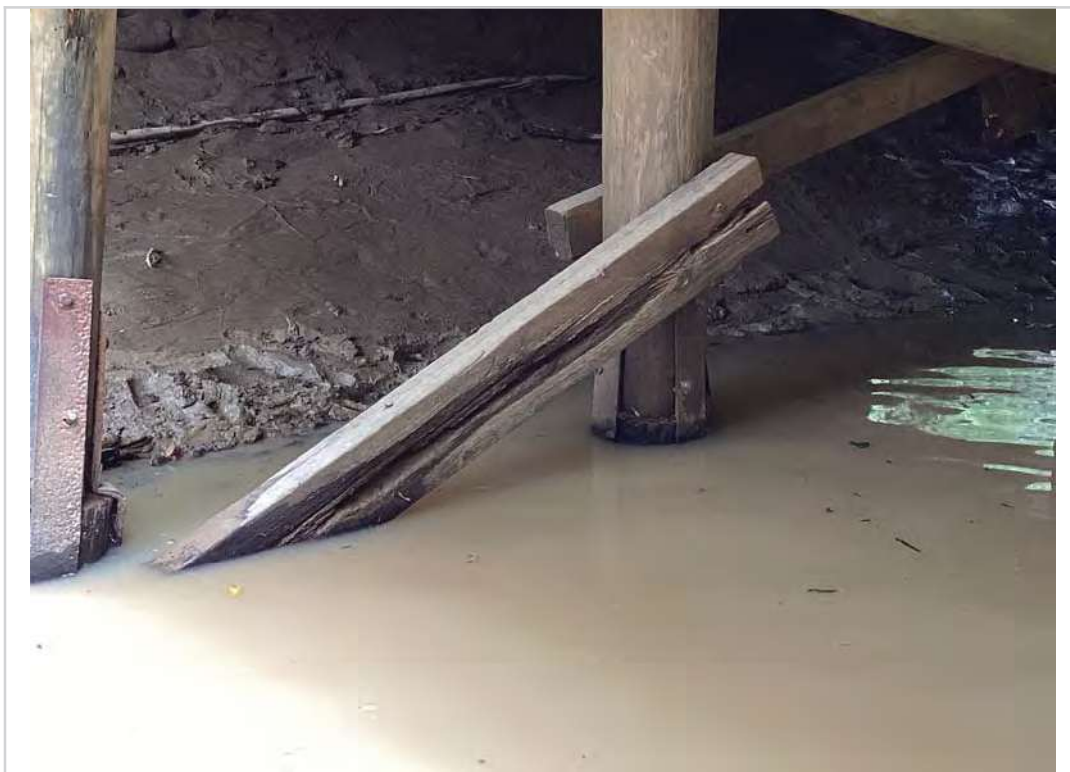
Bent #1 bracing decay (typical for bents 1 and 2)

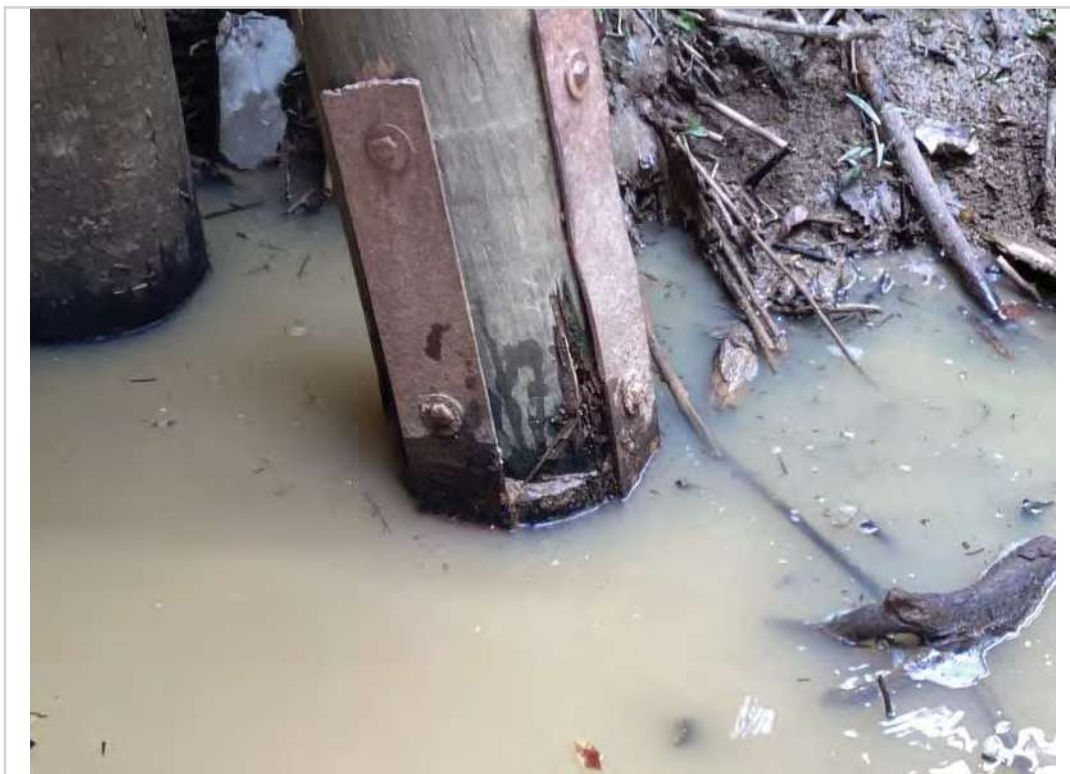
Bent #2 pile E decay

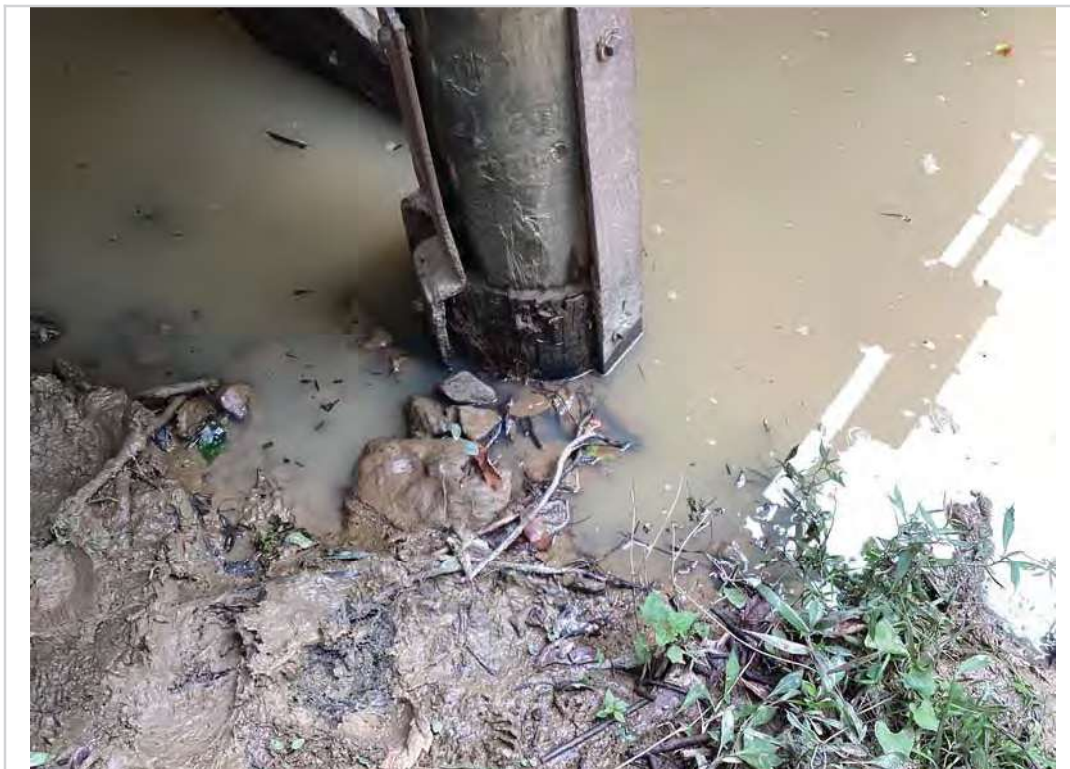
Bent #1 pile E decay

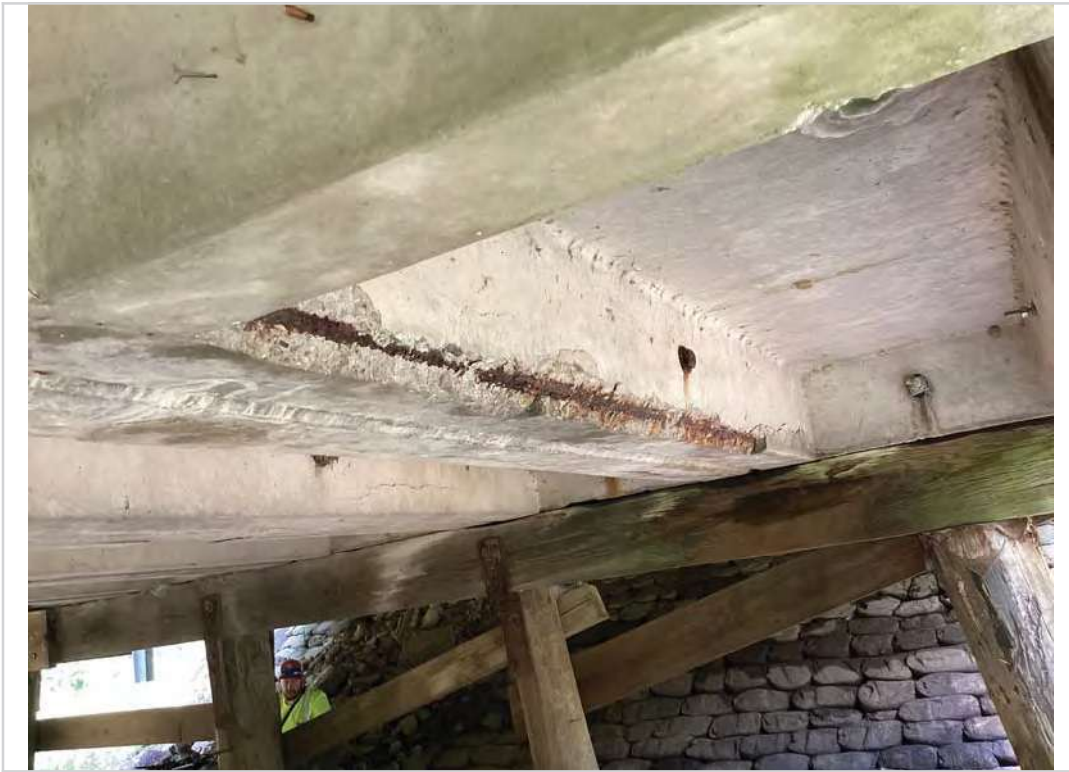
Span #3 PCCS "G" spall to steel
