IDENTIFICATION	
(1) State Names	47 - Tennessee
(8) Structure Number	33035560003
(5) Inventory Route	1
(2) Highway Agency District	Region 2
(3) County Code	33 - Hamilton

(4) Place Code	14000
(6) Features Intersected	CSX & NS RAILROAD
(7) Facility Carried	FAU 3556 350045W
(9) Location	WILCOX BLVD / RR YARDS
(11) Mile Point	0.150 mi

Inspection Team's Summary

This is a 17-span steel girder bridge. It was inspected by a Chattanooga bridge inspection team from Region 2 and found to be in overall "POOR" condition. The bridge rails, transitions, approach guardrails, and approach guardrail terminals do not meet current safety standards. The wearing surface has wide cracks at both approaches. The bridge rails are damaged on the right side. The left side has a curb with separates this structure from the adjacent structure.

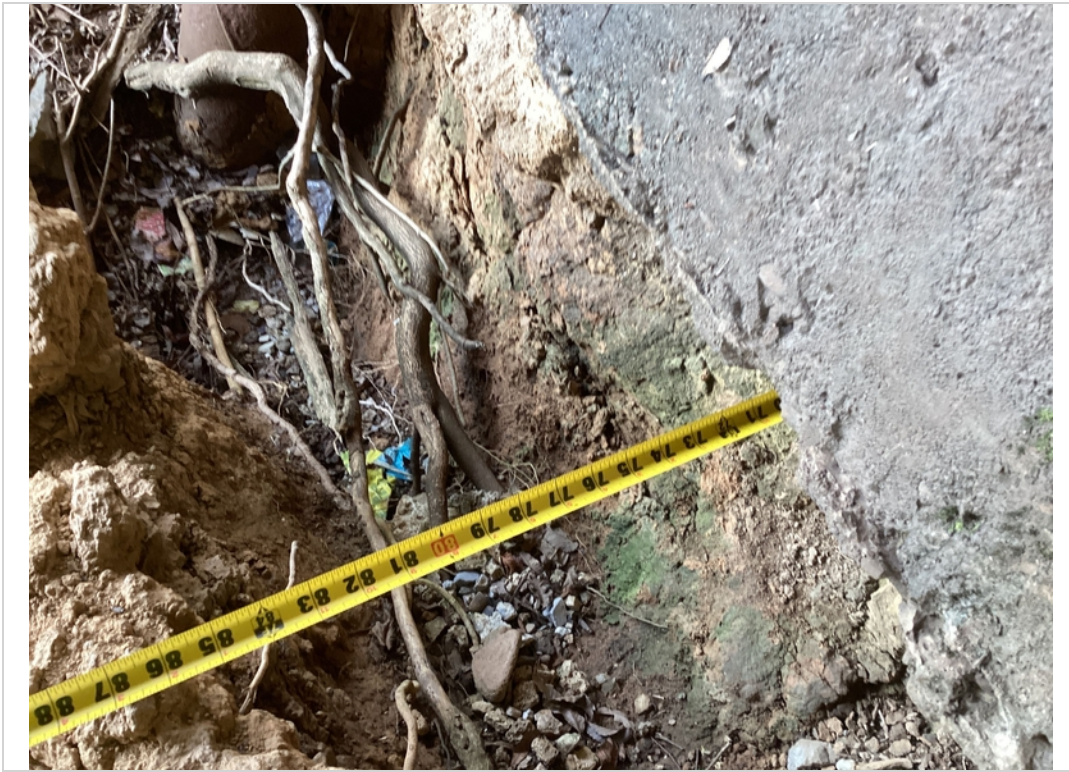
Undermining at abutment 1, right, up to 5' deep

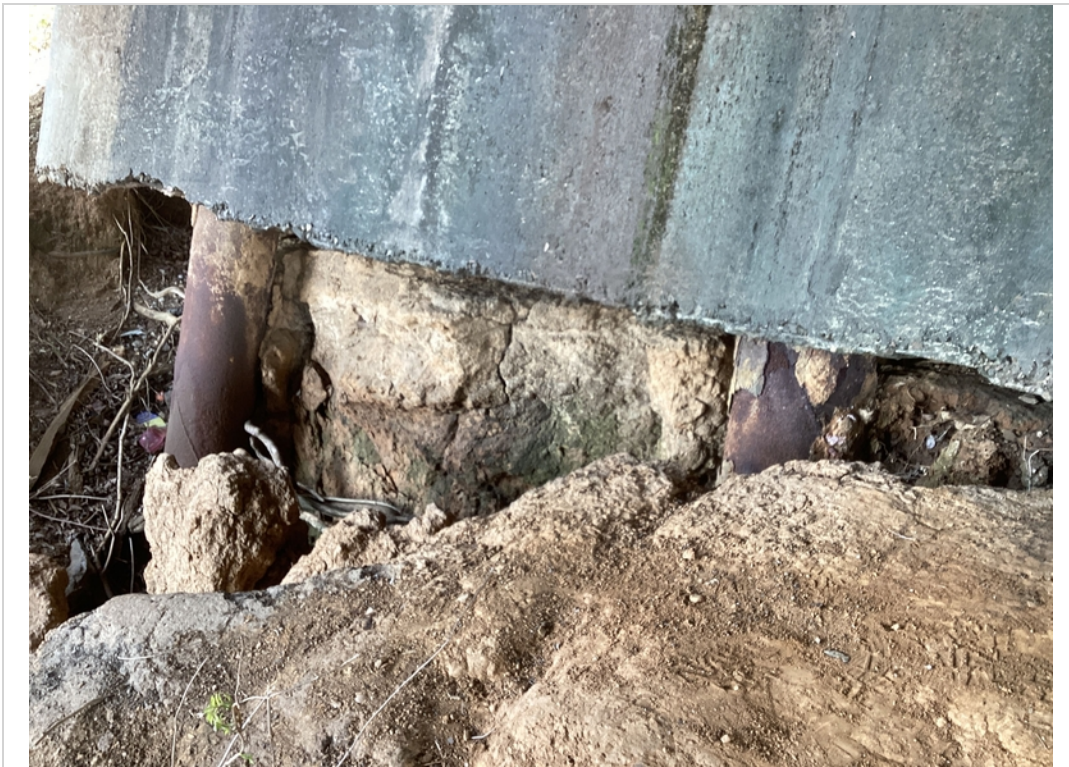
Erosion, exposed piles at abutment 1

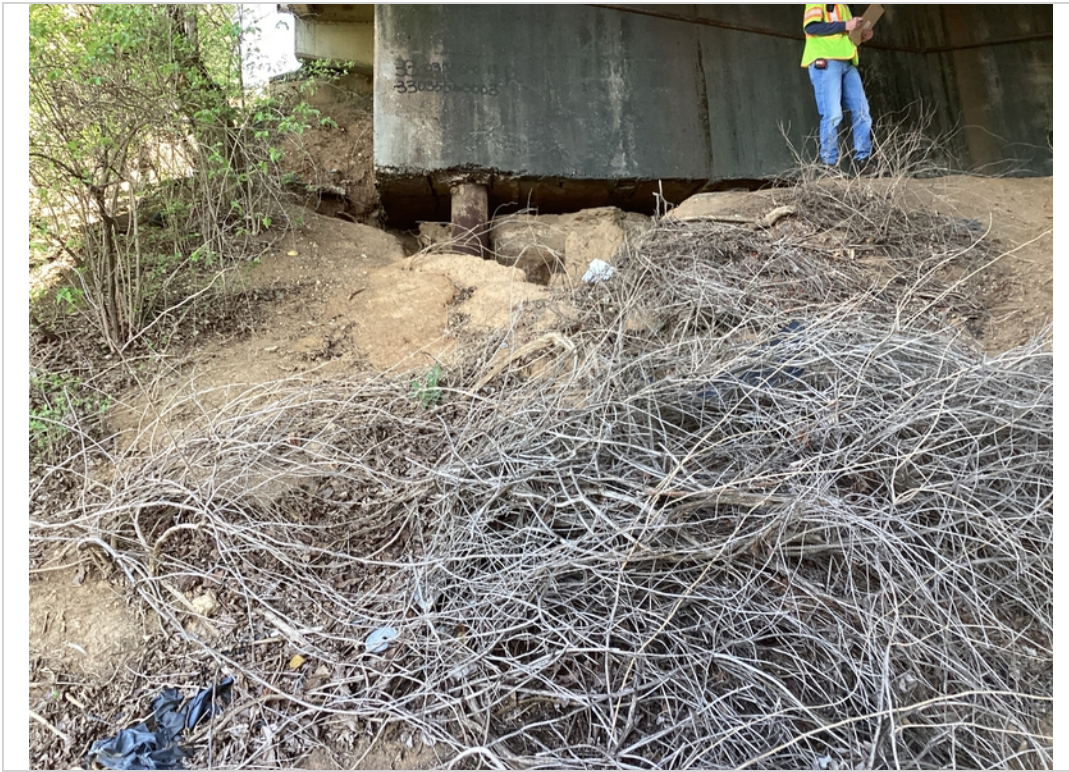
Erosion at abutment 1

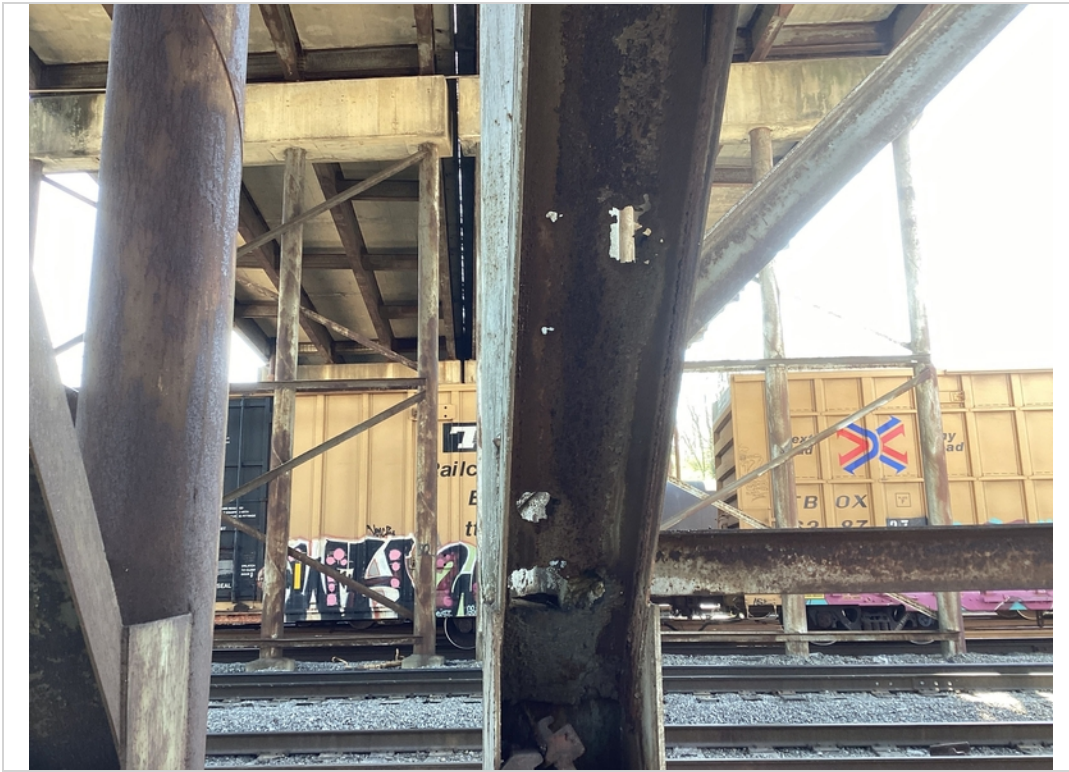
Cross bracing 10-11, diagonal brace, left - multiple holes through

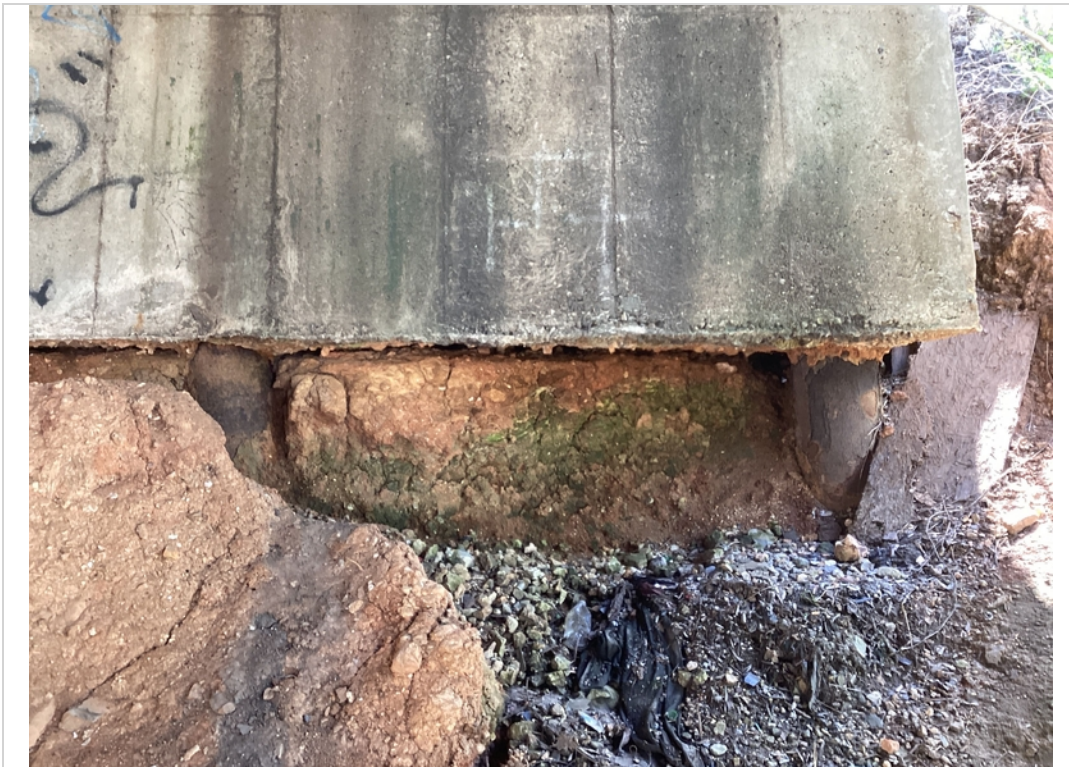
The substructure is rated "POOR." Piles with section loss of up to 1/8" deep are exposed at both abutments. Erosion and undercutting are present at both abutments and some of the concrete bent column collars.. The bridge seat and cap at the bents have cracks, spalls, rebar exposed, loss of bearing area and delamination. Some bracing have areas of section loss creating hole-throughs in the flanges and webs.

Undercutting and exposed piles with section loss at abutment 2

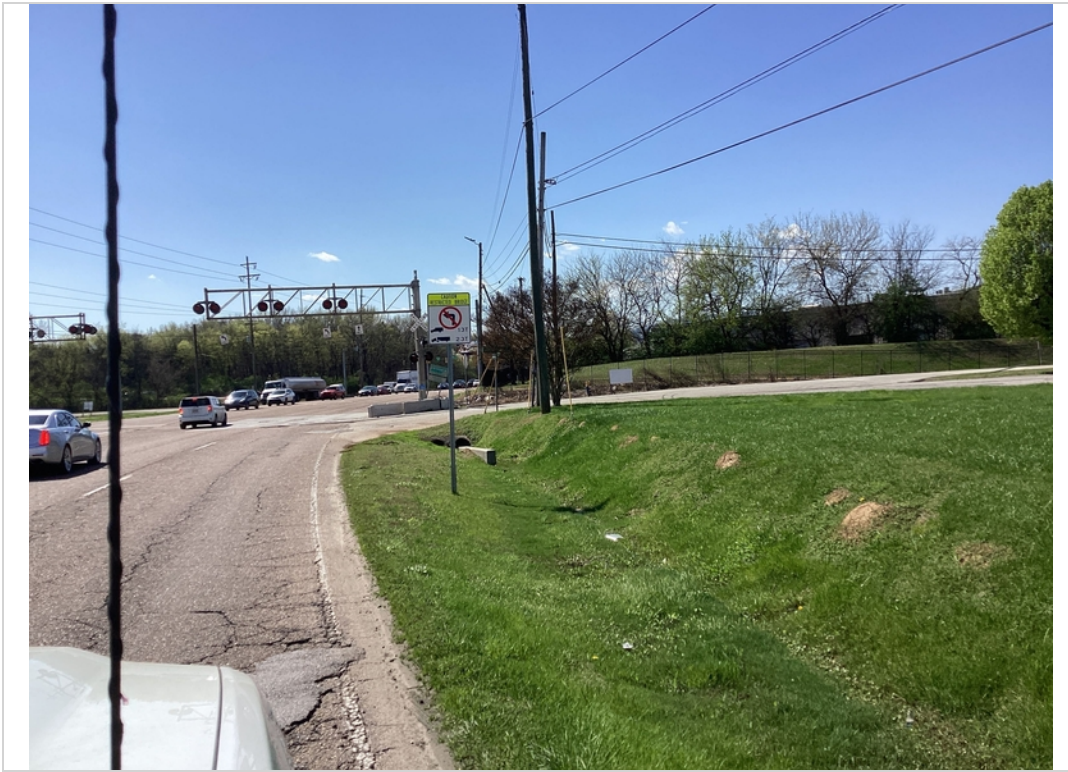
Southbound Riverside drive - weight posting

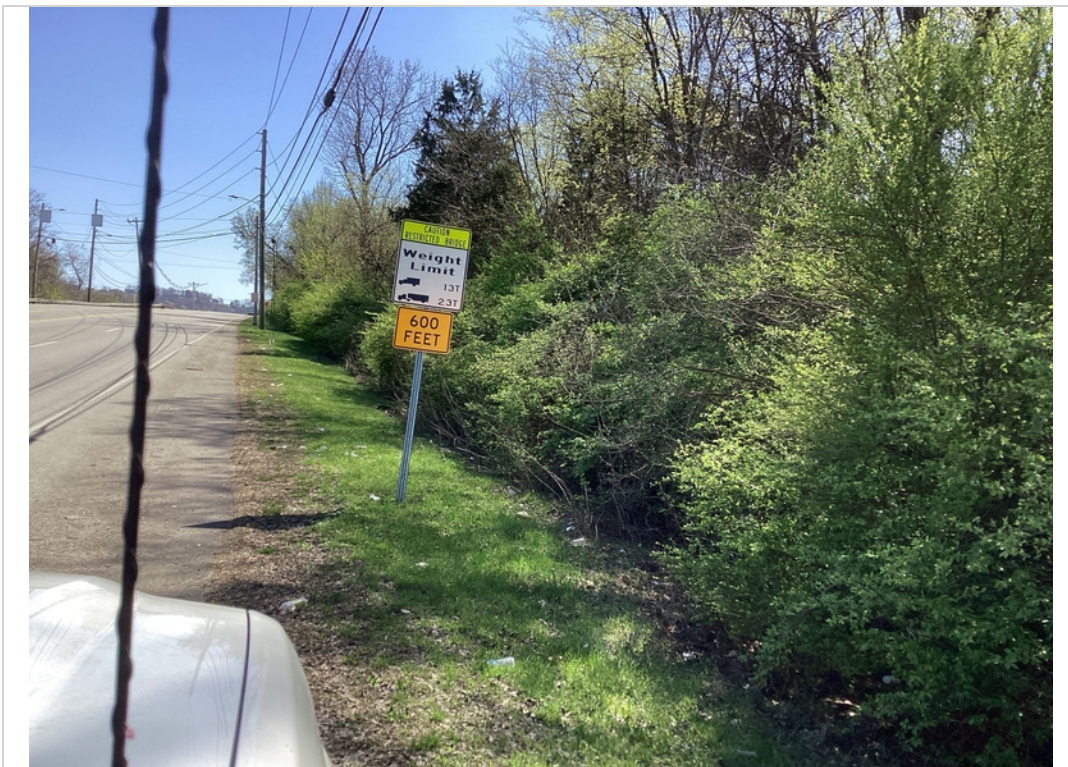
Approach 1, eastbound on Wilcox - weight posting

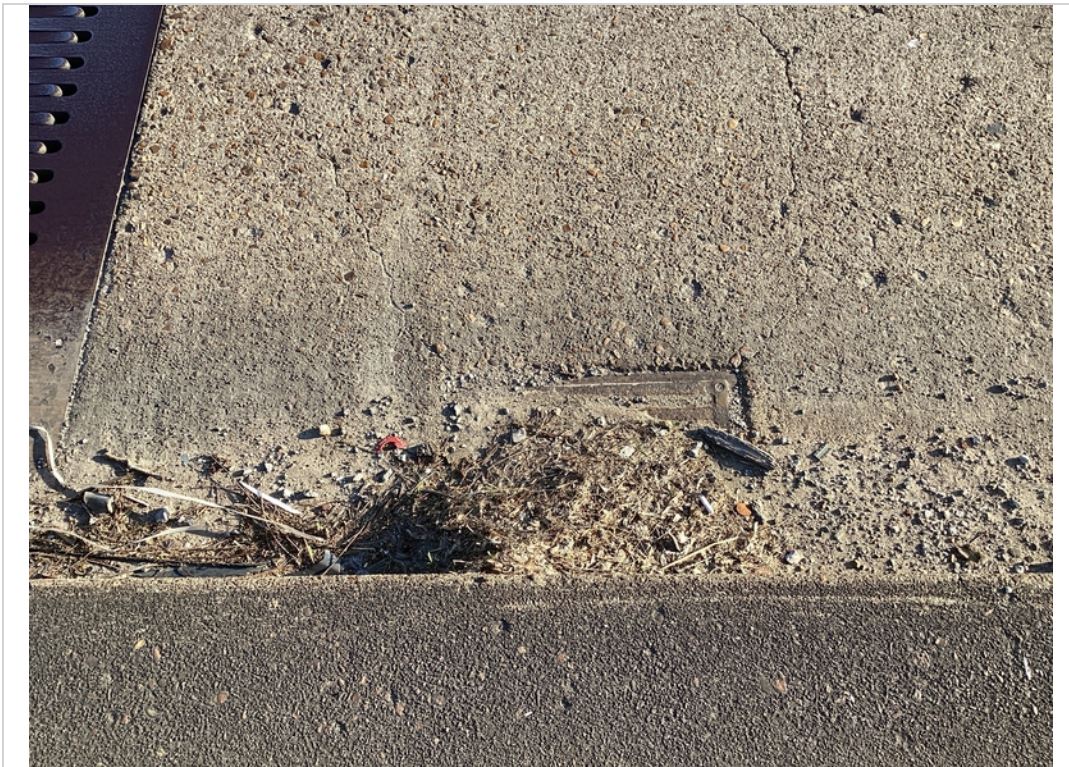
Drain Blocked - Beginning of Span #2
