Region 03, 19 - Davidson County

I40 LL / 8TH AVE (SR 6)

| IDENTIFICATION | |
|---|---|
| (8) Structure Number | 19I00400080 |

3 span Bridge / W.P.G.
I-40 WB / 8th AVE (SR 6)

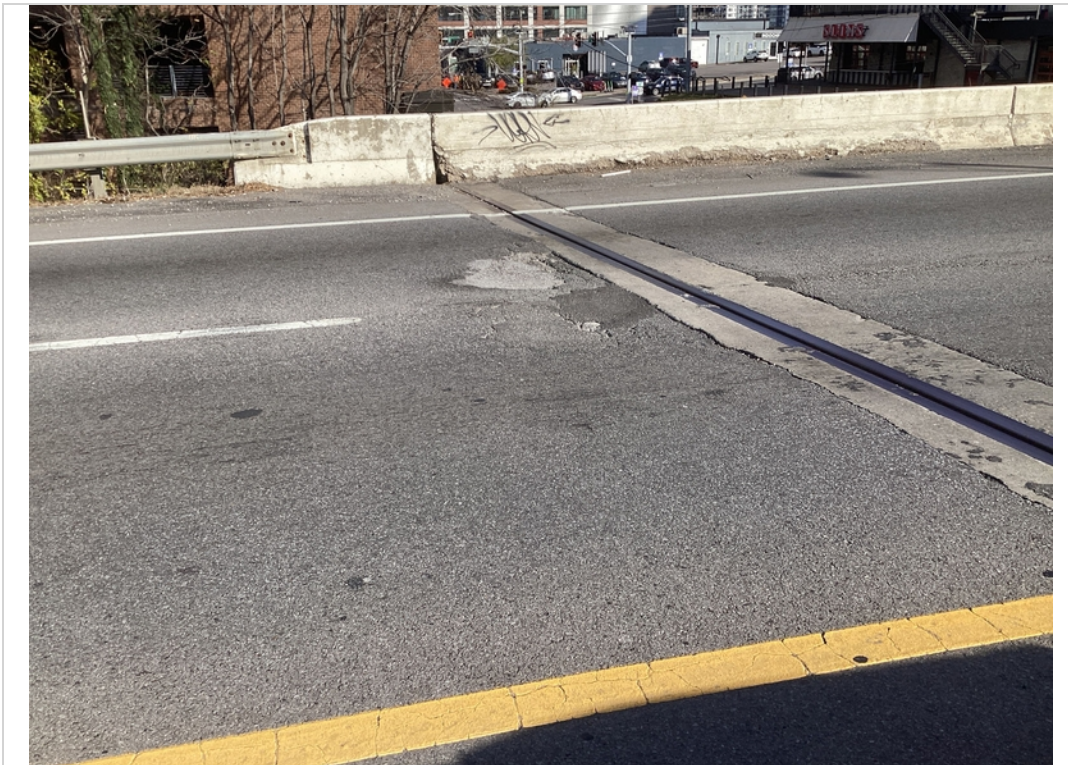
A approach pavement patches depression

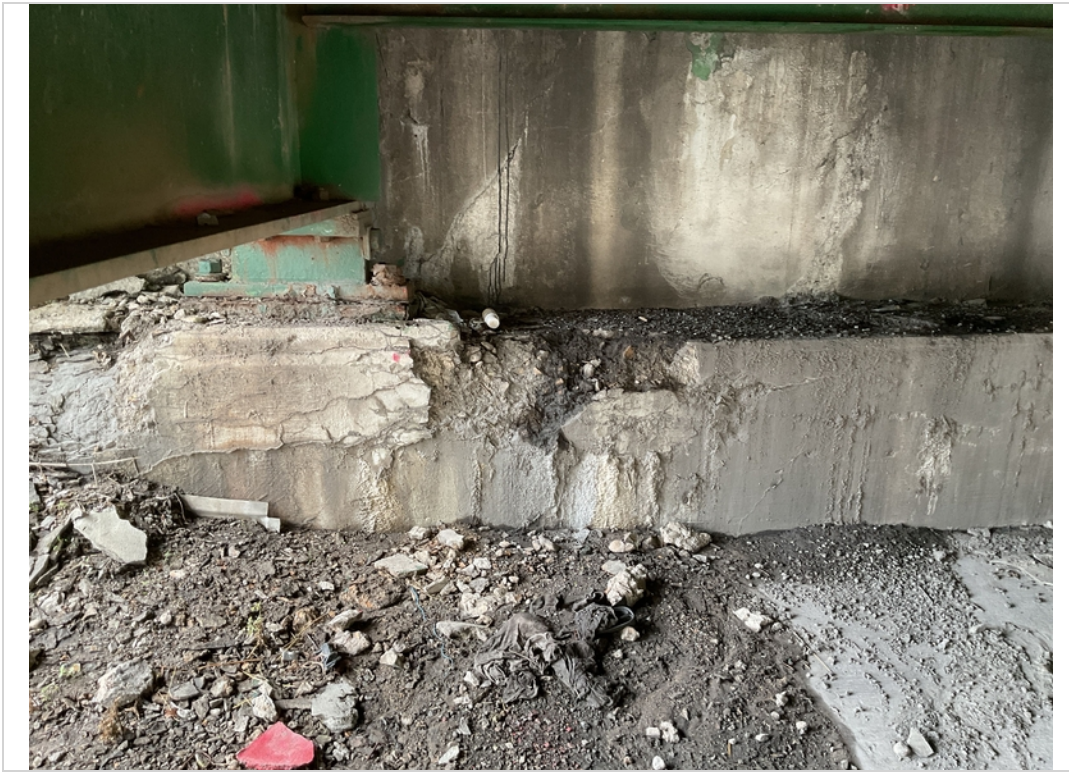
| Abutment Backwall | (Fair) | ABUTMENT #1 & #2 LT SIDE- MOD SPALLS W/EXP. STL.--#2--POOR |

Abut 2 hvy scale.

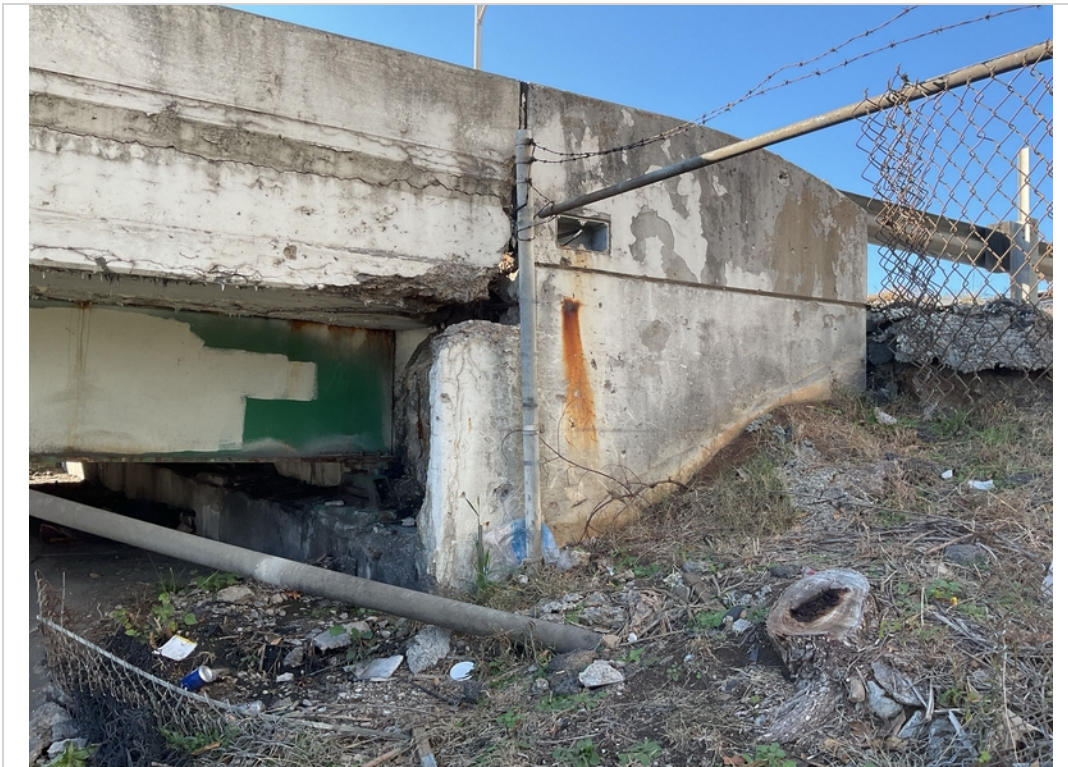
| Abutment Wings | (Poor) | ABUTMENT # 1 LT SIDE- HVY SCALE & MAP CRACKS |

Abut 1 left wing vert.h.c.

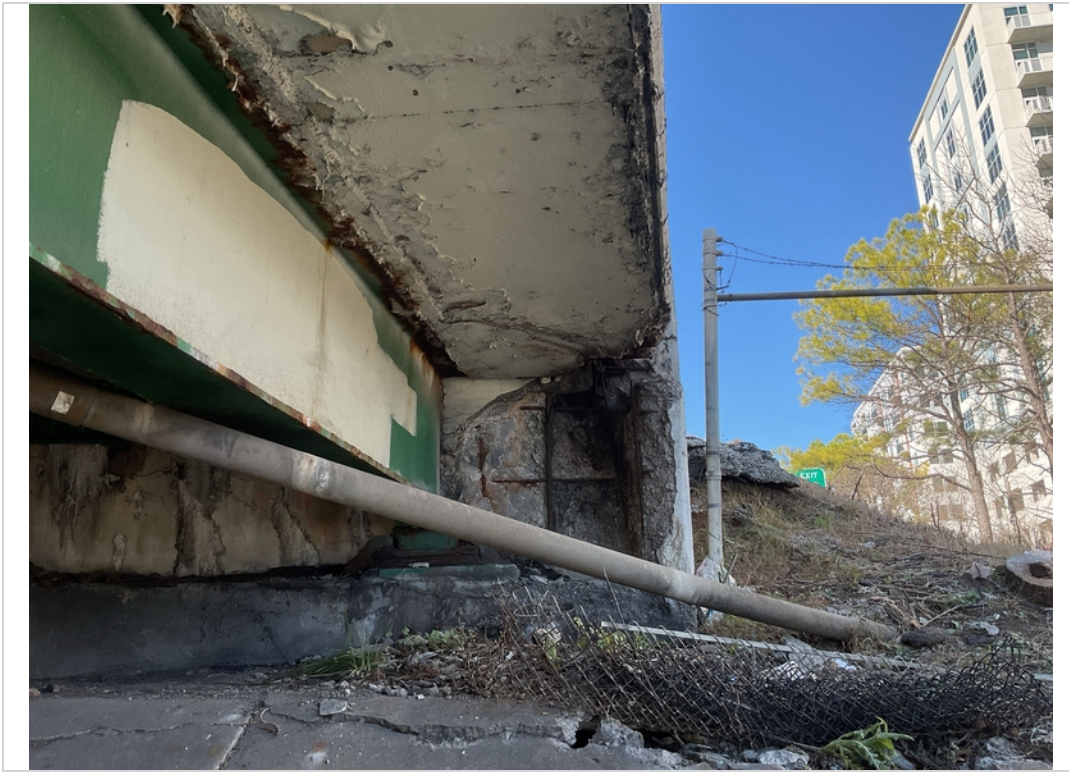
Abut 1 left @left wing hvy scale w/exp steel

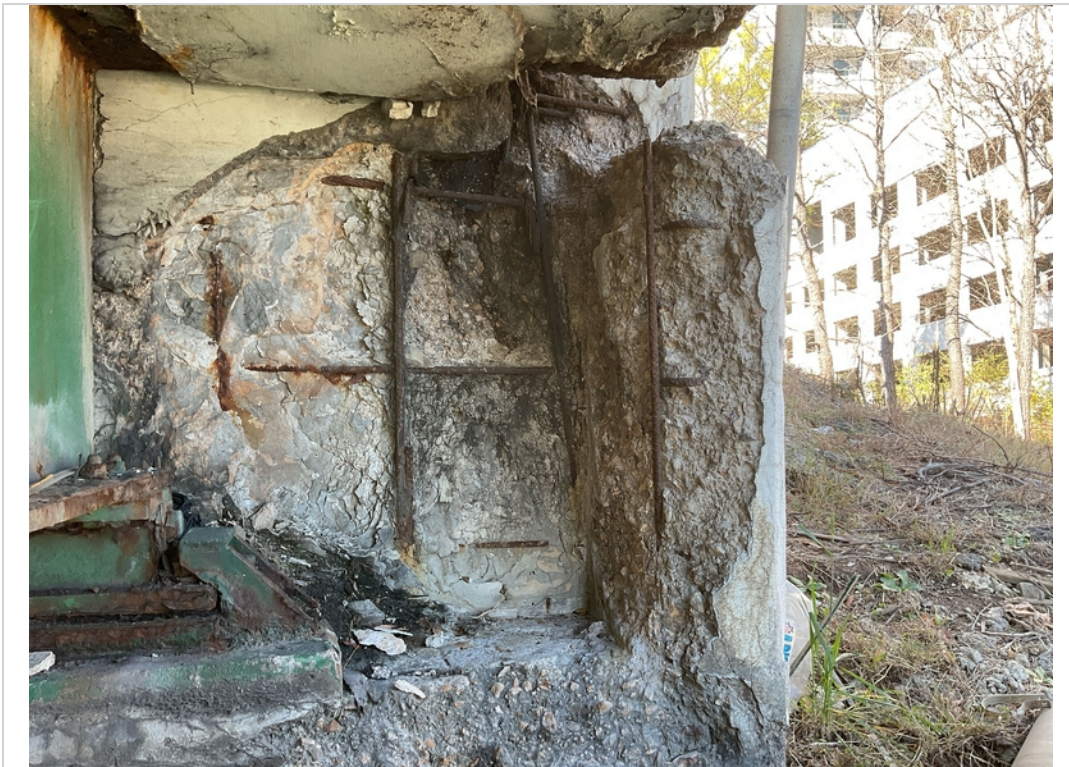
Abut 1 left hvy scale W/exp steel

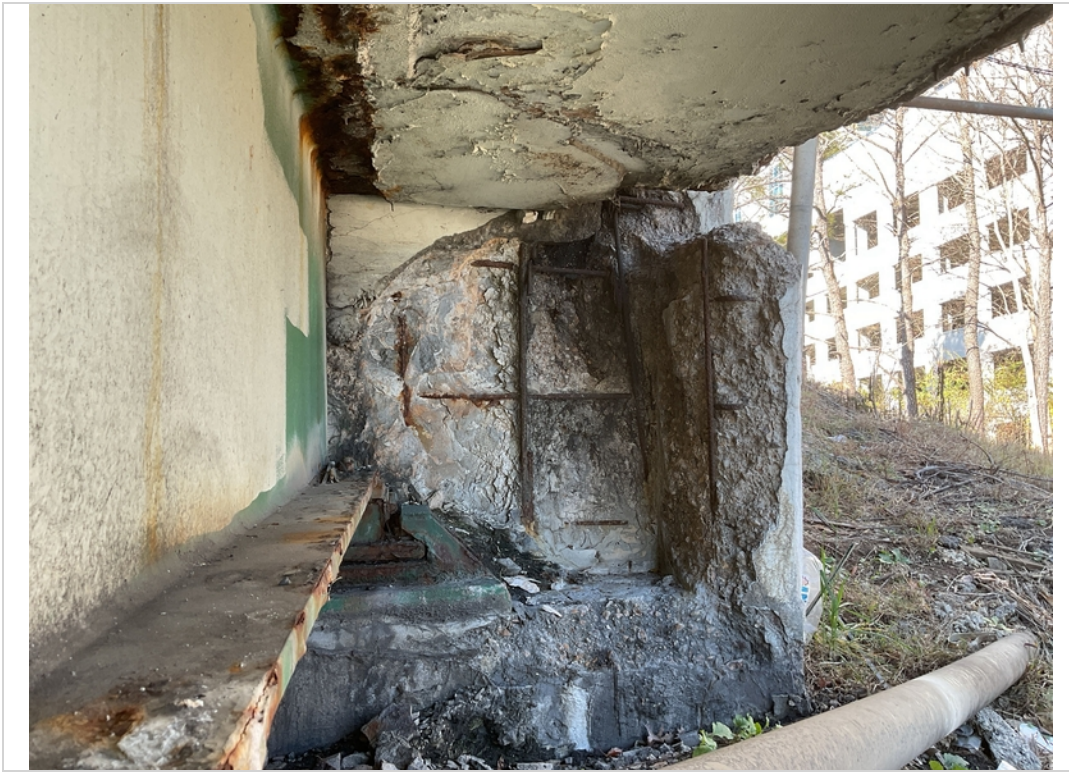
Abut 1 left hvy scale w/exp steel.

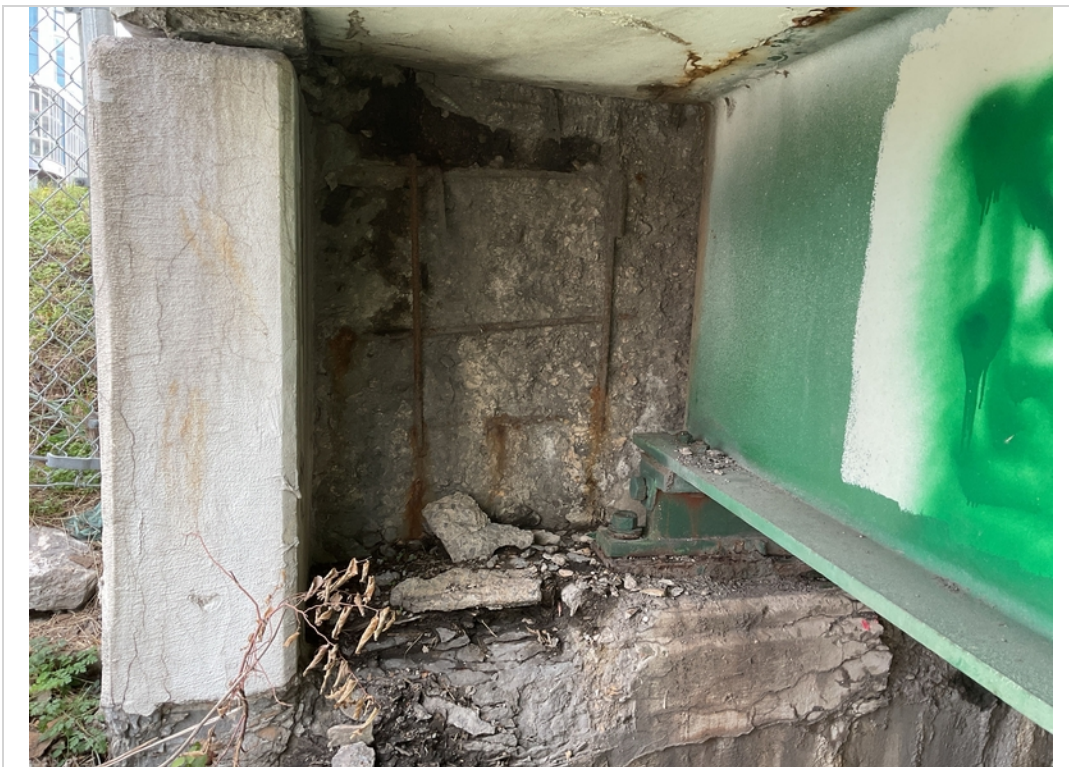
Abut 2 hvy scale w/exp steel.

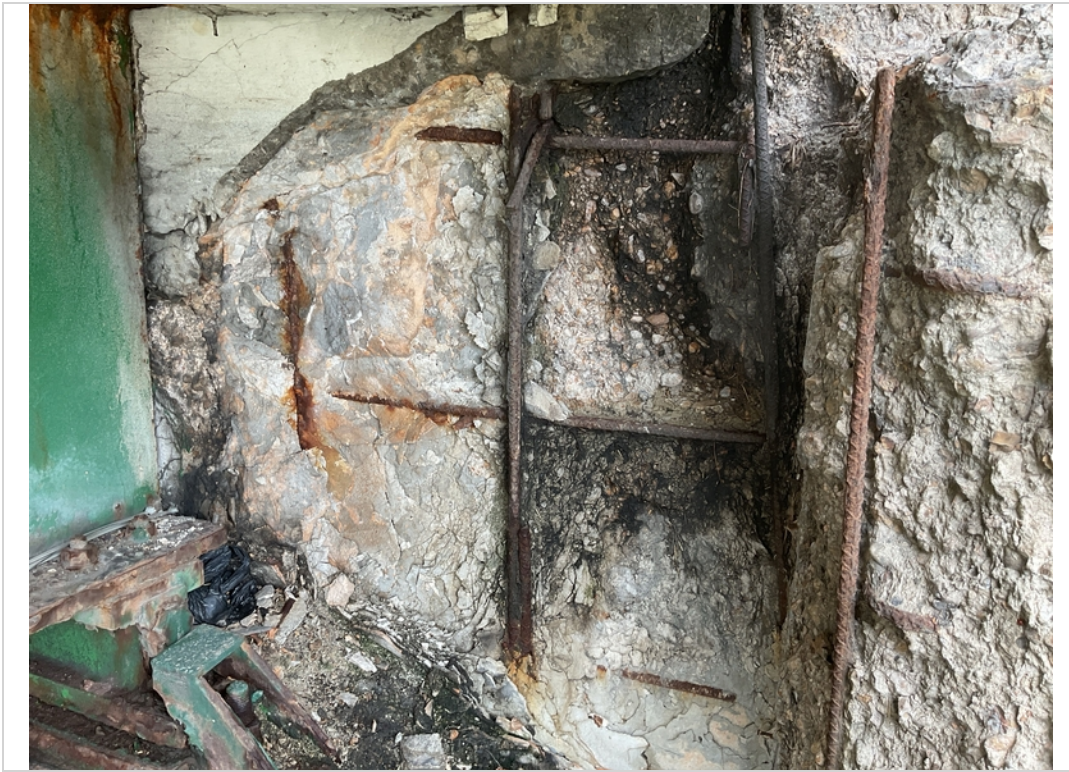
Abut 1 hvy scale exp steel

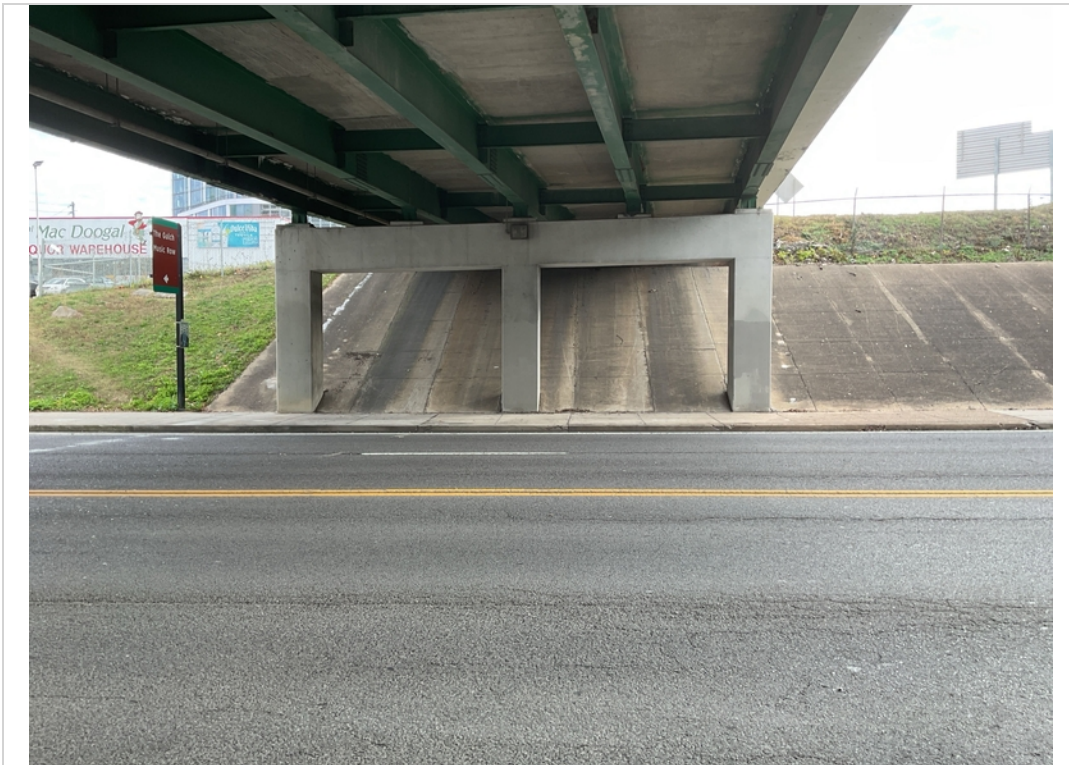
Bent 2.

| Bent Caps | (Good) | H.L. CRACKS @ BENT #2 |
