Latitude:36.14810, Longitude:-86.77920

Region 03, 19 - Davidson County

I40 RMP / 8TH AVE (SR 6)

3 span Bridge / W.P.G.  
I-40 Ramp / 8TH AVE (SR 6)

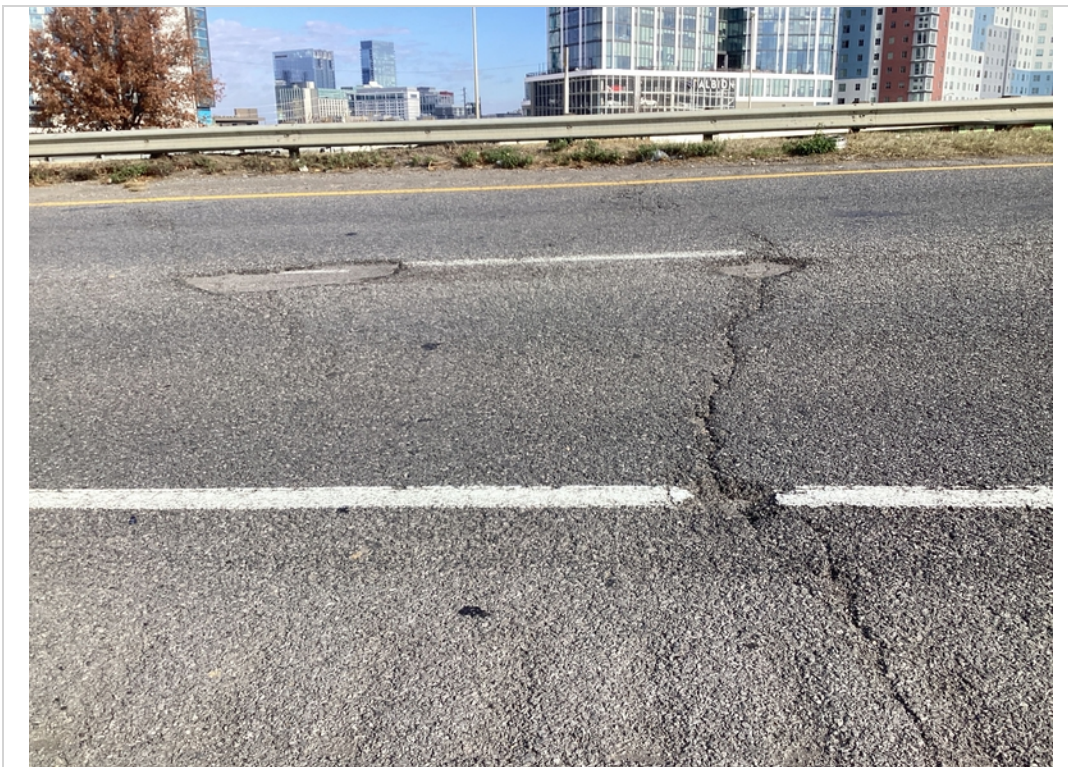
Approach alignment is good. Approach pavement is poor with potholes at 'A' end along paved over joint. The approach embankment is poor at 'B' end right side with heavy erosion with undermining at end of structure. Bridge railing is poor and substandard with heavy scale and spalls with exposed steel. Approach guardrail is good and standard.

B approach pavement potholes

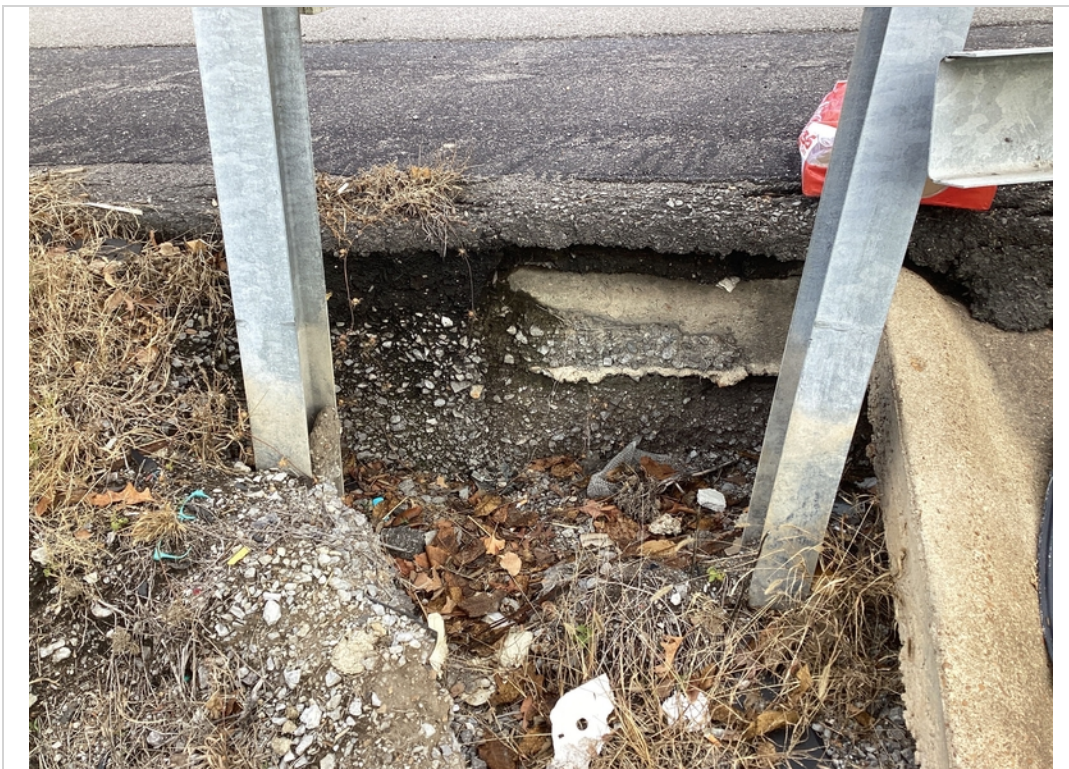
A approach right erosion

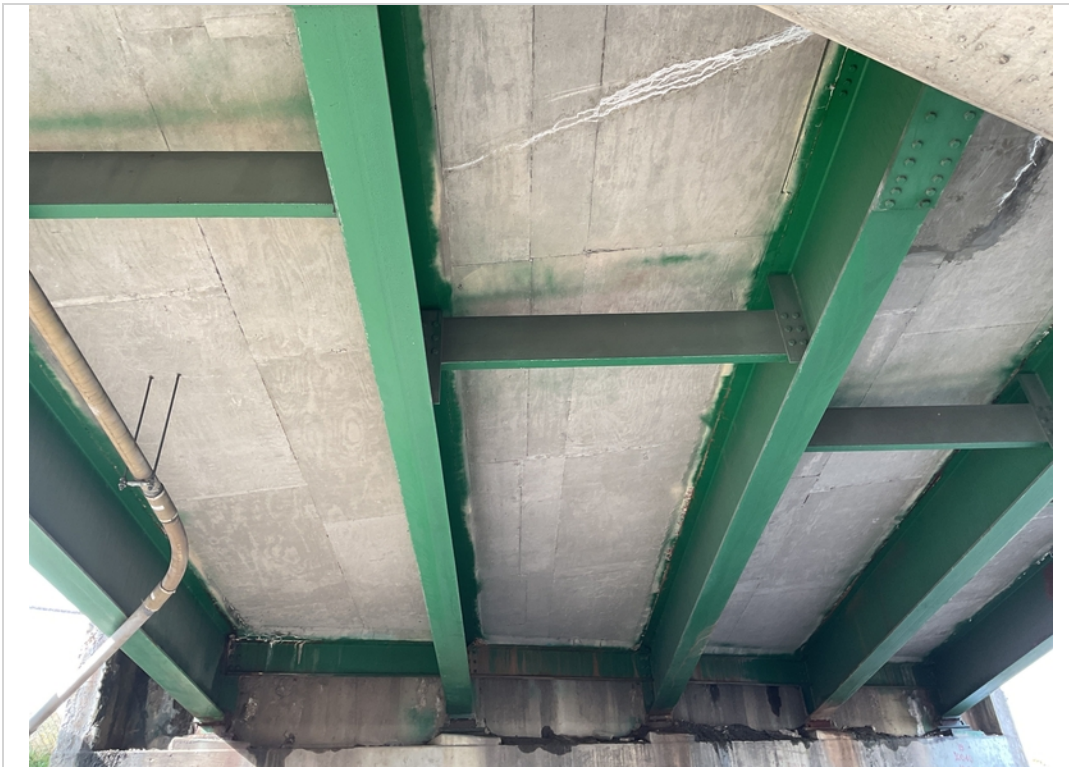
Bottom deck span 1

The asphalt wearing surface is good. Joint leakage is good. Expansion devices are non-existent being paved over. Bottom deck is fair with light spalls with exposed steel and hairline map cracks with efflorescence in span #1. Partial and full depth repairs were made on the deck in all spans with some repairs failing.

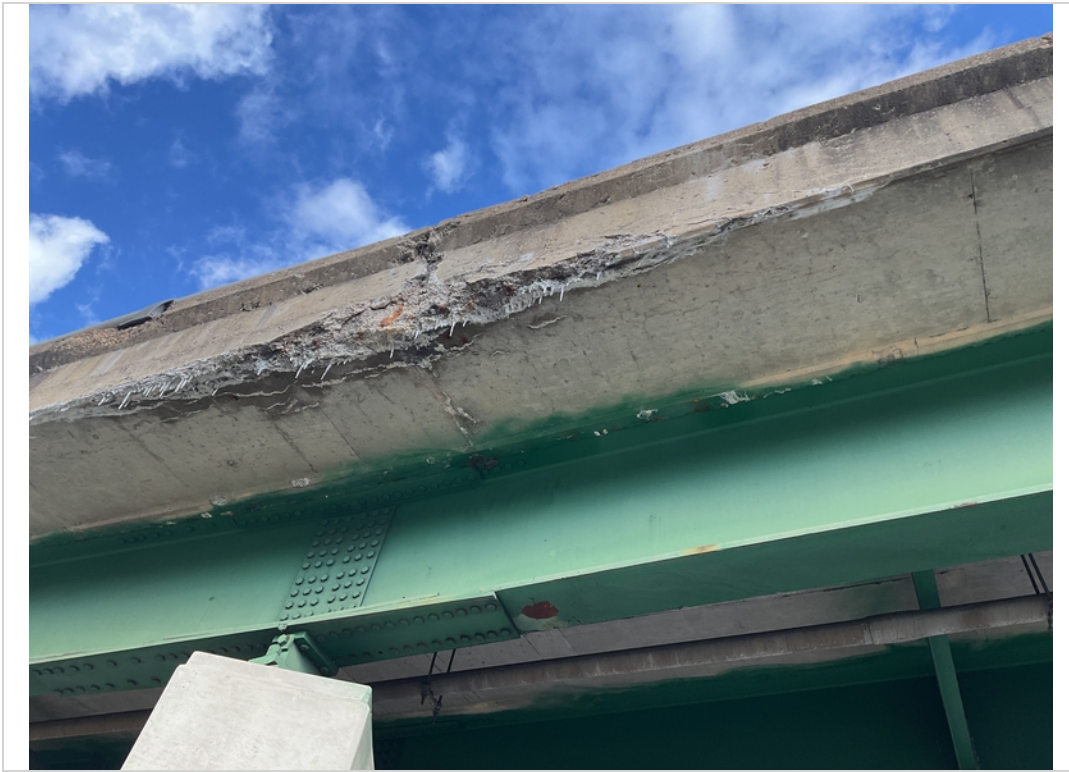
Overhang span 2 right side scale with eff

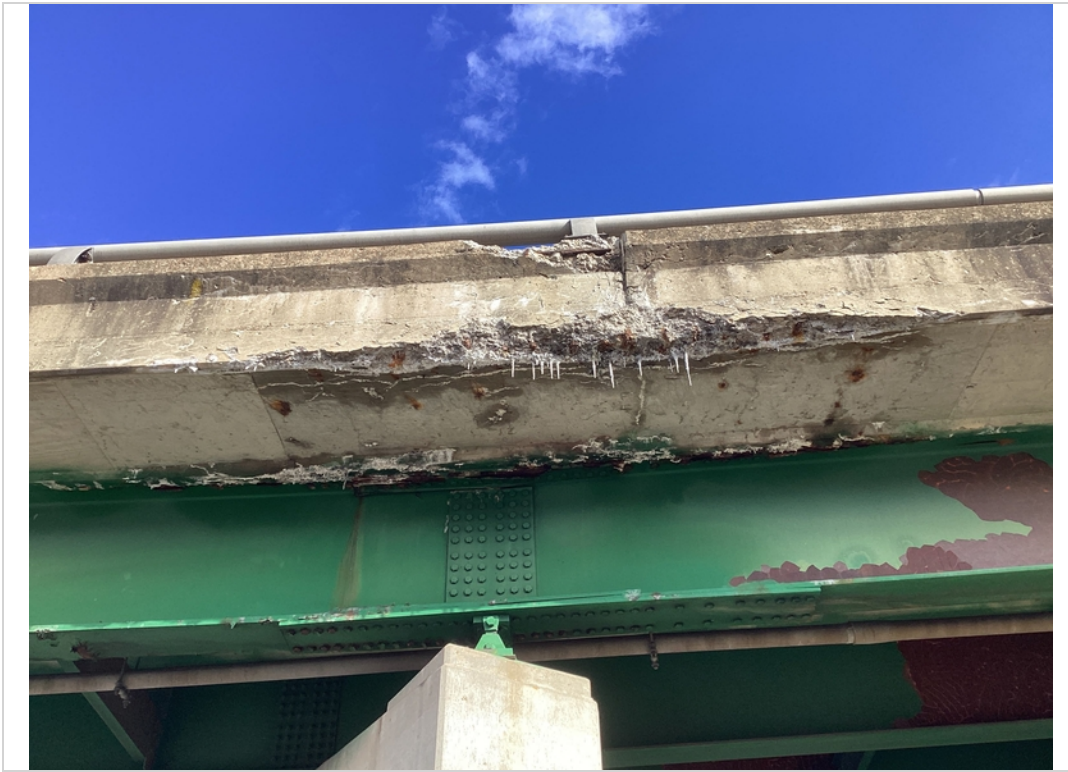
Bridge Railing Rating (Poor) HVY SCALE & SPALLS W/EXP STL

Parapet right span 3 heavy scale with exposed steel

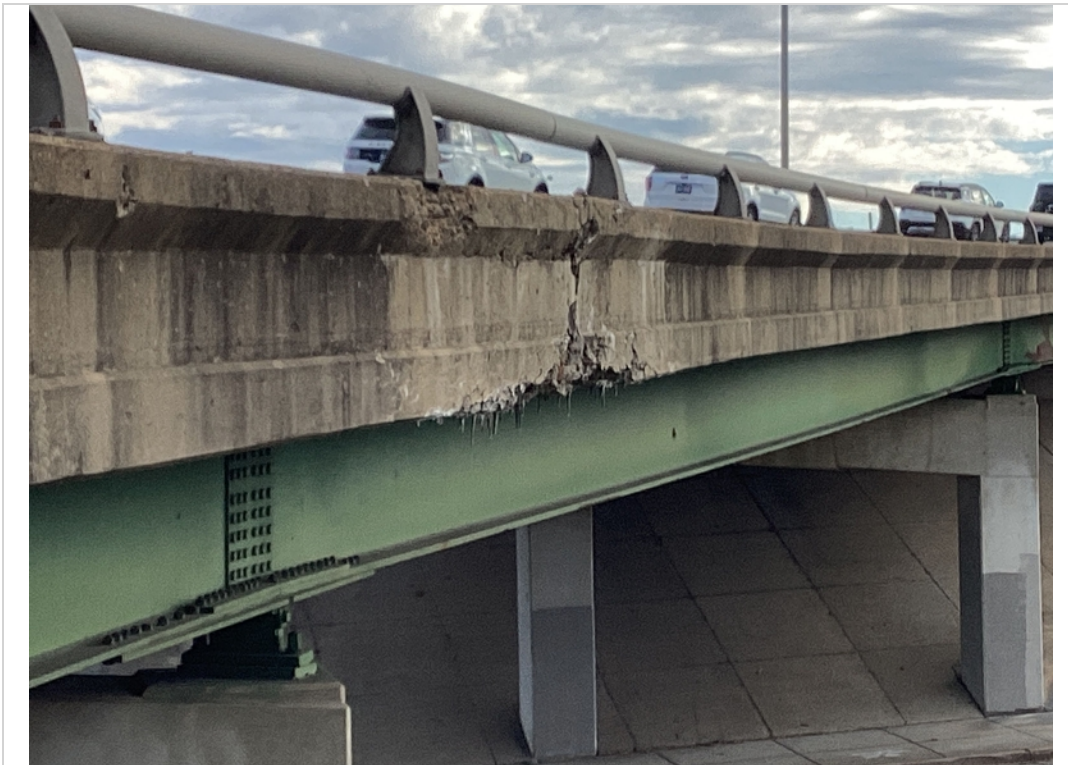
Span 2 parapet scale

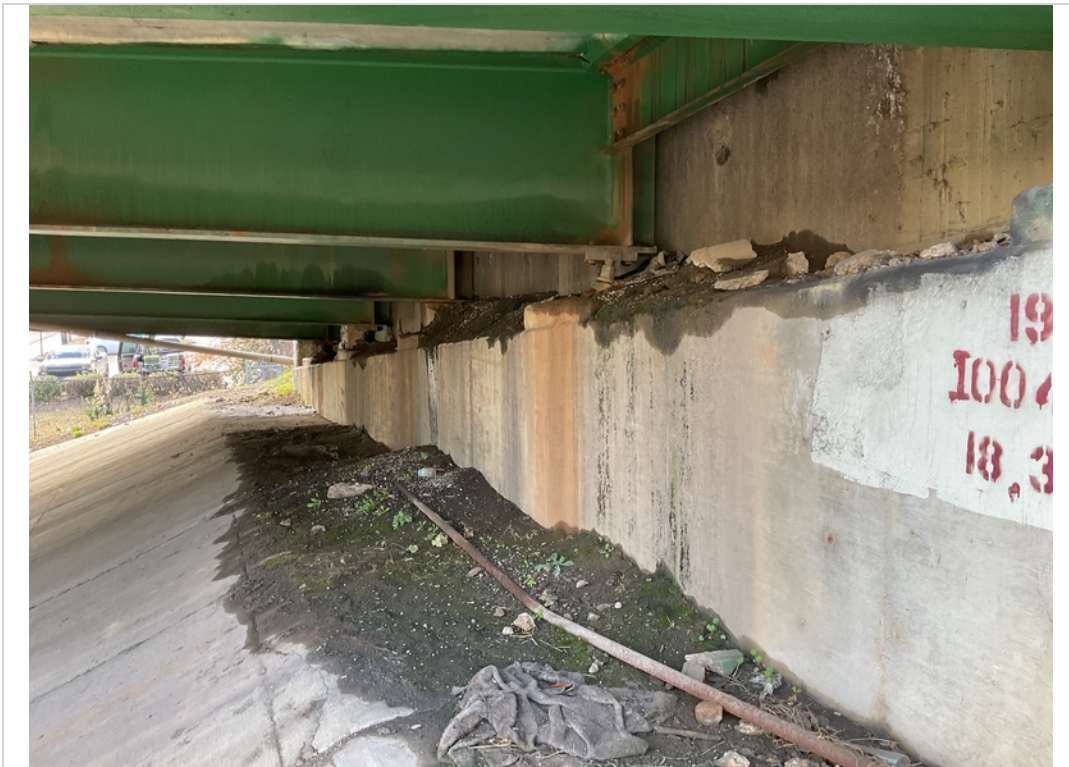
Abut 1

Abutment caps are good, although heavy debris accumulation was noted on top of caps. The backwall at abutment #1 is poor due to heavy spalling. Wings are fair with map cracking at abutment #1. Bents are good.

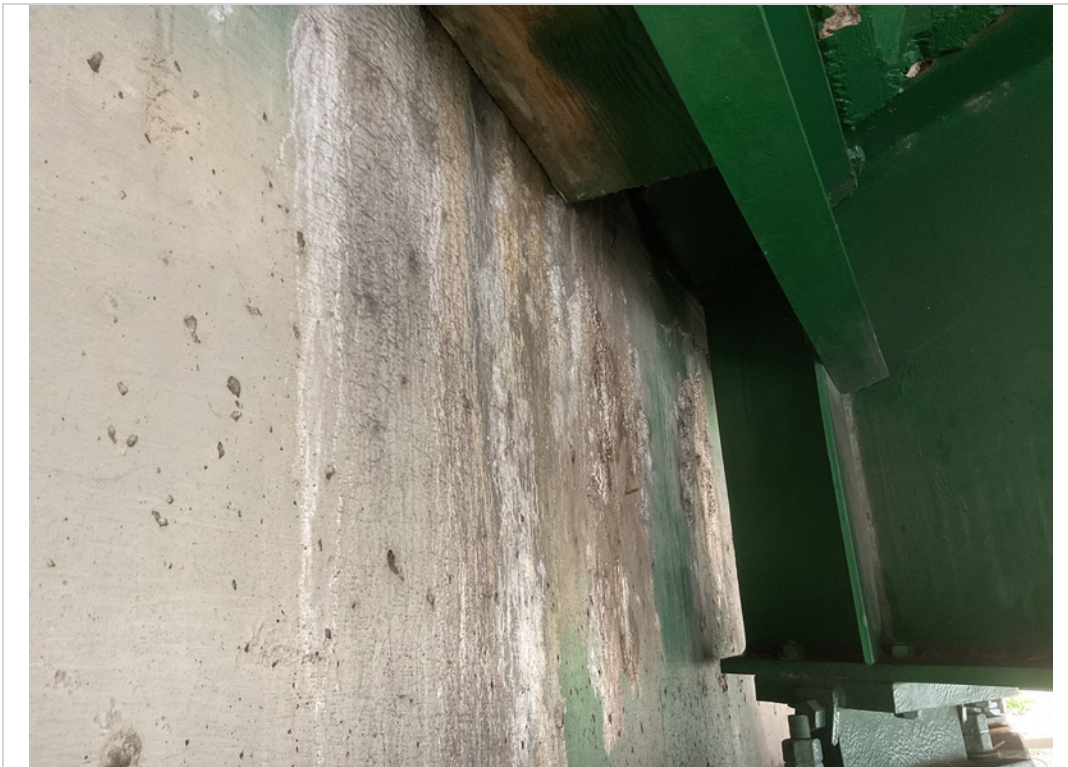
Abut 2 hvy eff

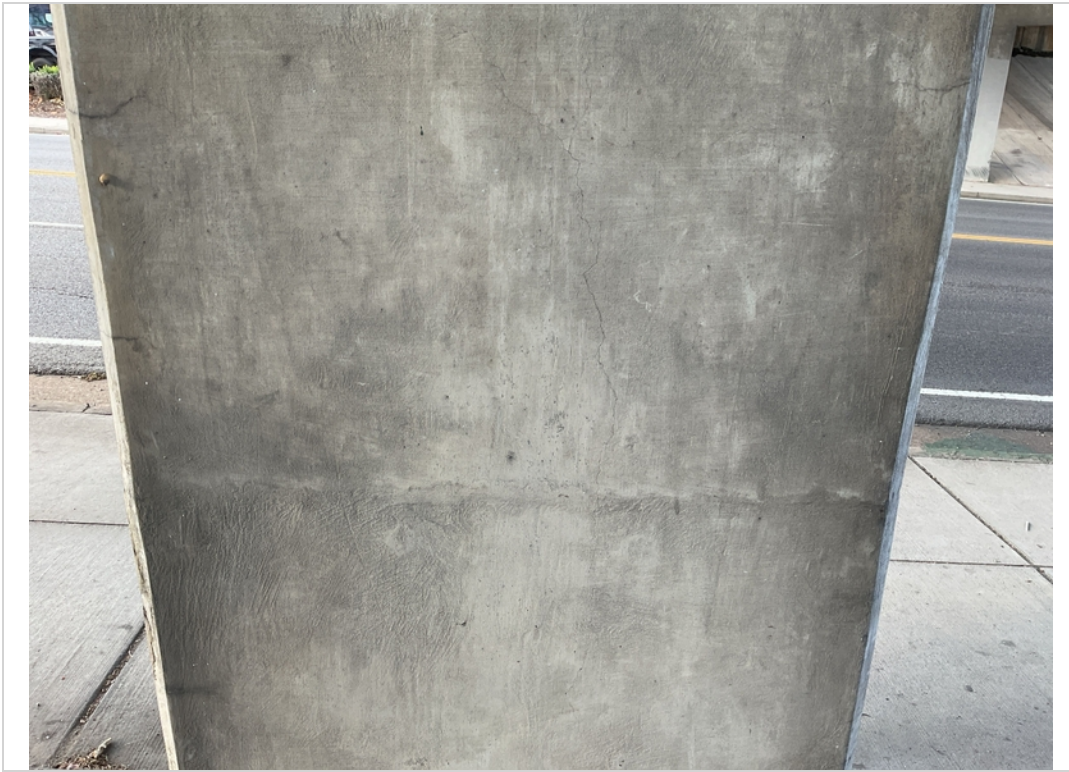
Pier 2 all columns Vert. H.c.
