SHELBY COUNTY

BRIDGE MAINTENANCE RECOMMENDATIONS

LOCATION: 79-SR057-08.18-R

BRIDGE INSPECTION REPORT

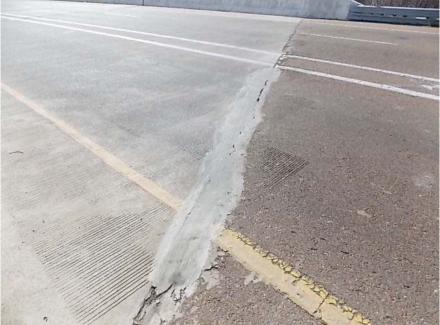
SPAN 1 CONCRETE TOP DECK PATCHED

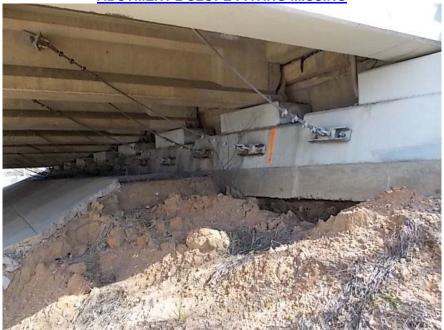
ABUTMENT 2 SECTION OF SLOPEPAVMENT MISSING DUE TO CONSTRUCTION, ABUTMENT 1 PLATE AND BOLT MISSING. ABUTMENT 1 EQ NOT CONNECTED.

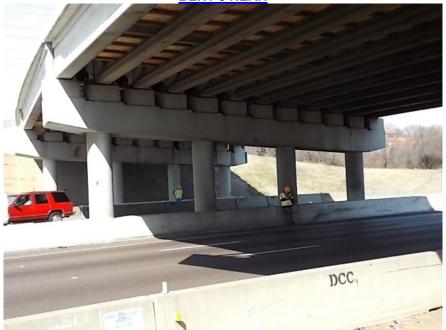
BENT 2 REAR

BENT 2 CAP HAS SECTION BEGINNING TO SPALL THAT COULD FALL INTO ROADWAY.

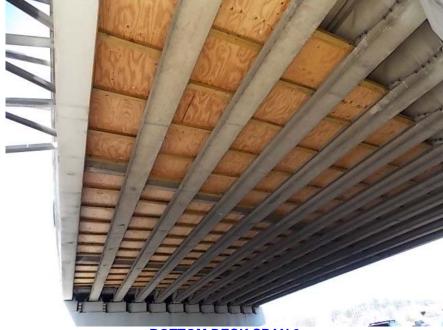
BOTTOM DECK SPAN 3

NOTE: BRIDGE IS RATED POOR DUE TO UNKNOWN CONDITION OF SPAN 2&3 BOTTOM DECK UNDER PLYWOOD FORMS.

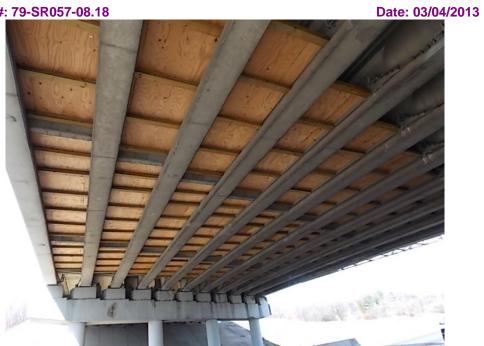
BOTTOM DECK SPAN 2

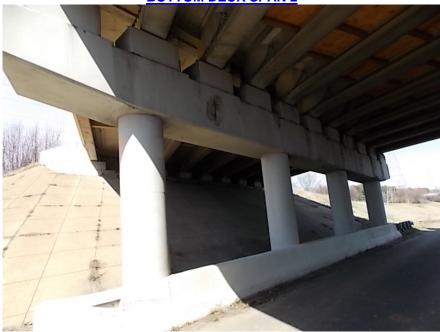
BENT 1 RISER CLOCK SPALLING UNDER CONCRETE I BEAM A&B, THE VERTICAL CLEARANCE IS UNDER CONSTRUCTION.

SUGGESTED ROUTINE MAINTENANCE AND COMMENTS				
REPAIR CONCRETE BEAM "G" SPAN NO.1				
REPAIR DIAPHRAGMS IN SPAN NO.2				
REPLACE CONCRETE RISER BLOCKS AT BENT NO.1				
CLEAN AND SEAL ROADWAY EXPANSION JOINTS.

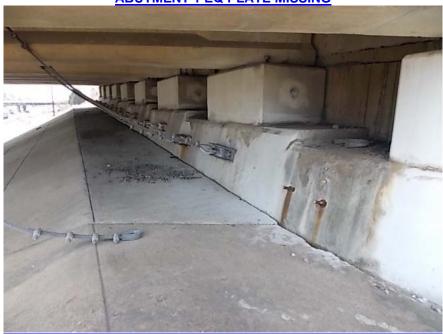
ABUTMENT 1

03-04-2013 UNDERPASS IS UNDER CONSTRUCTION. ABUTMENT # 1 EARTHQUAKE DEVICES NOT CONNECTED.
