## Polk County

### Regular Inspection Report

Location: 70-SR040-03.12

14 Span Bridge

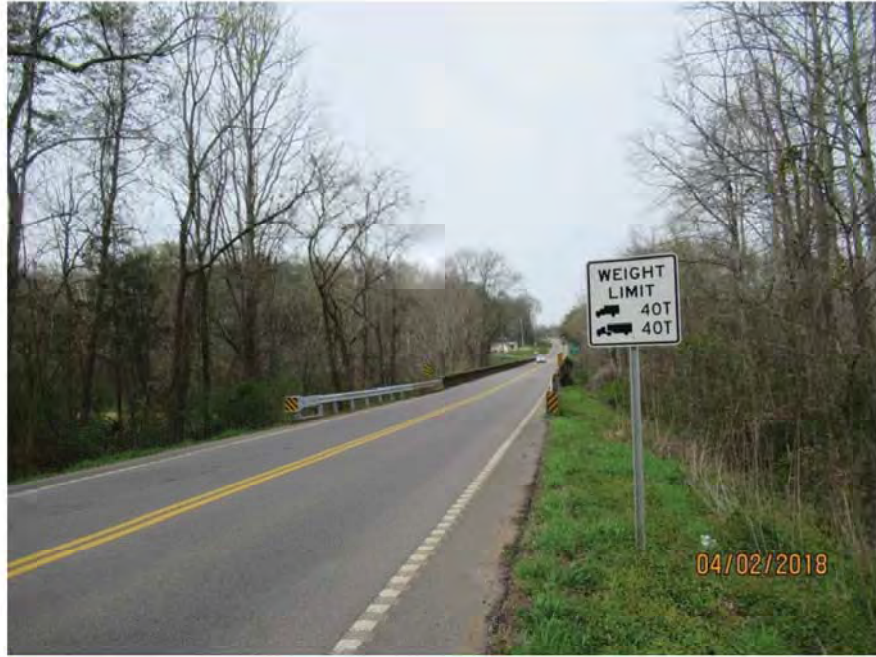
LOOKING BACK ON STRUCTURE - WEIGHT POSTING – TO BRADLEY COUNTY
