I-40 Crossing I-40 E.B. / WOLF RIVER

90 - LAST INSPECTION DATE 10/02/2024

IDENTIFICATION	
(1) State Names	47 - Tennessee
(8) Structure Number	79I00400059
(5) Inventory Route	1
(2) Highway Agency District	Region 4
(3) County Code	79 - Shelby

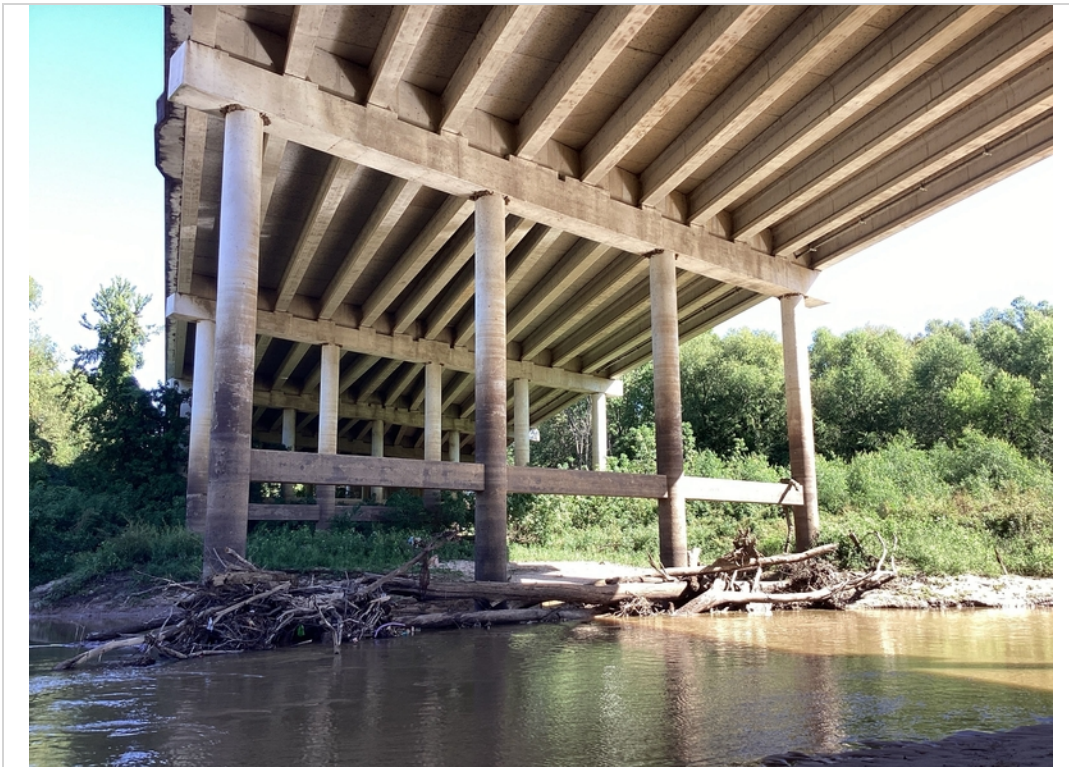
Pier #4 looking forward

Date Added	Recommendation	Priority
10/02/2024	LEVEL THE WEARING SURFACE AT APPROACH NO.2	
10/02/2024	CLEAR APPROACH DRAINS.	
10/02/2024	CLEAR DRAINS	
10/02/2024	REPAIR ROADWAY EXPANSION DEVICE IN SPAN NO.1, 11A & 11B	
10/02/2024	REMOVE DEBRIS FROM BENT NO.3 & 4	
09/09/2022	CUT AND REMOVE VEGETATION FROM CHANNEL

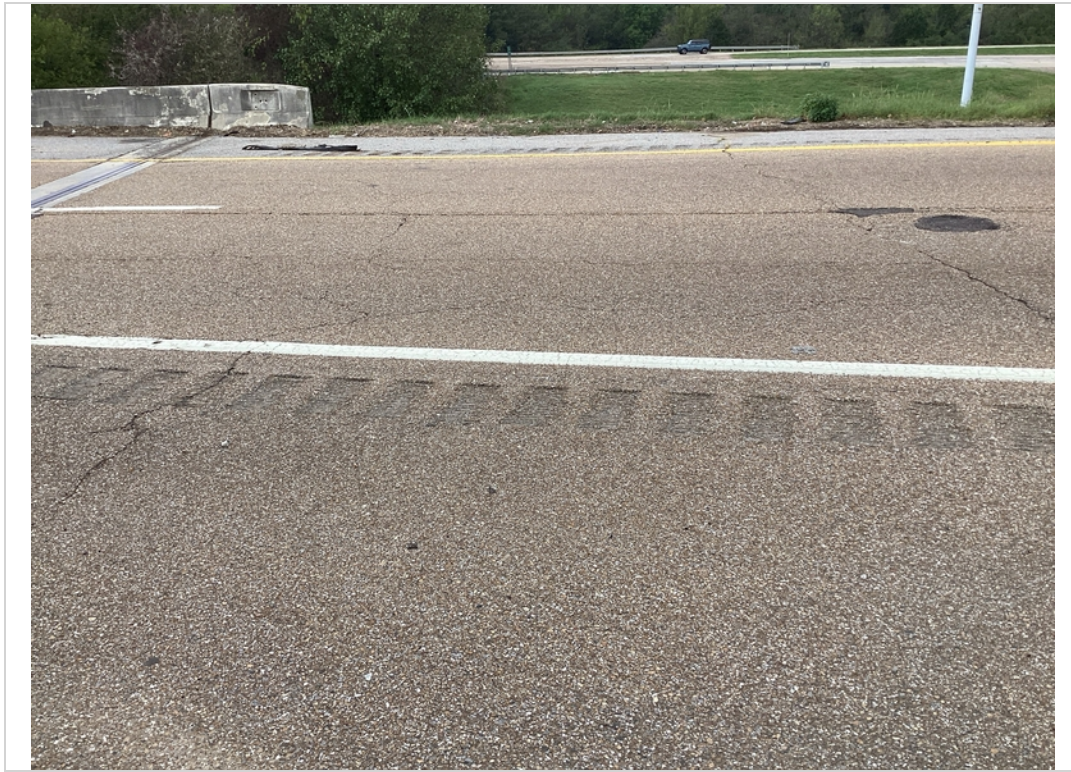
Approach 2 asphalt left side

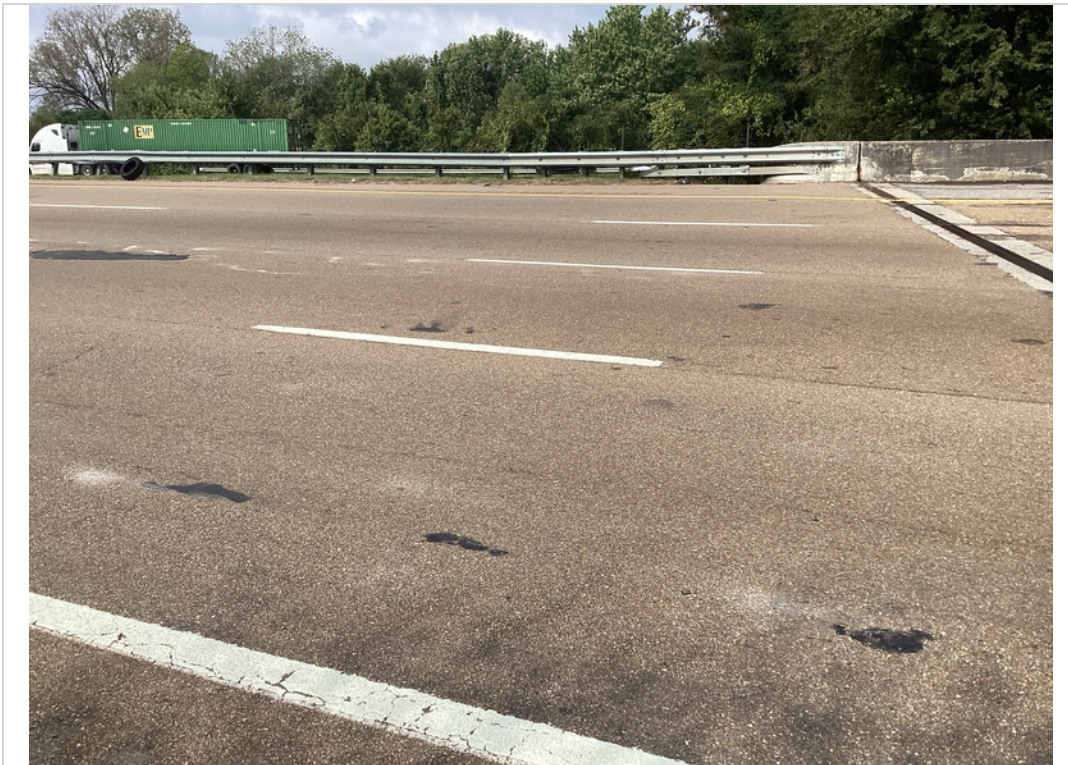
1/8" cracks and patching

Approach 1 asphalt

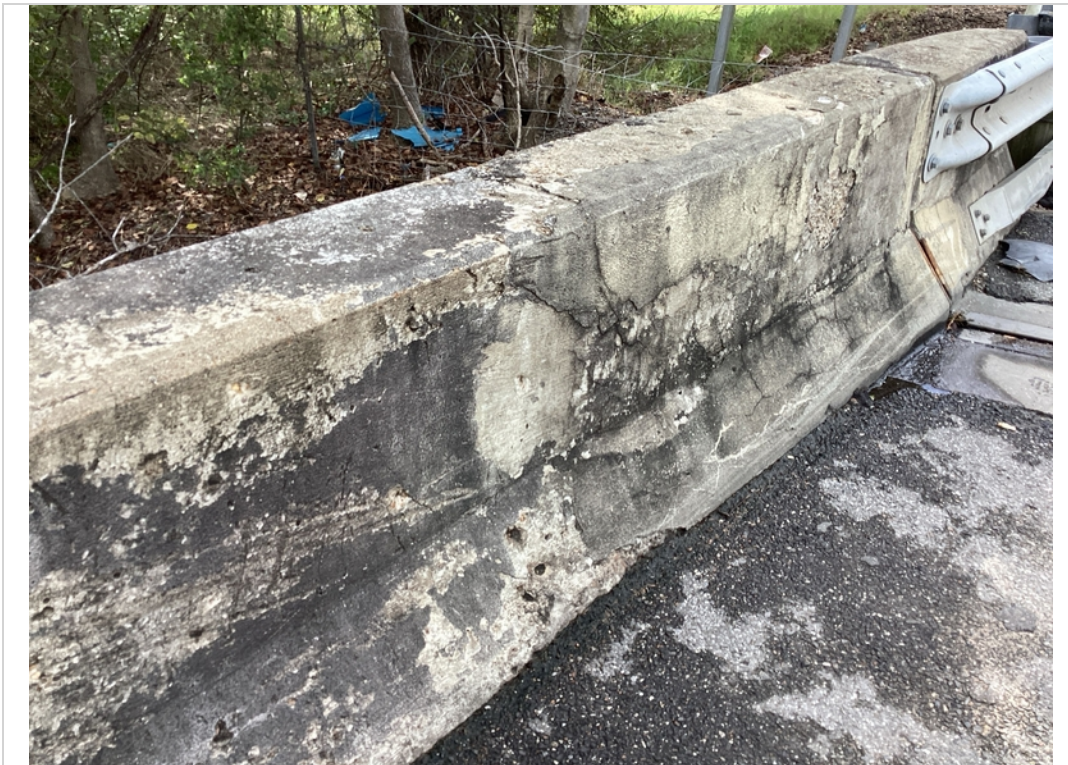
Span 1 parapet , typical

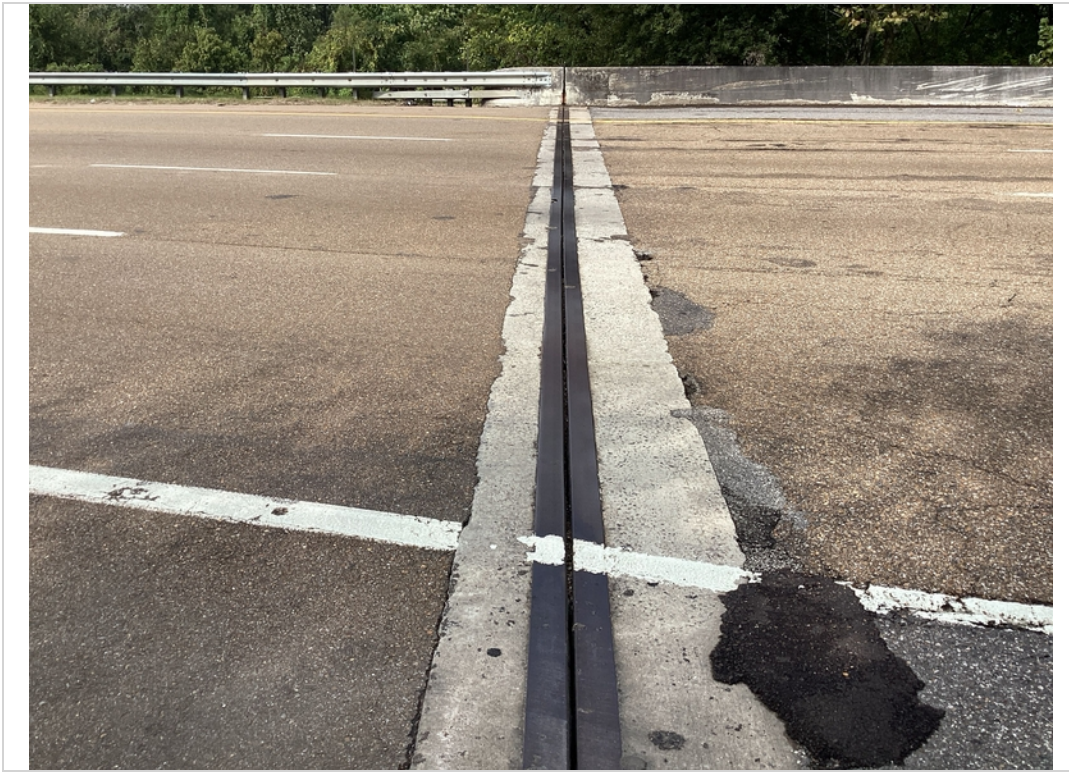
Span 1 joint

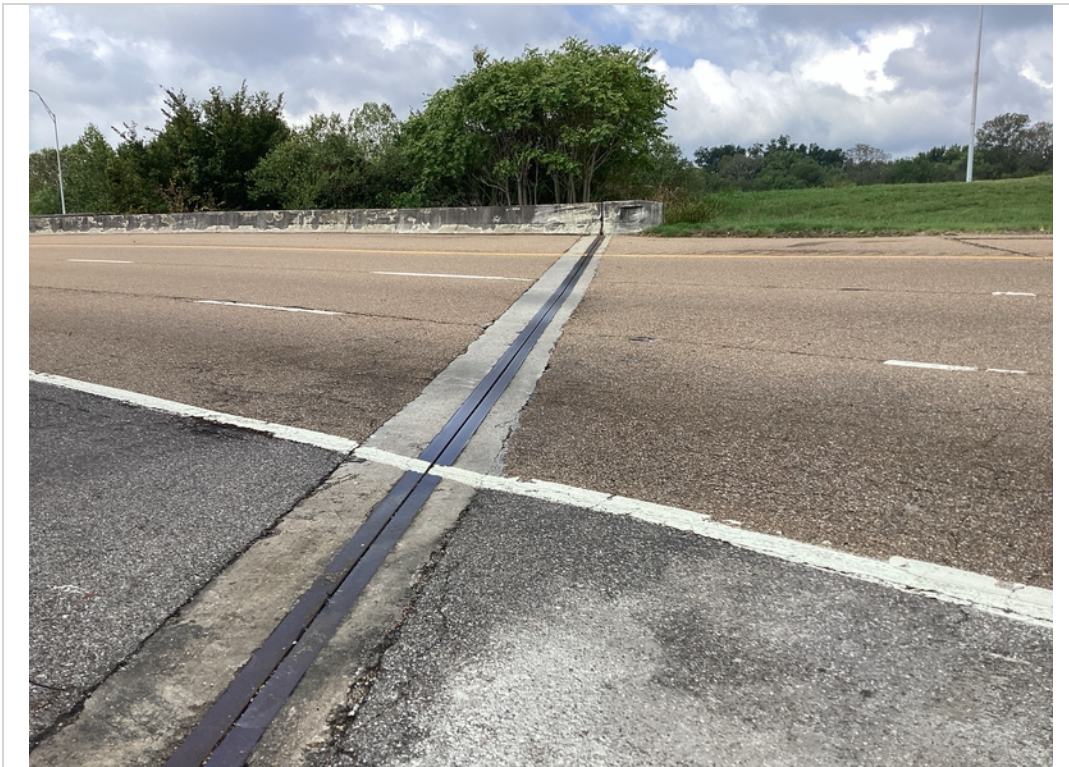
Approach 2 joint span 11B

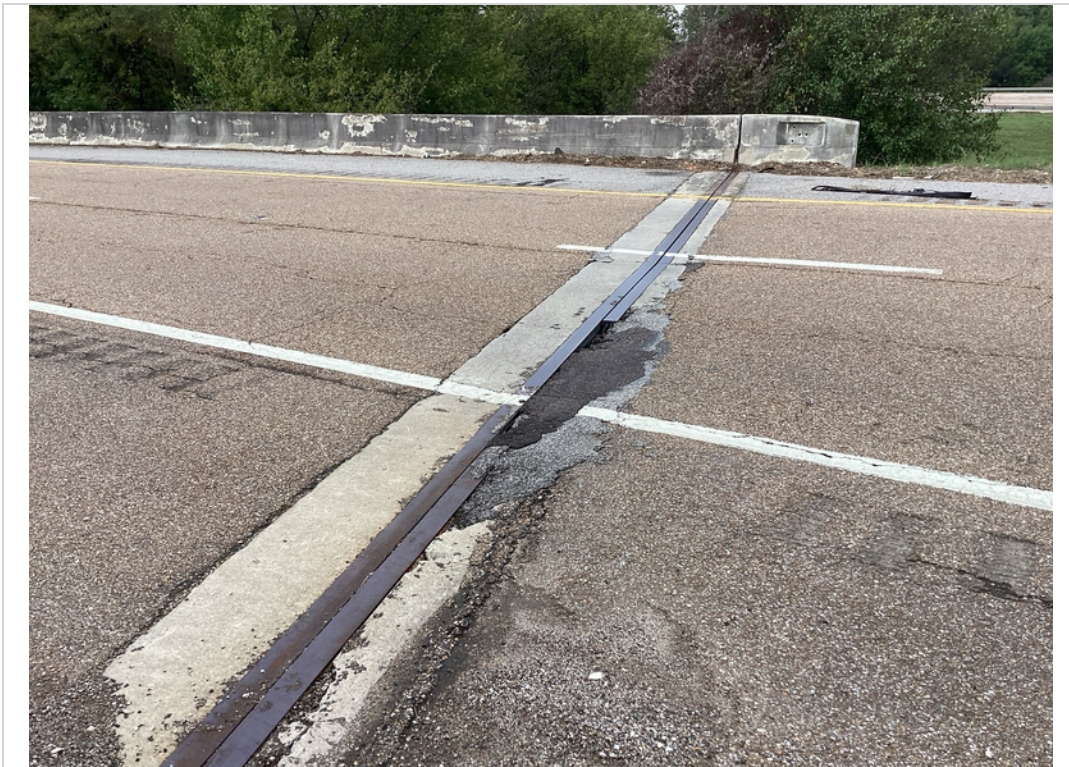
Approach joint on 11A

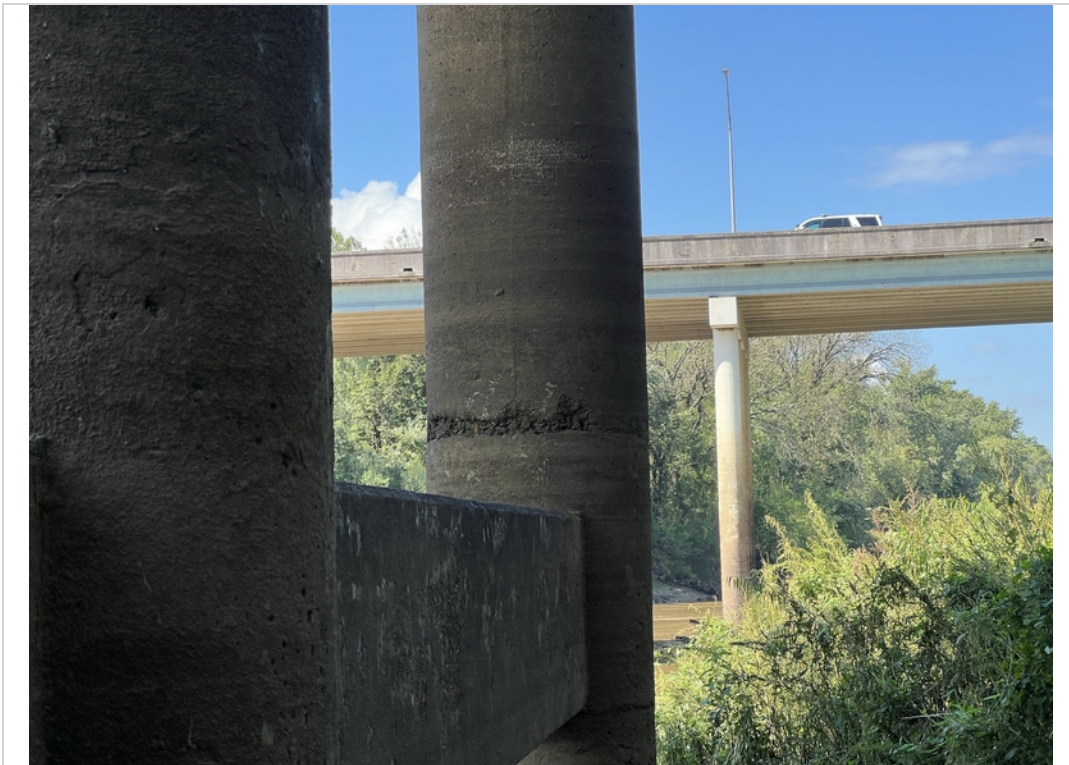
Bent Caps	(Good)	Damage
Bent Columns	(Fair)	Abrasion
Bent Plumb	(Good)	
Bent Footing	(Not Visible)	
Bent Bearing Surface	(Good)

Bent 5 pile "A" abrasion

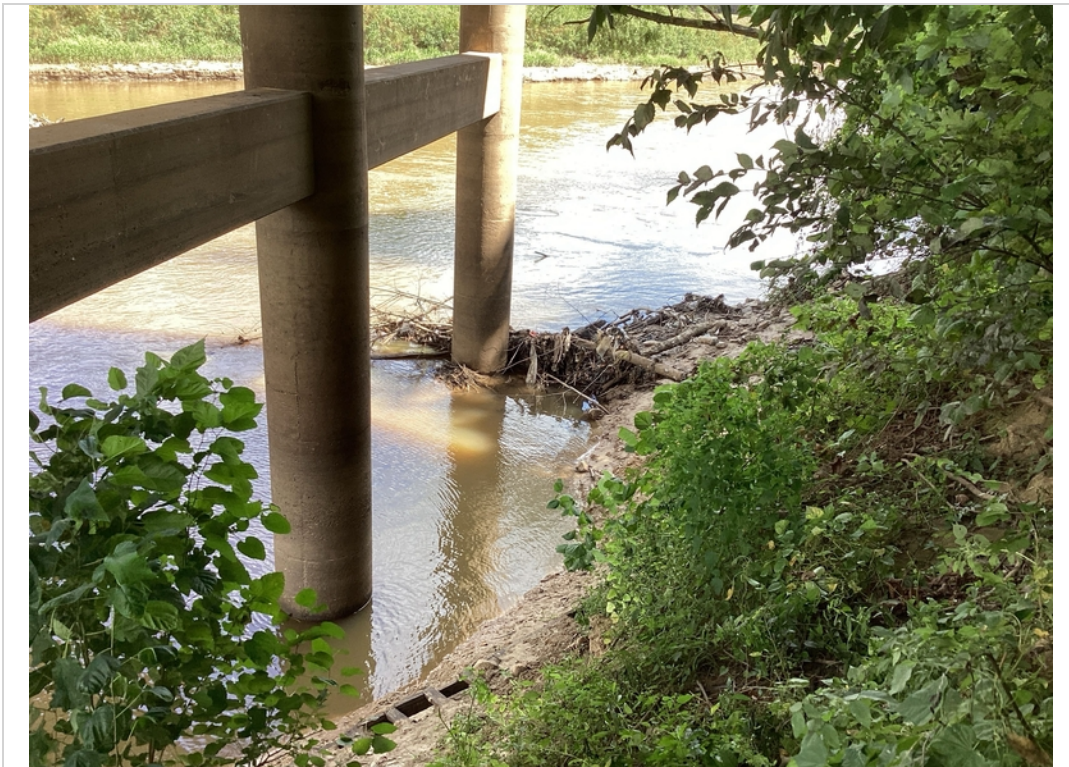
Bent 2 front side embankment washing
