I-24 Crossing I24 / NORTH FIRST ST

90 - LAST INSPECTION DATE 09/21/2021

IDENTIFICATION	
(1) State Names	47 - Tennessee
(8) Structure Number	19I00240107
(5) Inventory Route	1
(2) Highway Agency District	Region 3
(3) County Code	19 - Davidson

4 span Bridge / Cont. S.I.B
I-24 / North First Street

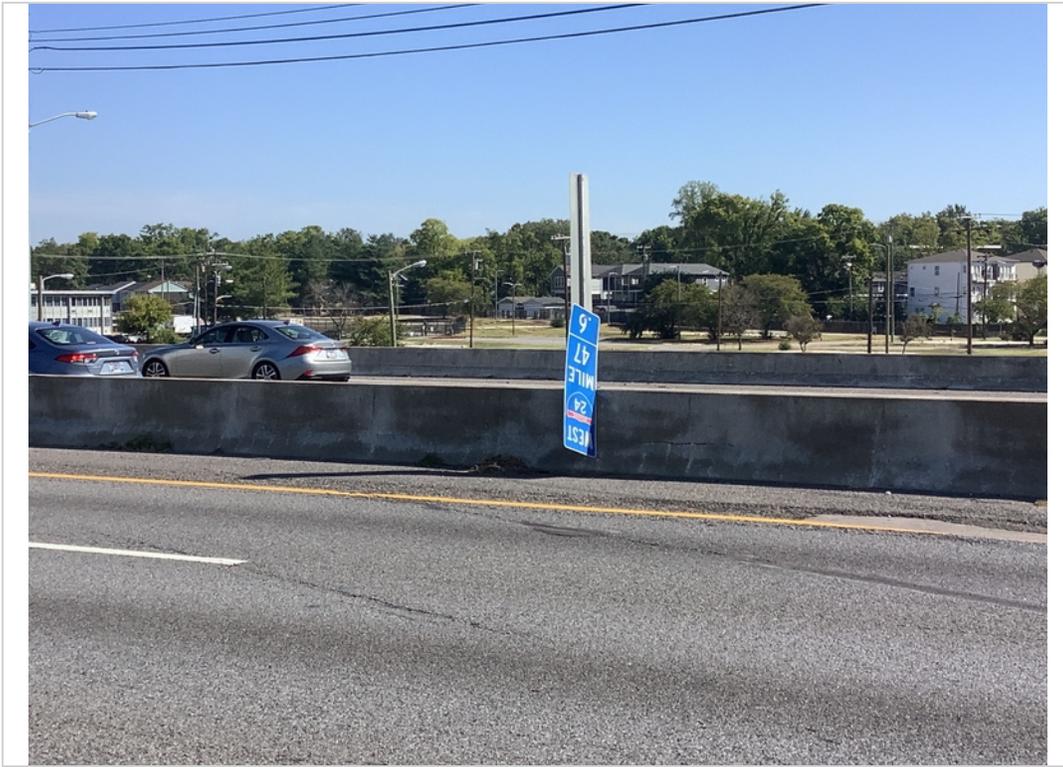
Fallen MM sign westbound span #1

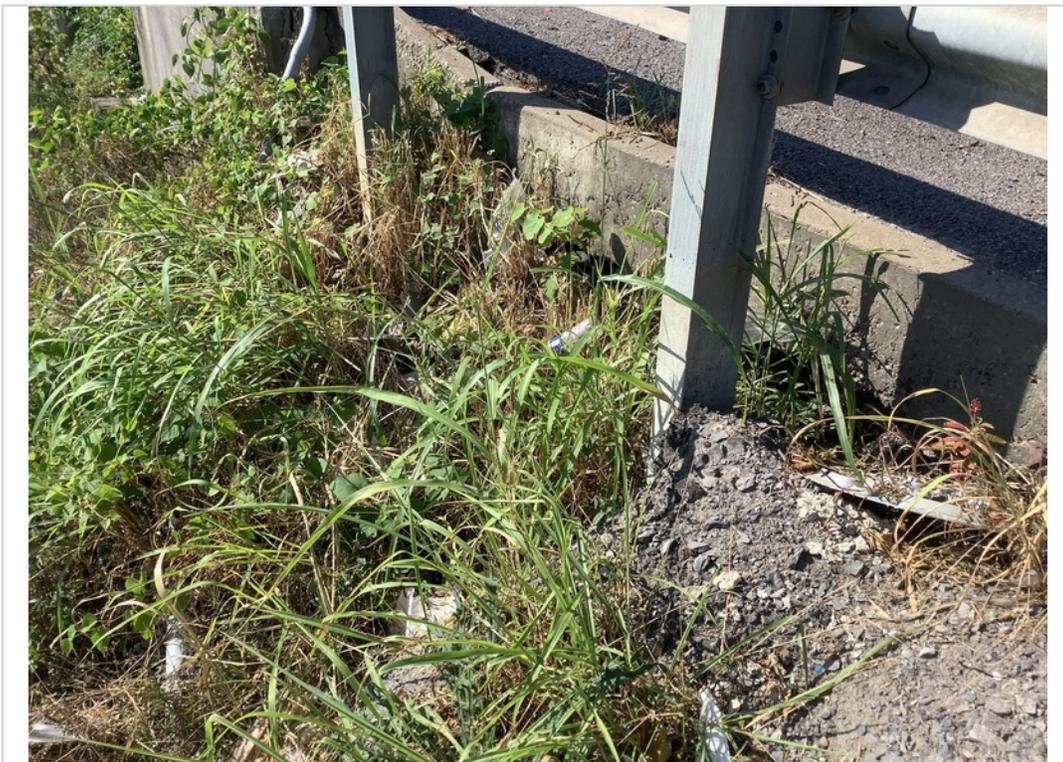
Moderate erosion, A approach, left westbound

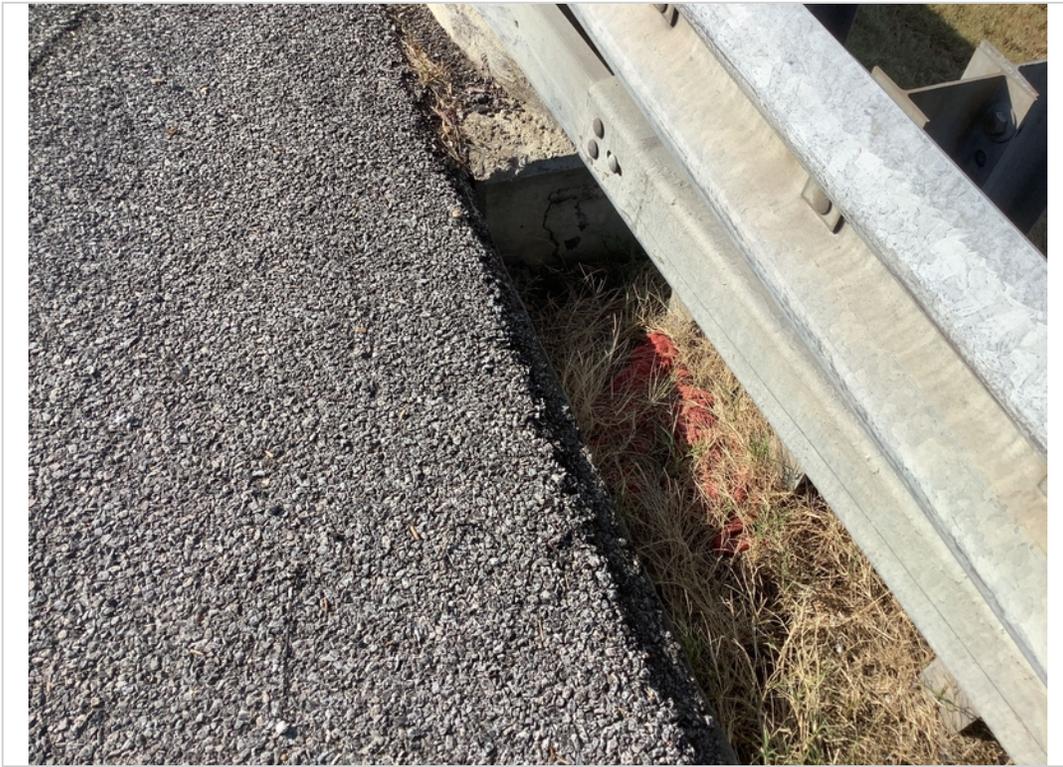
A approach right, light erosion

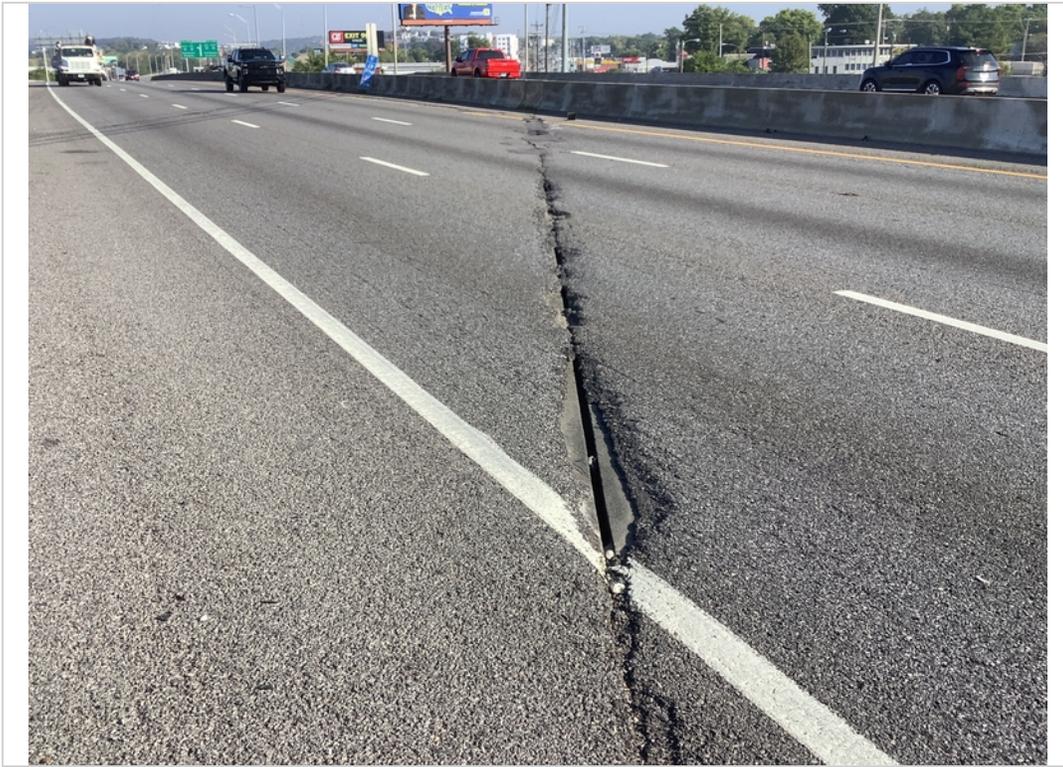
The asphalt wearing surface is fair with potholes, patches at paved over joints, some now only partially paved over. Drains are good. Joint leakage shows moderate to heavy stains on the abutments and bent caps. Bottom deck is fair with random spalls, delamination, and heavy hairline map cracks with efflorescence in all spans. Expansion joints that aren't paved over are poor due to missing filler.

Span #1, expansion joint, paved over, patches

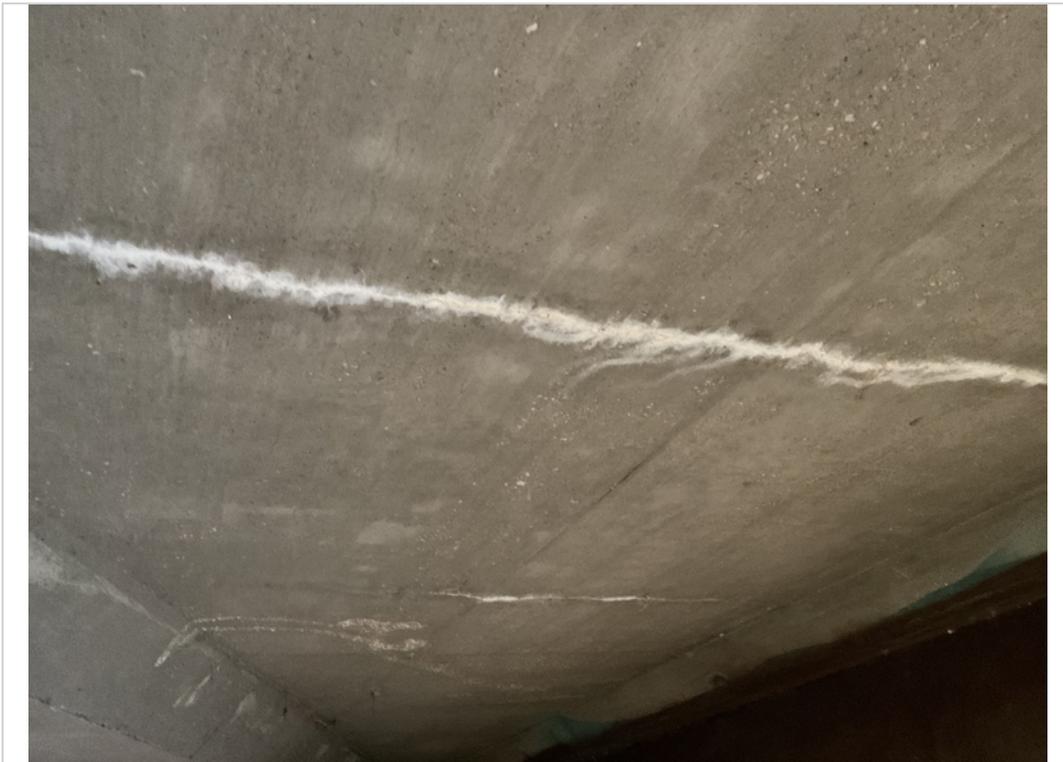
Span 4 bay J trans cracks with eff

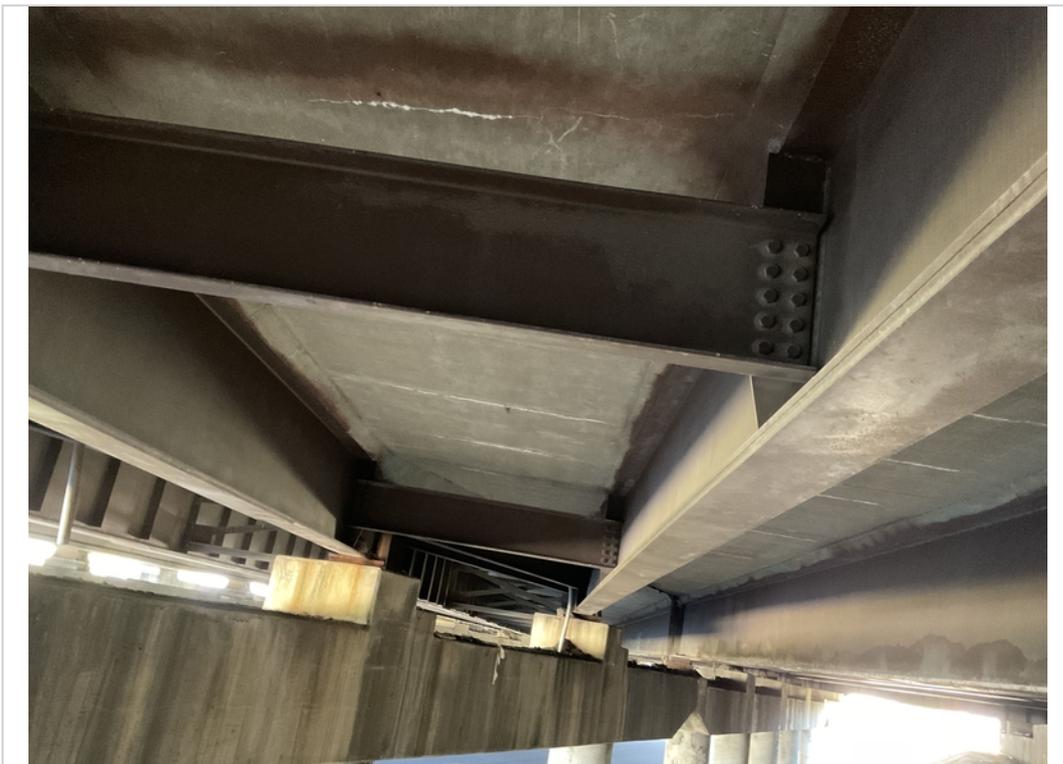
Span 4 bay H trans cracks with eff

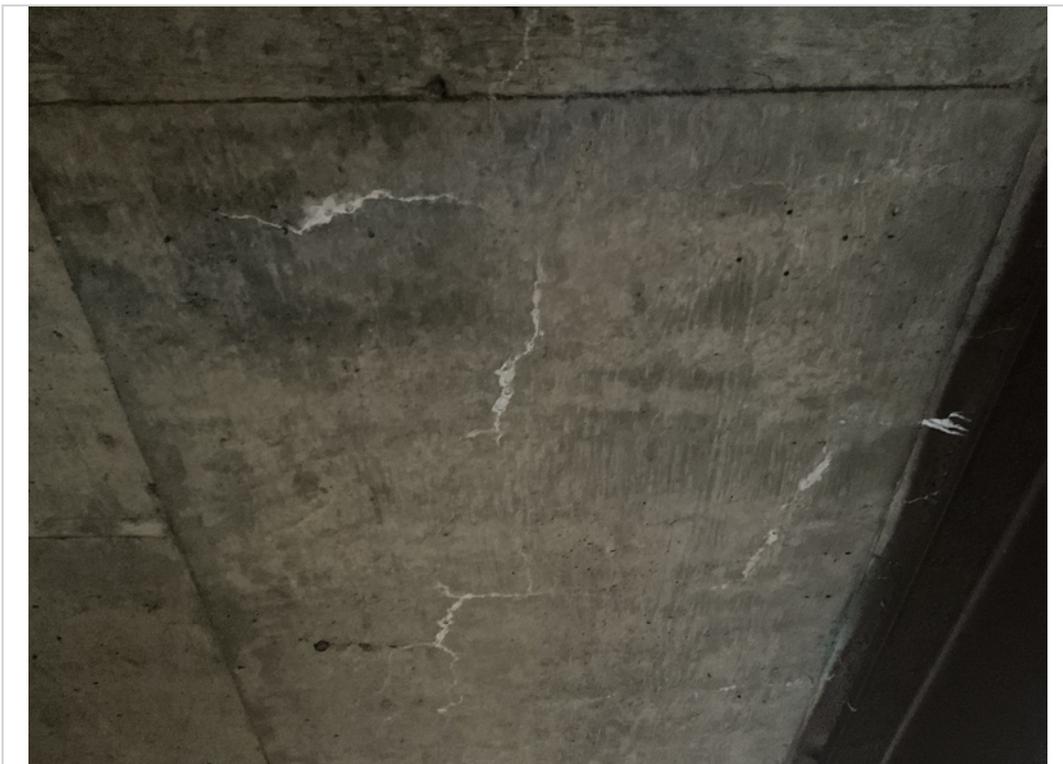
Span 4 bay F map cracks with eff

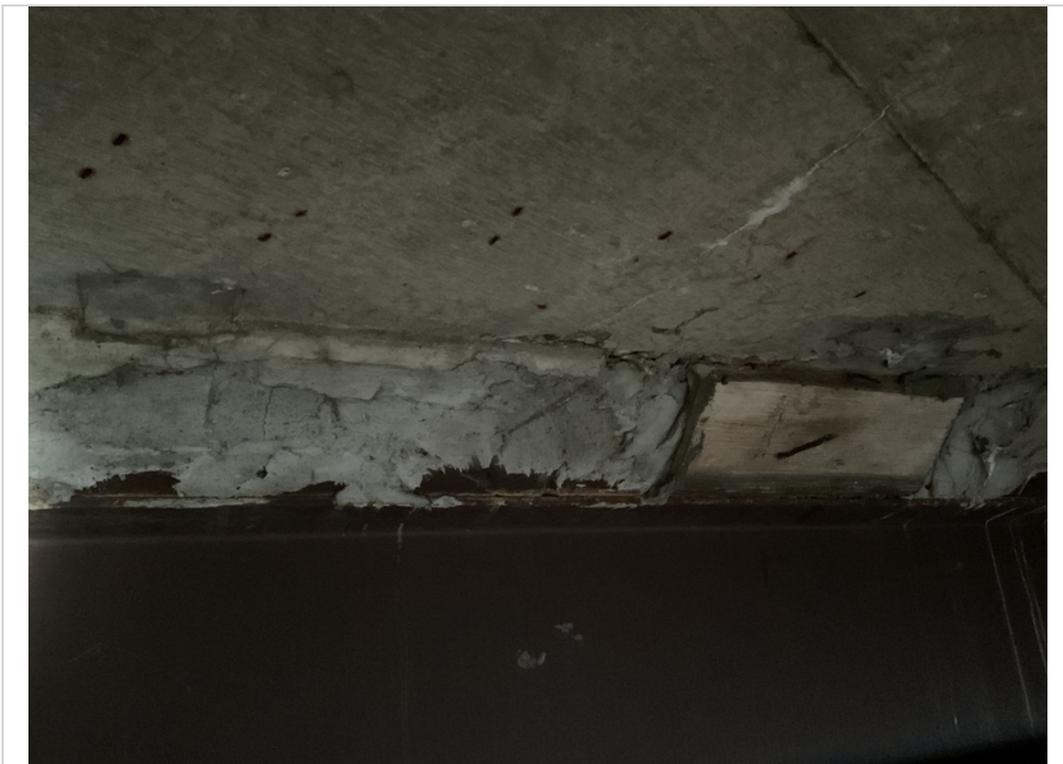
Span 4 Bay E patch

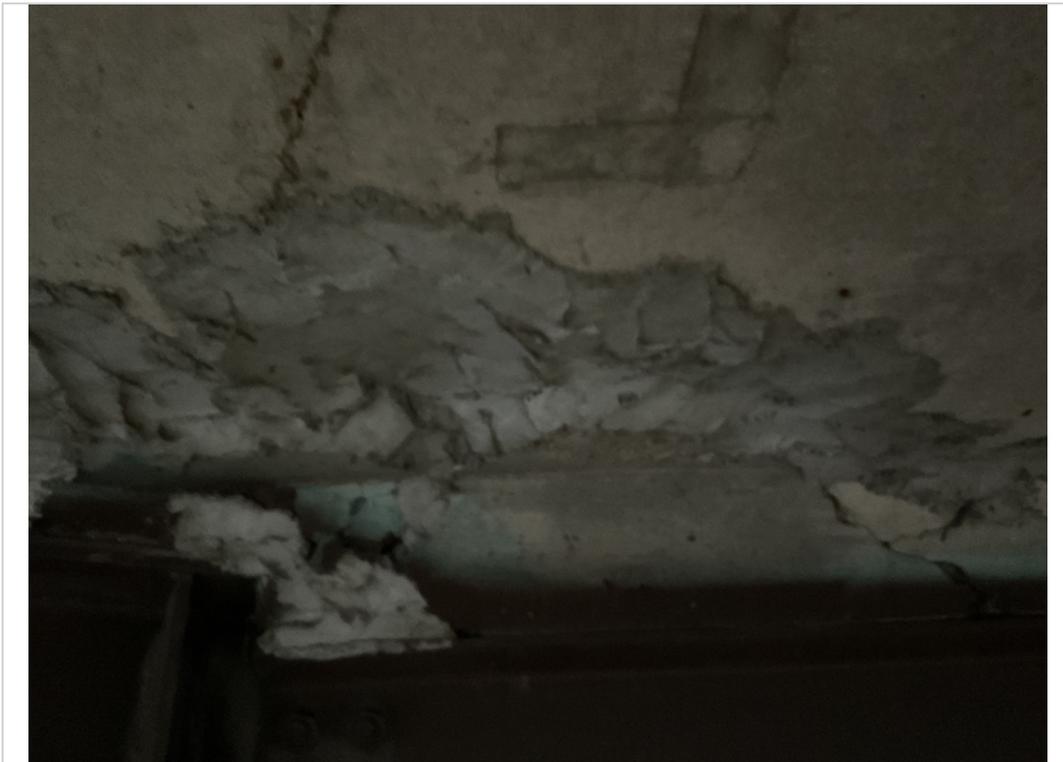
Span 4 bay C patch

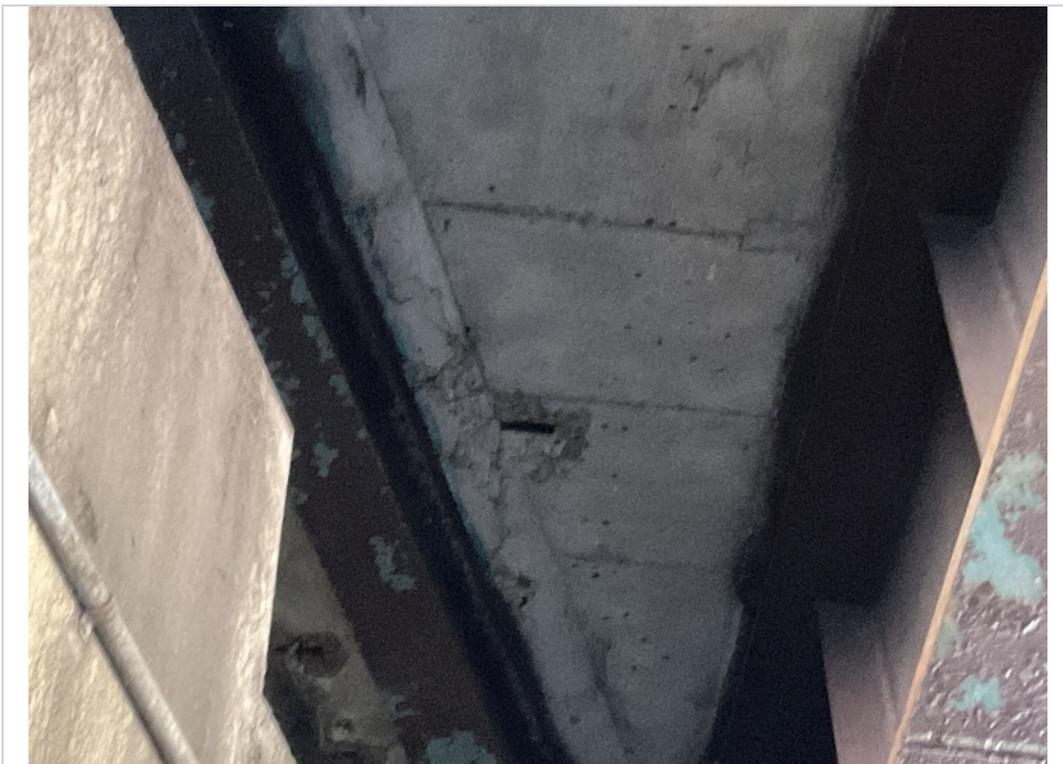
Span 3 bay E spall with exp steel

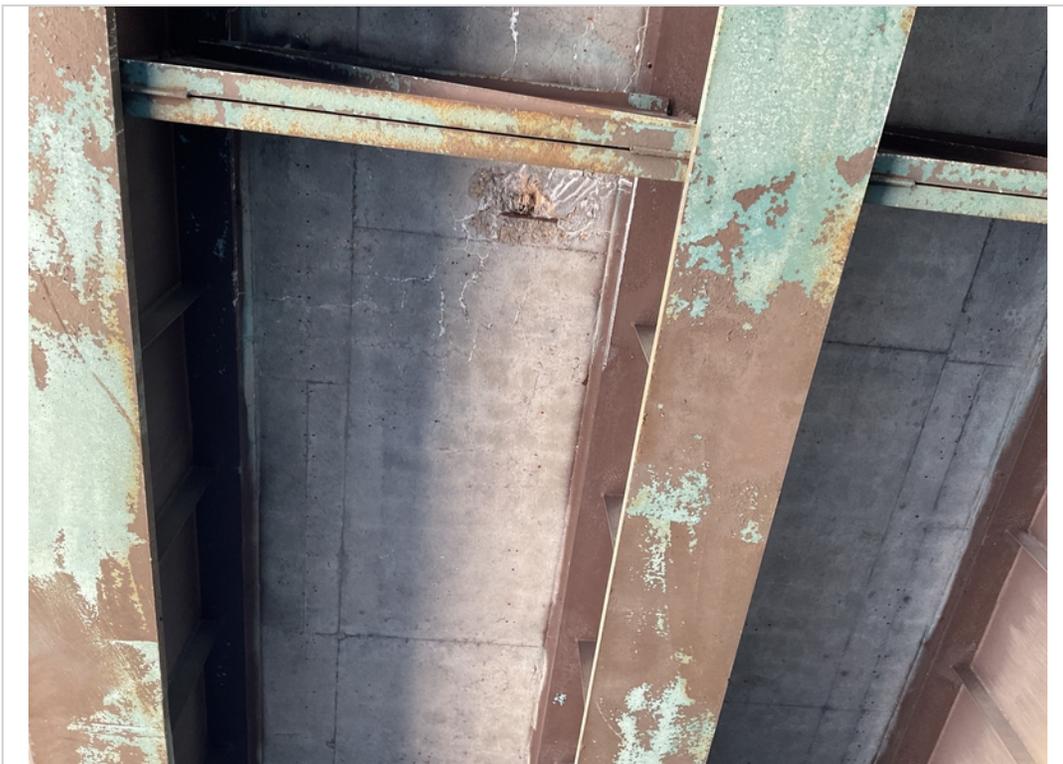
Span 3 bay C spall with exp steel

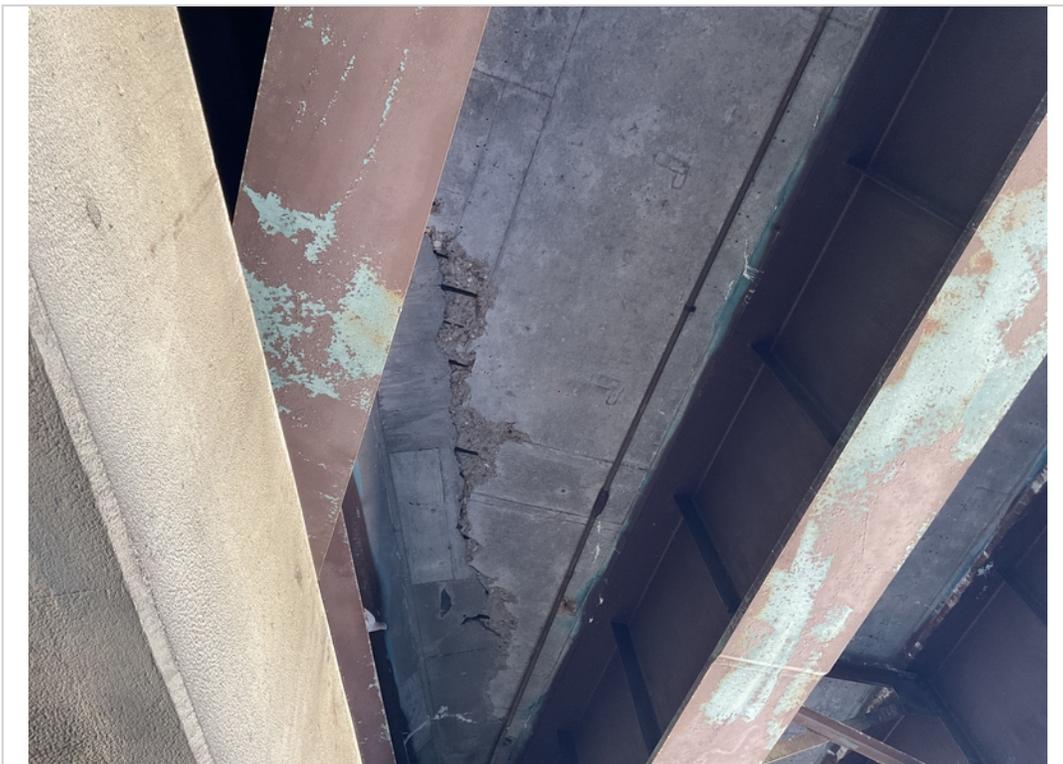
Span 3 bay D spall with exp steel

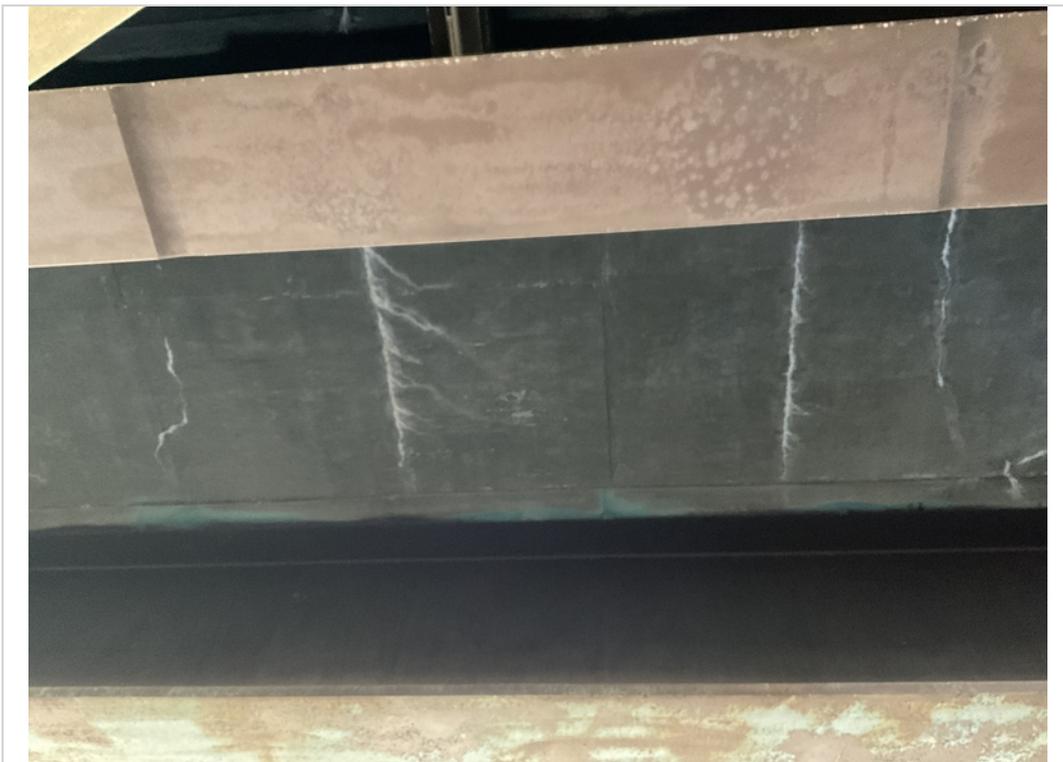
Span 3 bay G trans cracks with eff

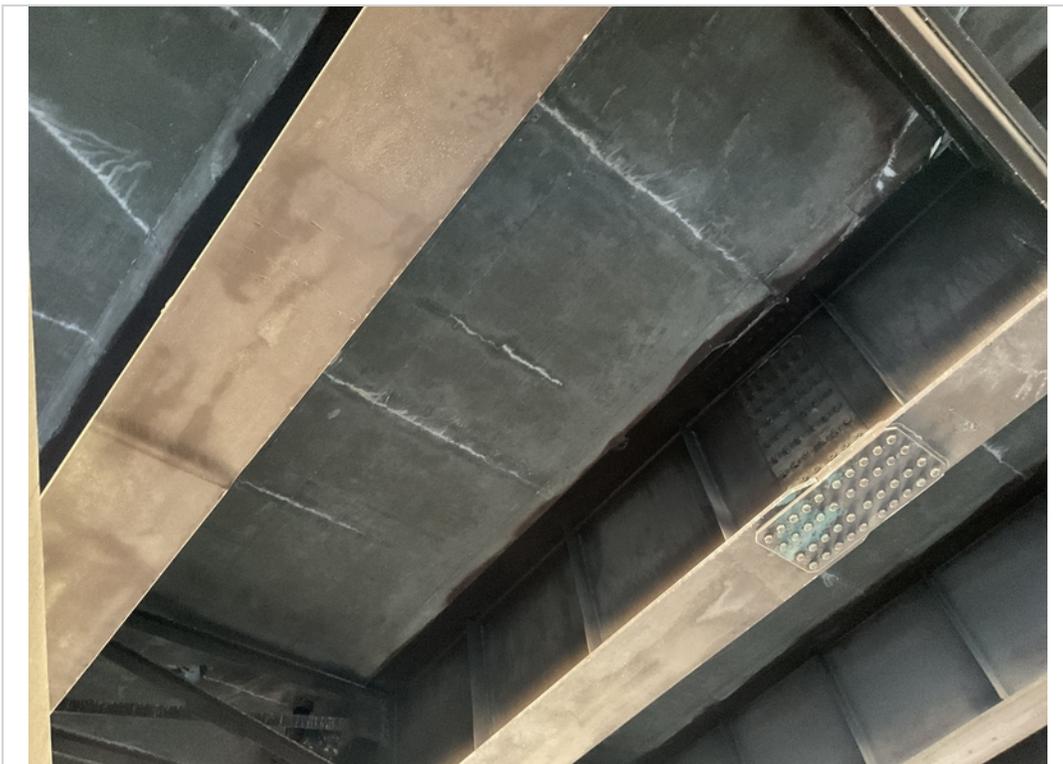
Span 3 bay I trans cracks with eff

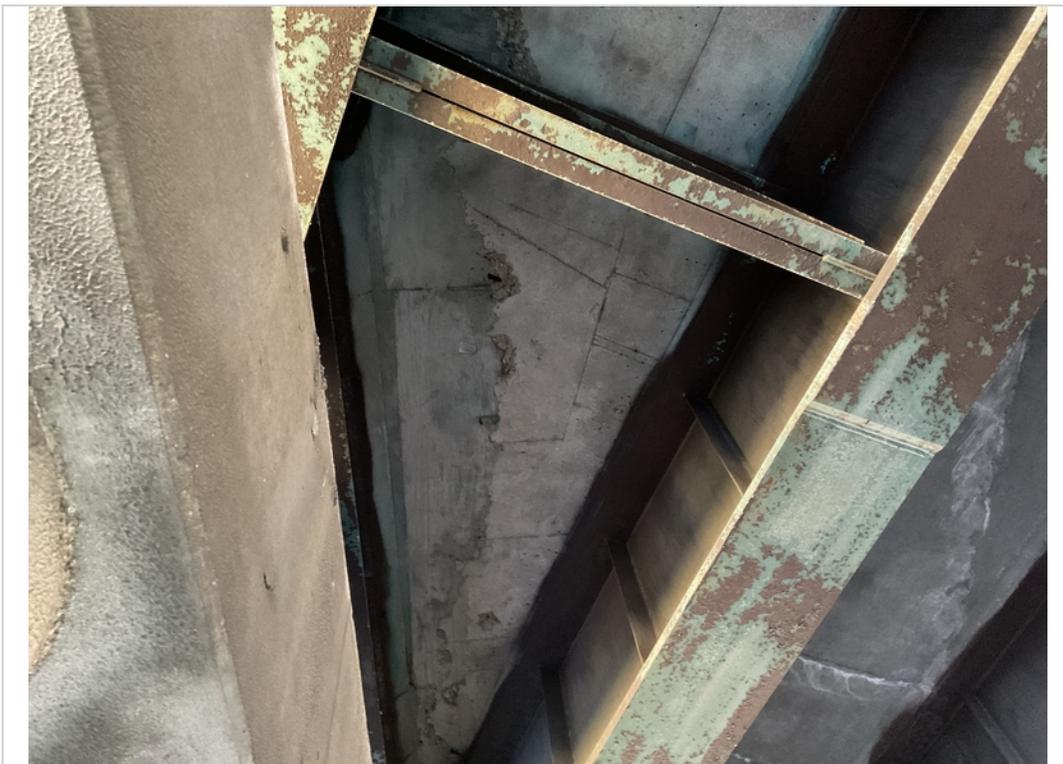
Span 3 bay J spall with exp steel

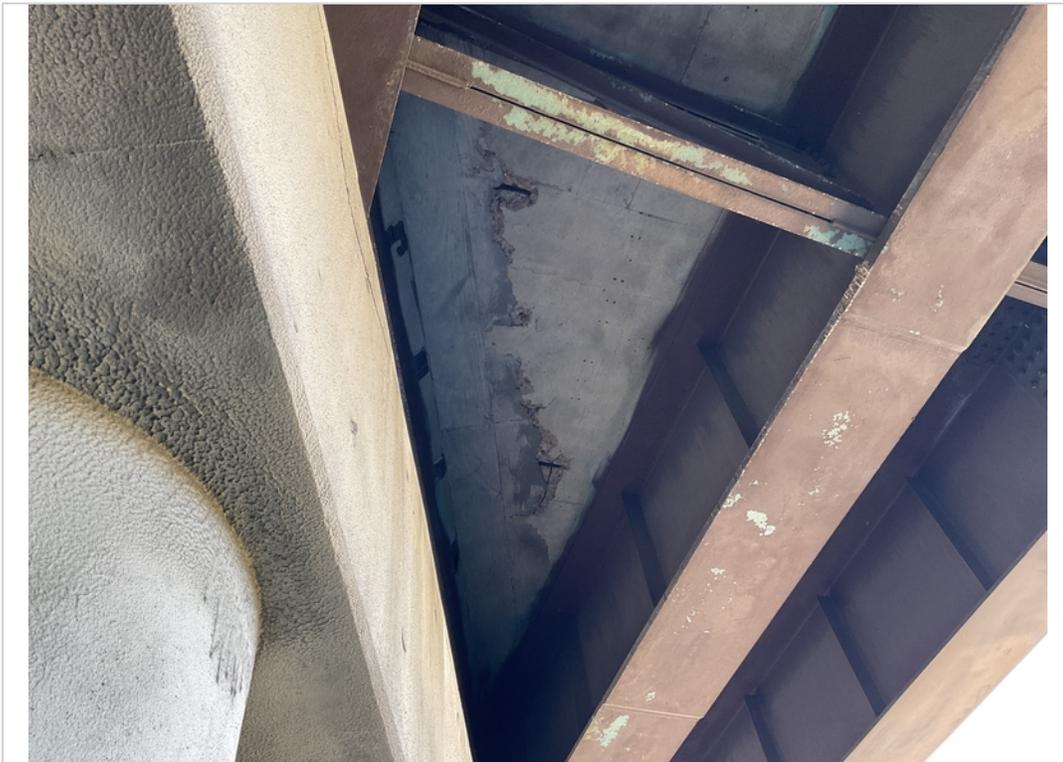
Span 2 bay N spall with exp steel

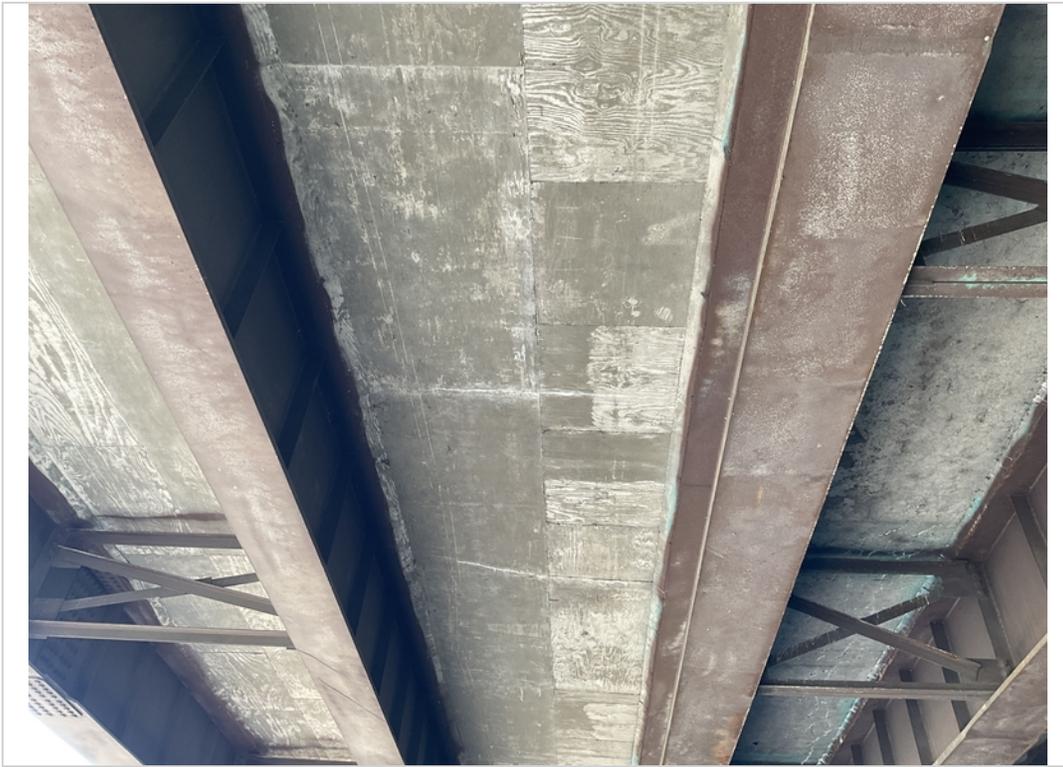
Span 2 bay B trans cracks with eff

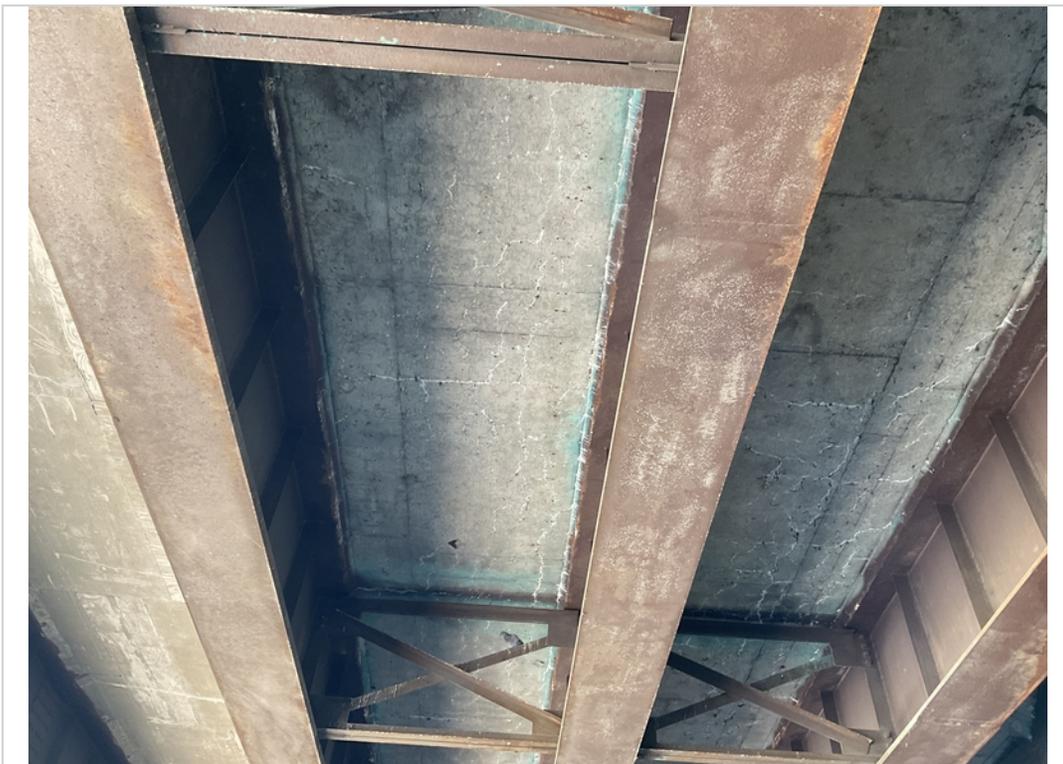
Span 2 bay C map cracks with eff

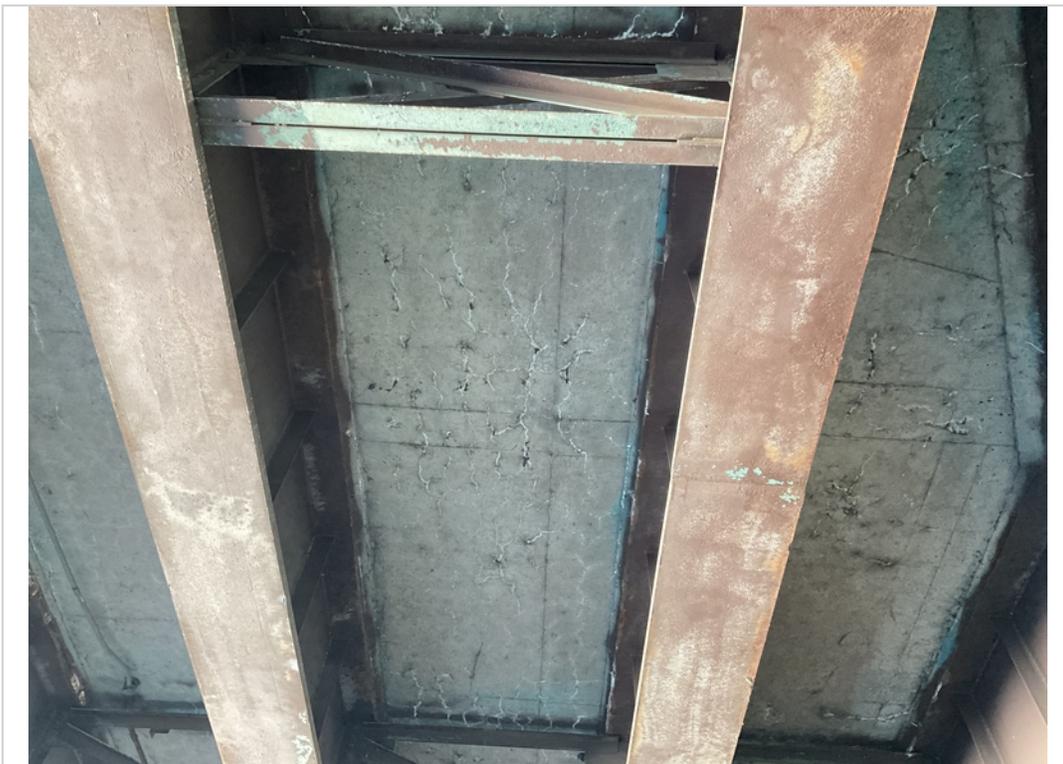
Span 2 bay E map cracks with eff

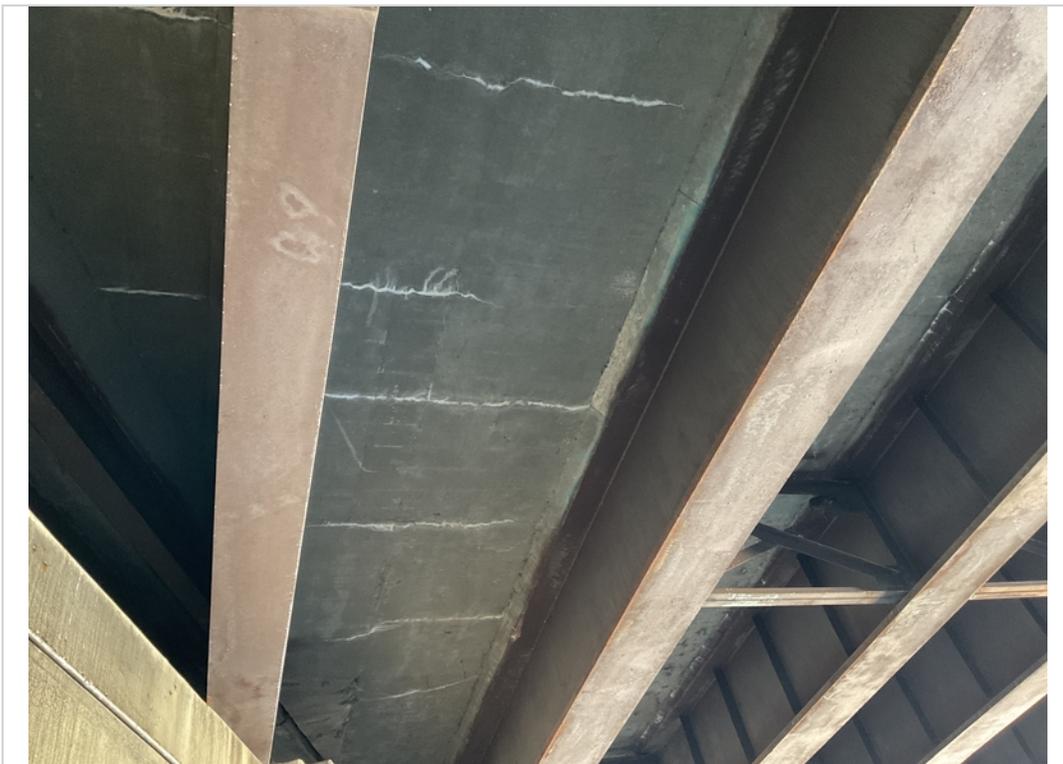
Span 2 bay G trans cracks with eff

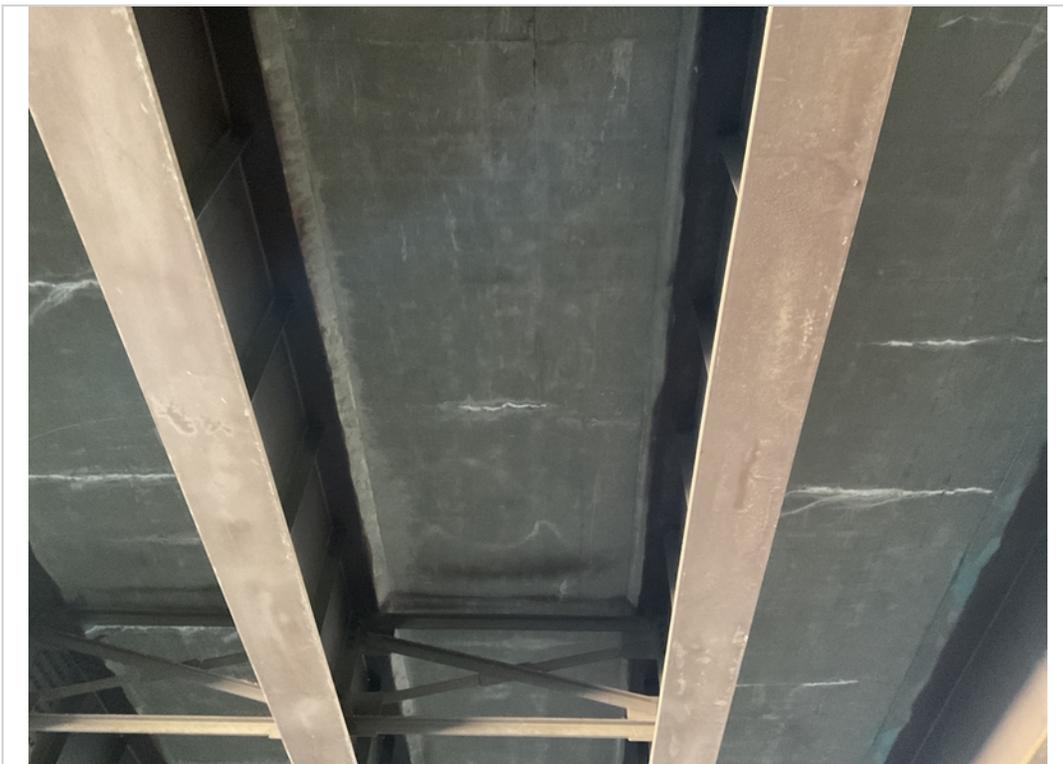
Span 2 bay I trans crack with eff

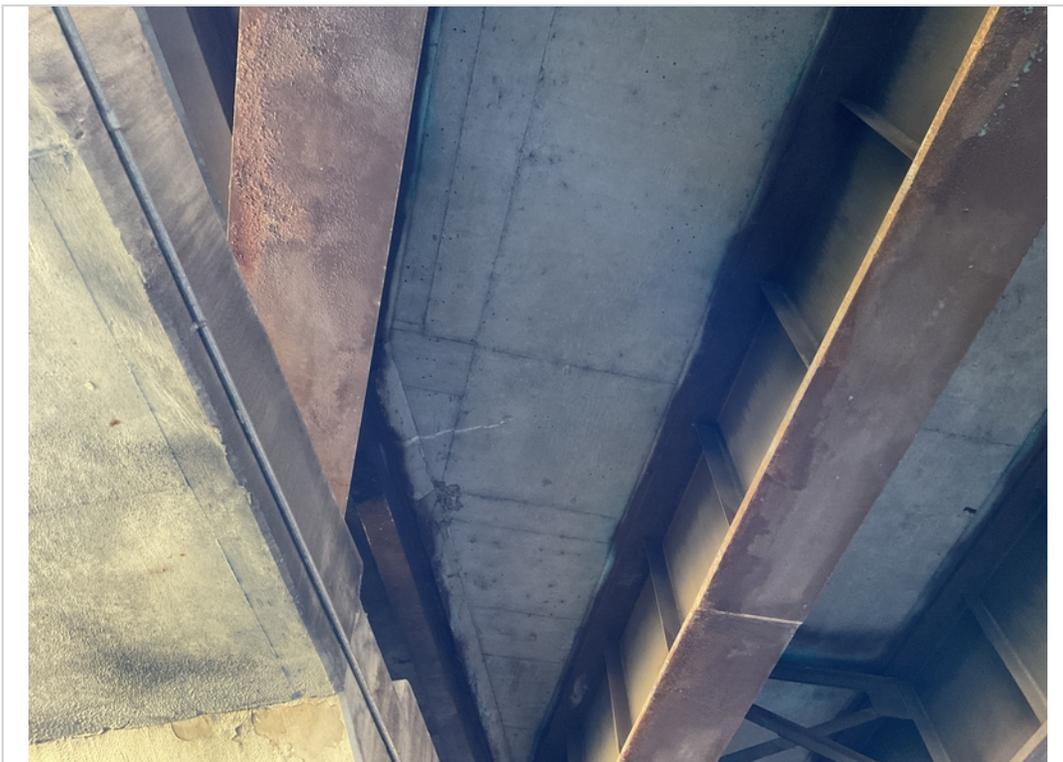
Span 2 bay N trans crack with eff

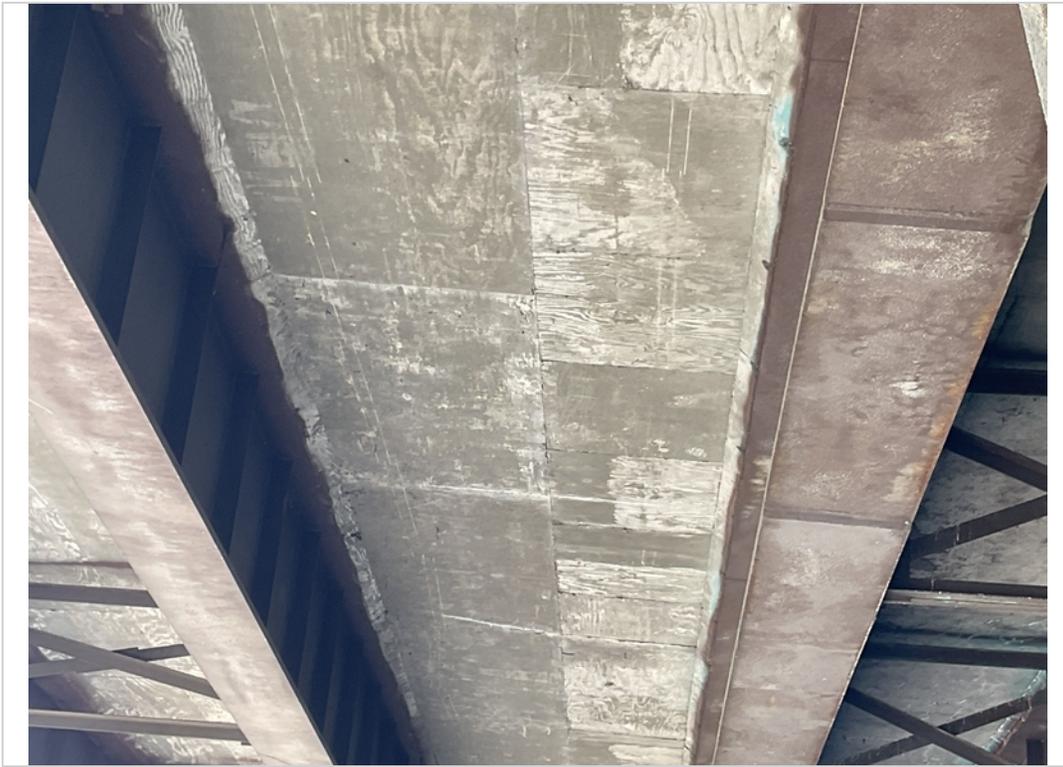
Span 2 bay B trans crack with eff

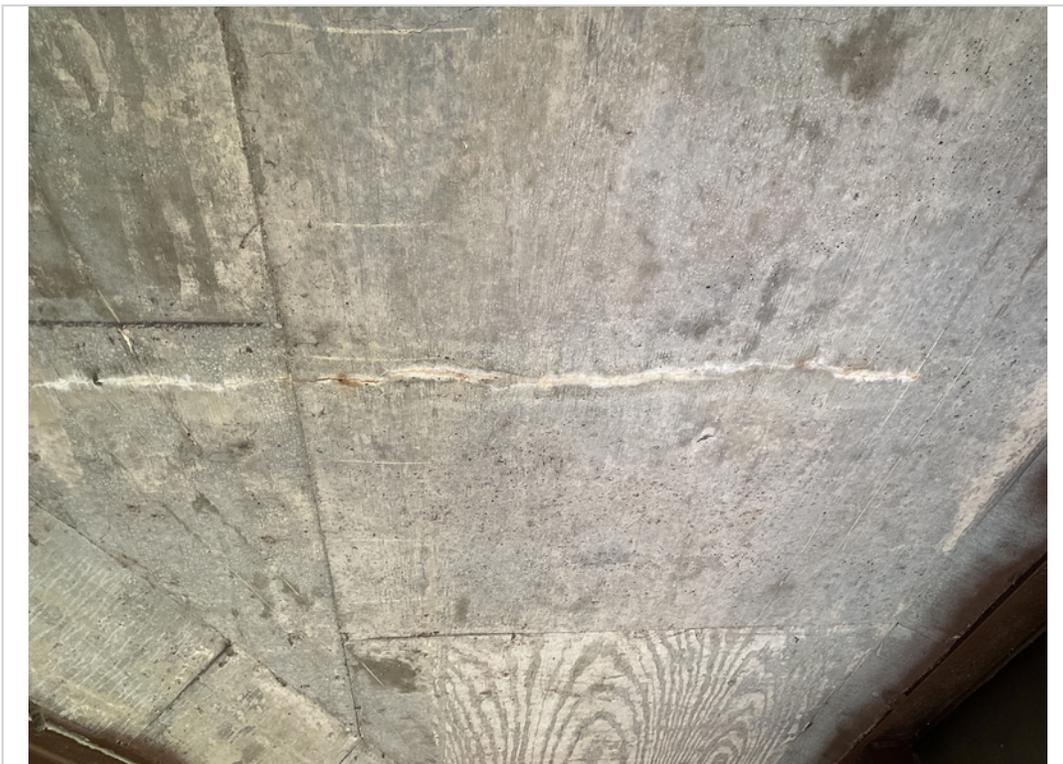
Span 1 bay A trans crack with eff

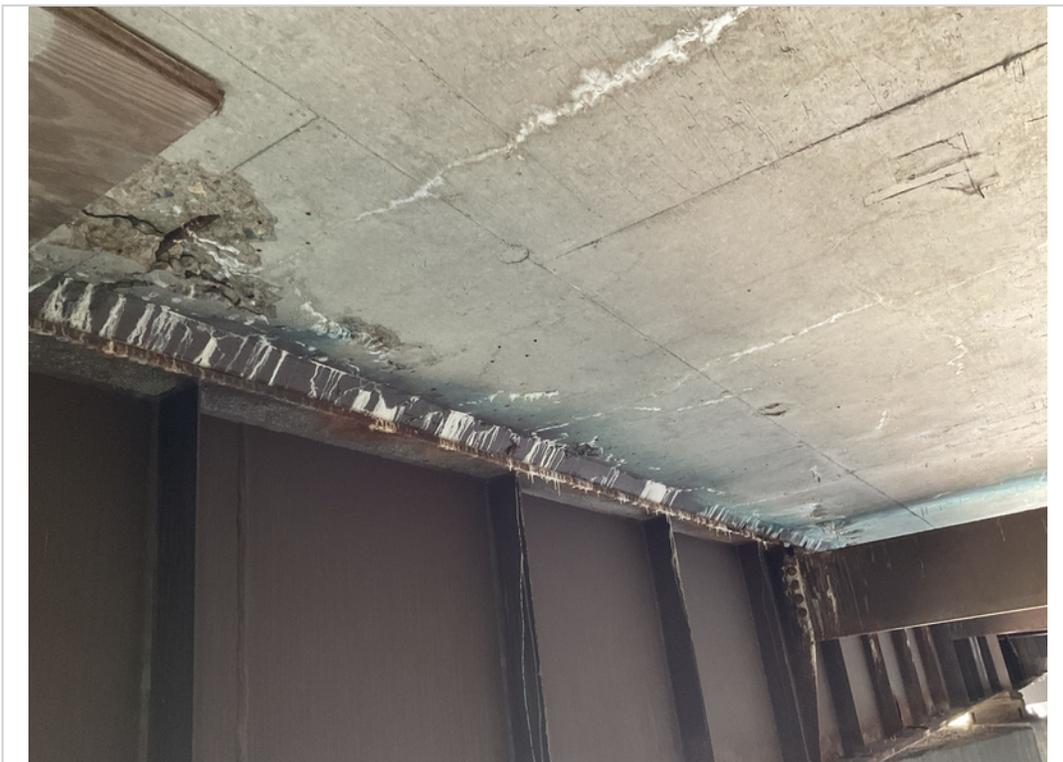
Span 1 bay C cracks with eff at top flange

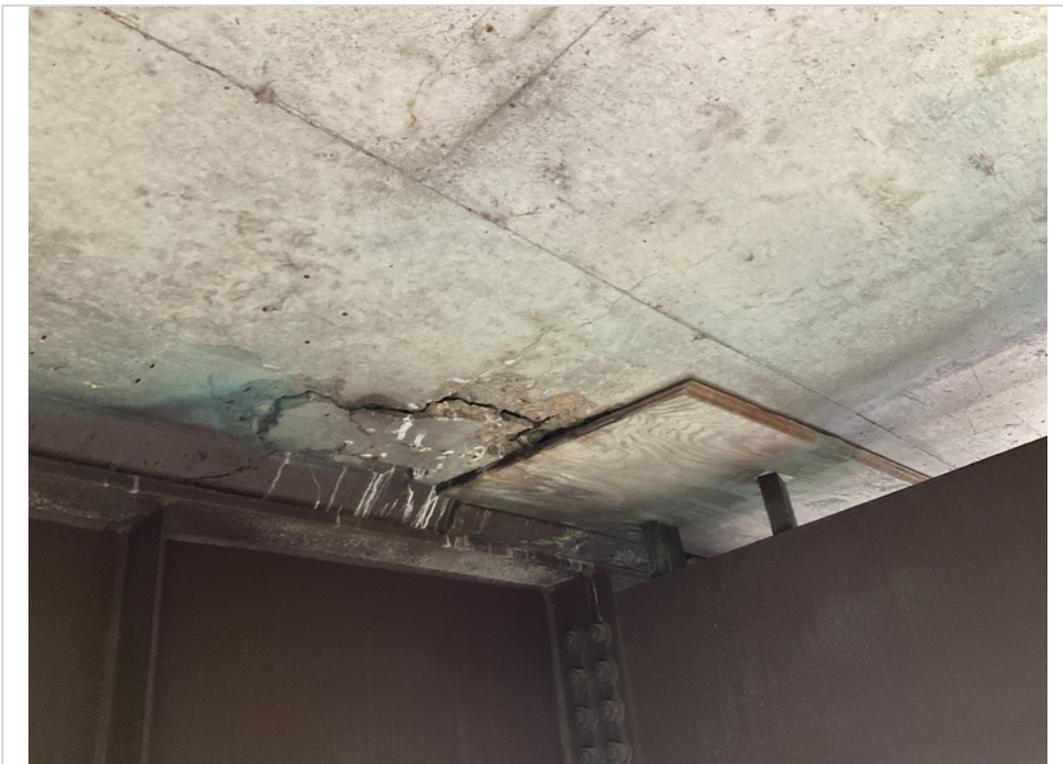
Span 1 bay C spall with exp steel

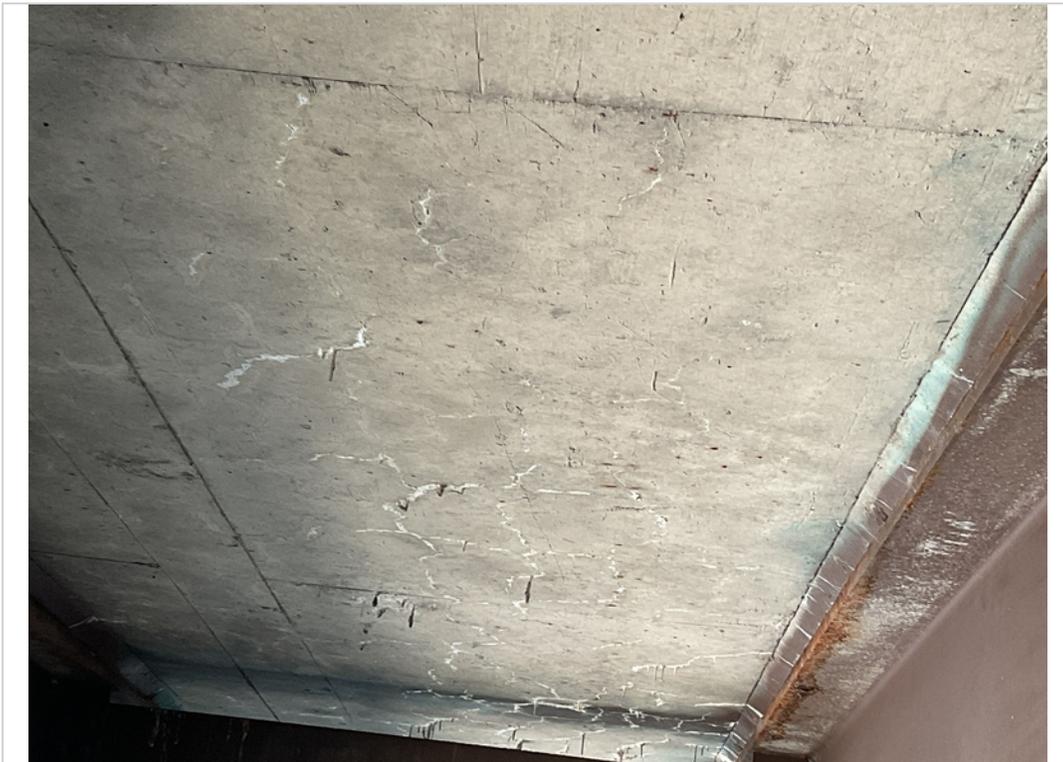
Span 1 bay D map cracks with eff

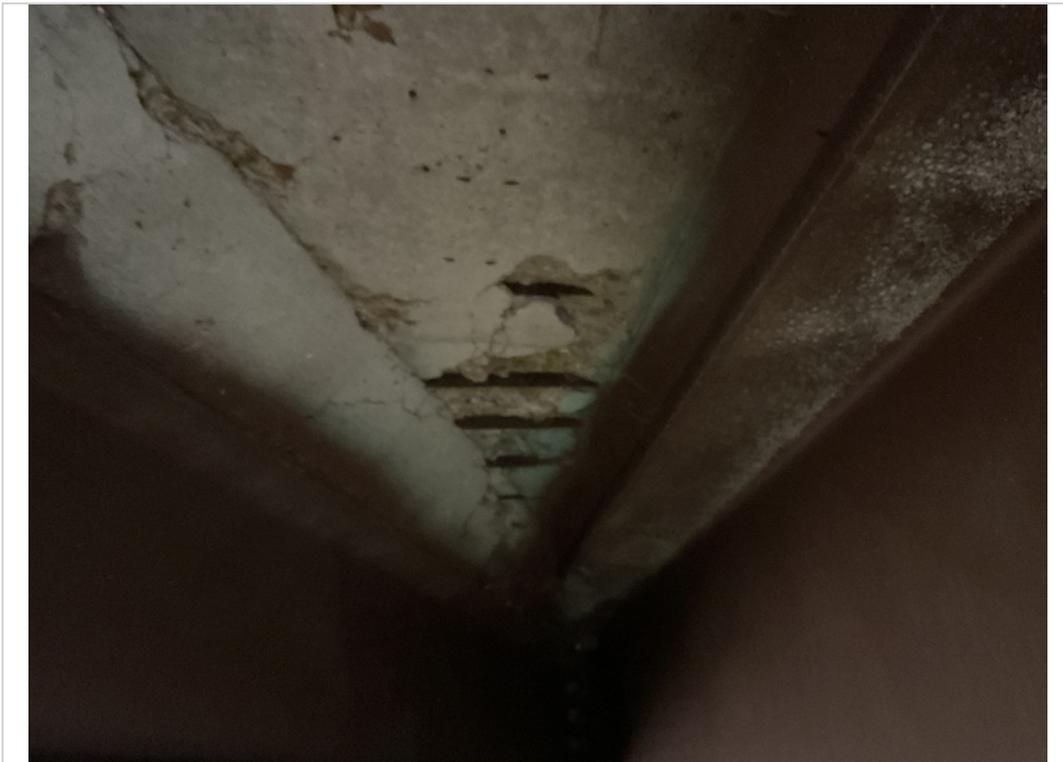
Span 1 bay E spall with exp steel
