I-24 Crossing I24 / NORTH FIRST ST

90 - LAST INSPECTION DATE 09/21/2021

IDENTIFICATION	
(1) State Names	47 - Tennessee
(8) Structure Number	19I00240107
(5) Inventory Route	1
(2) Highway Agency District	Region 3
(3) County Code	19 - Davidson

4 span Bridge / Cont. S.I.B
I-24 / North First Street

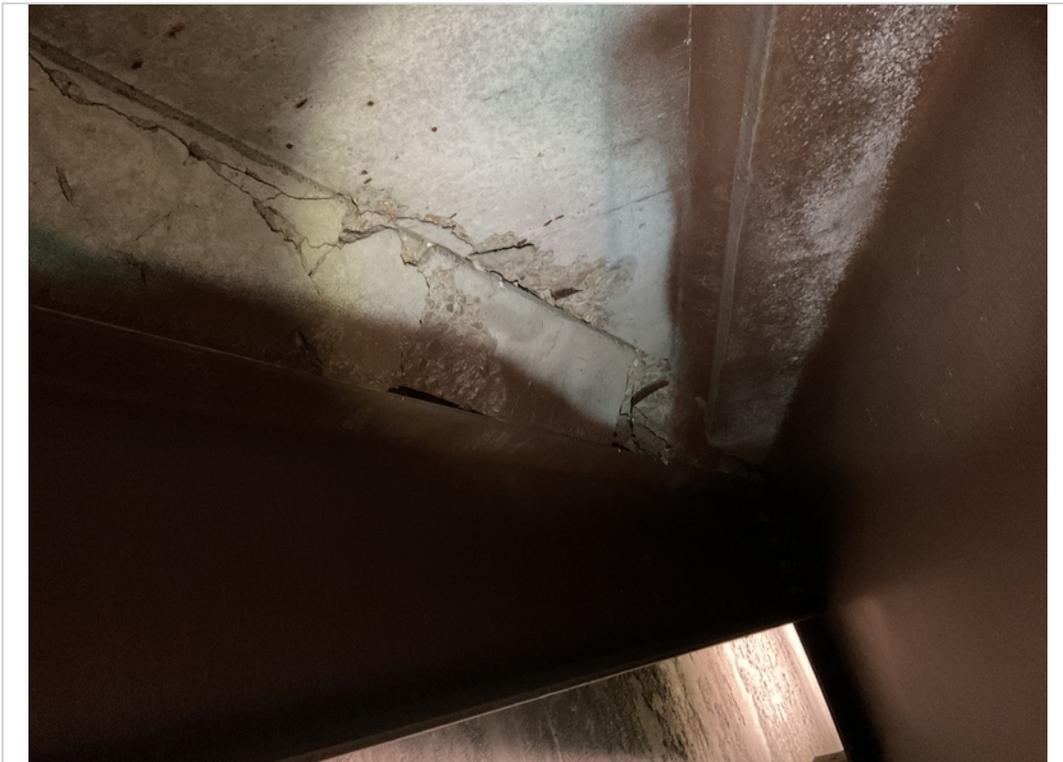
Span 1 bay F spall with exp steel

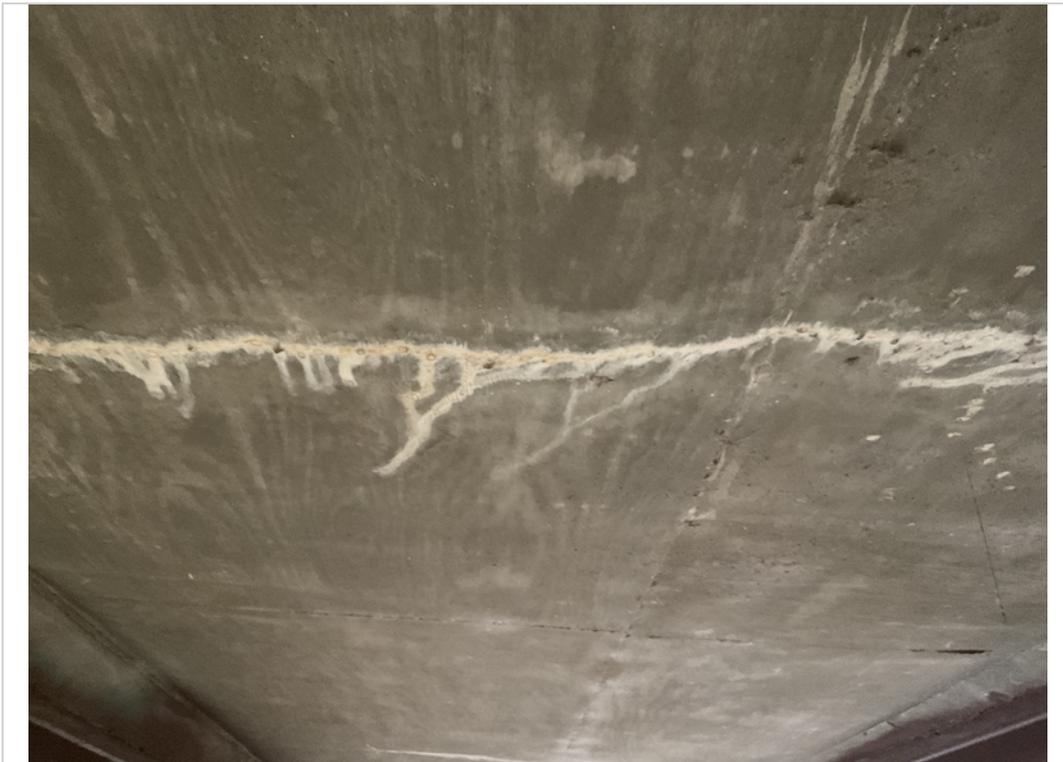
Span 1 bay G trans crack with eff

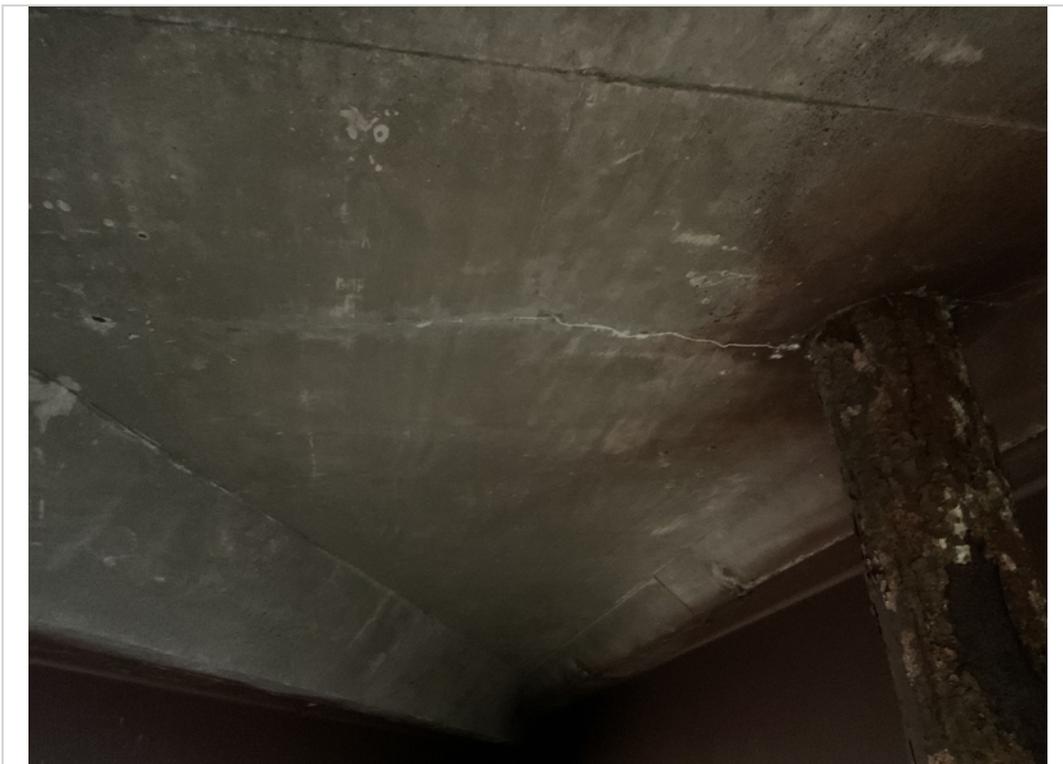
Span 1 bay I trans crack with eff

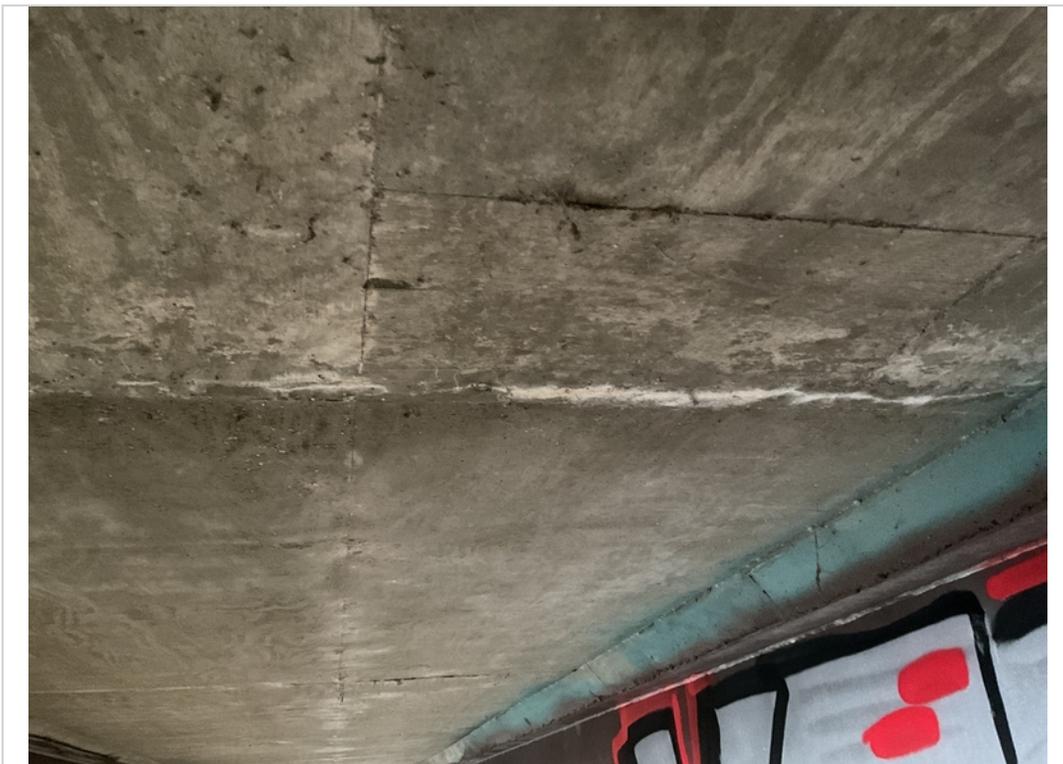
Span 1 bay J trans crack with eff

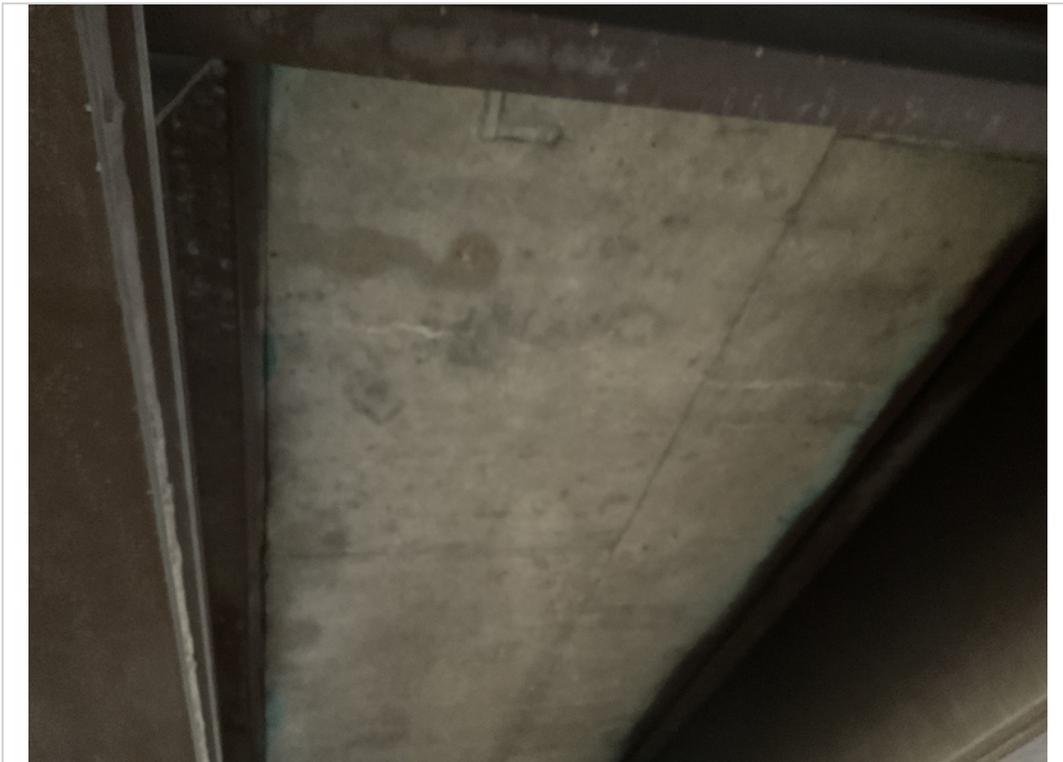
Span 1 bay N trans crack with eff

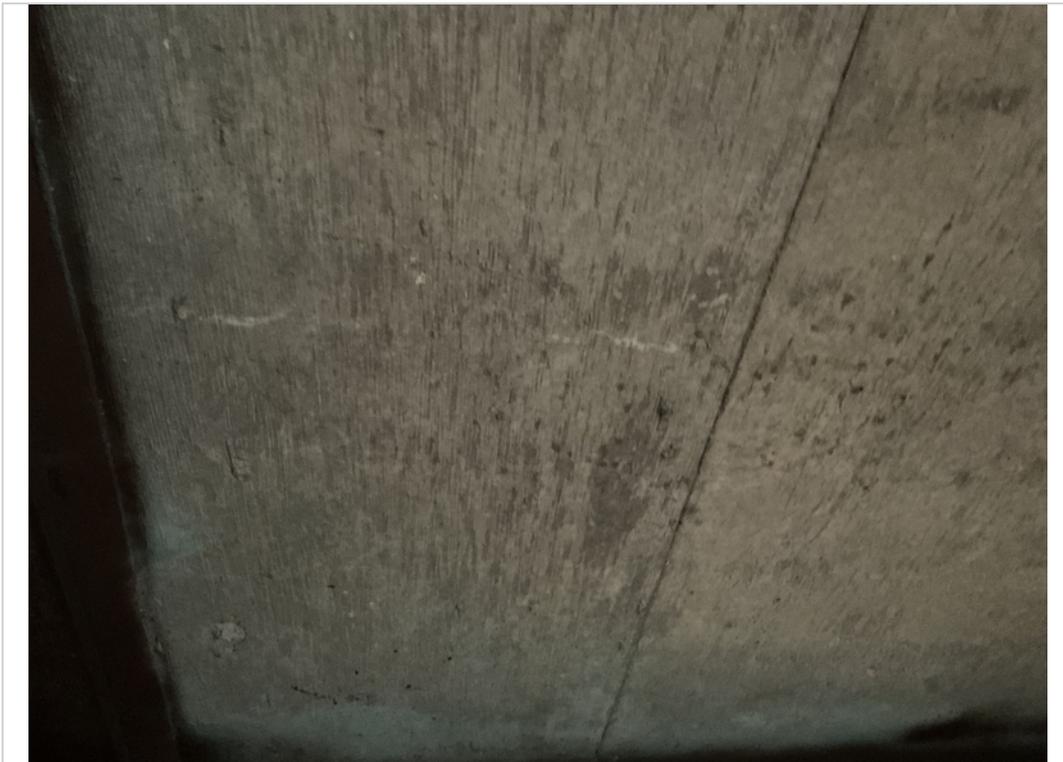
Span 1 bay O trans crack with eff

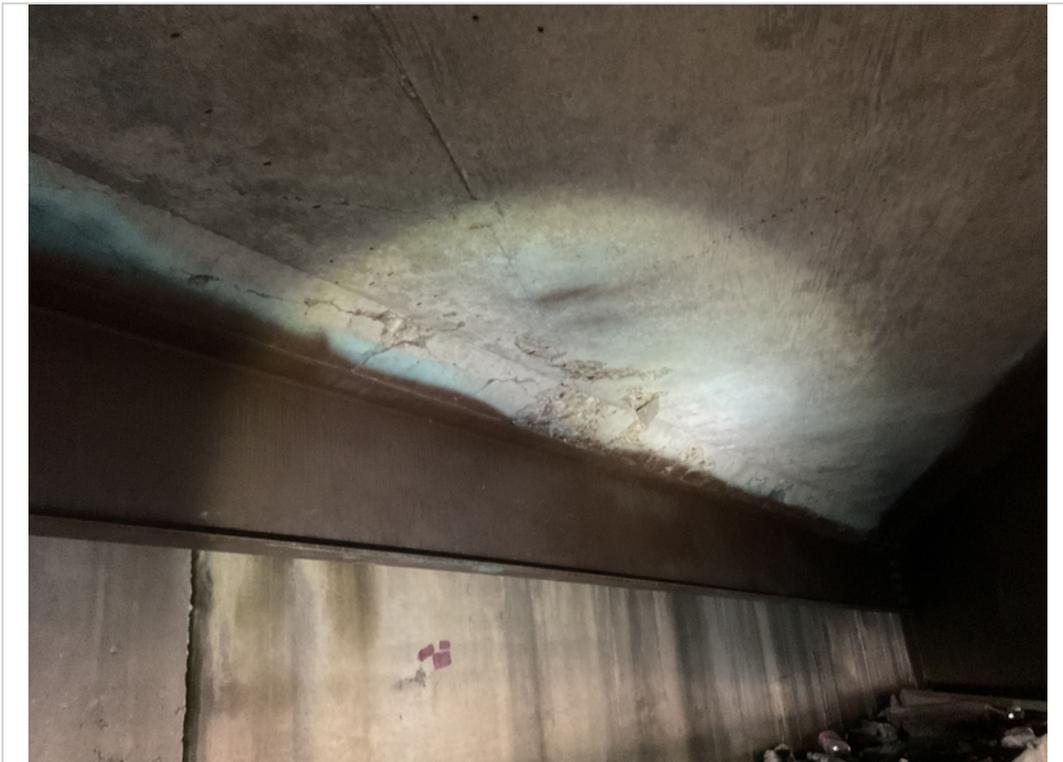
Span 1 diaphragm O spalling

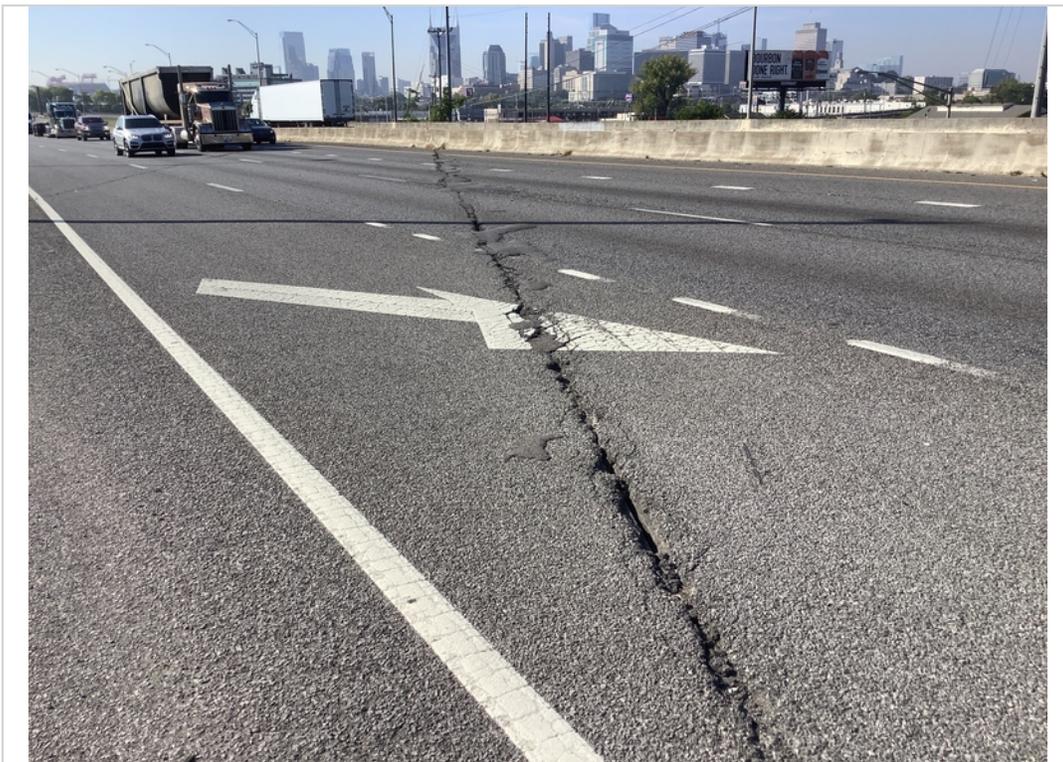
Expansion joint, span #4, patches, Westbound

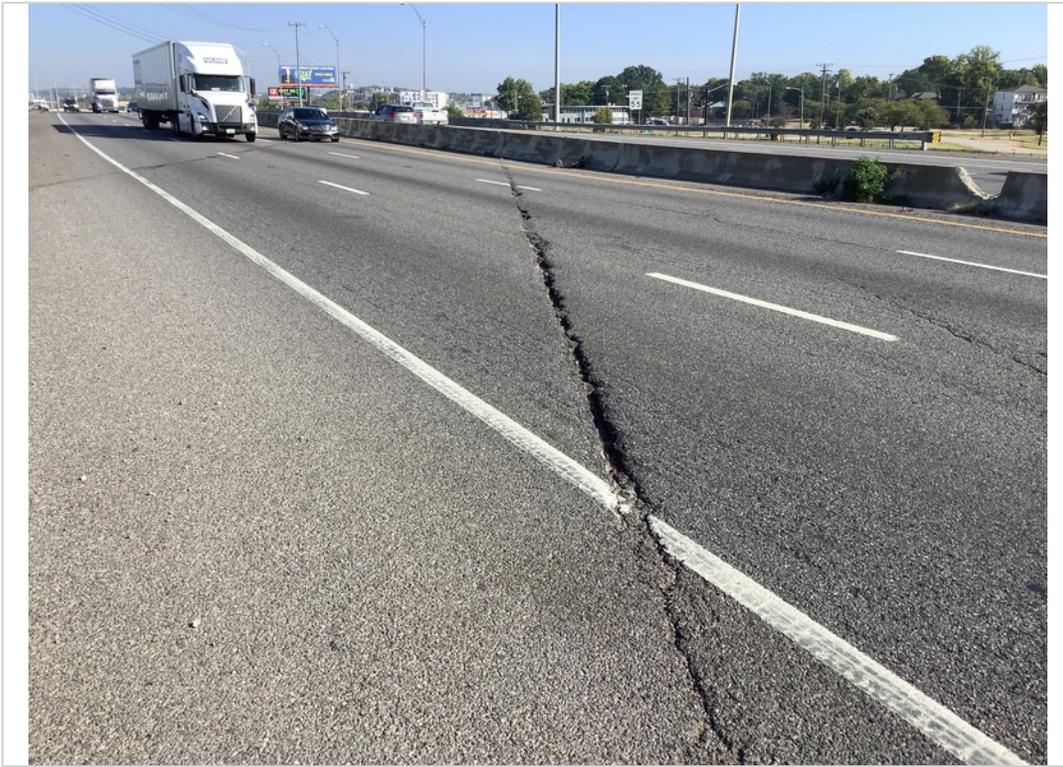
Span #4 expansion joint, partially paved over, patches, potholes

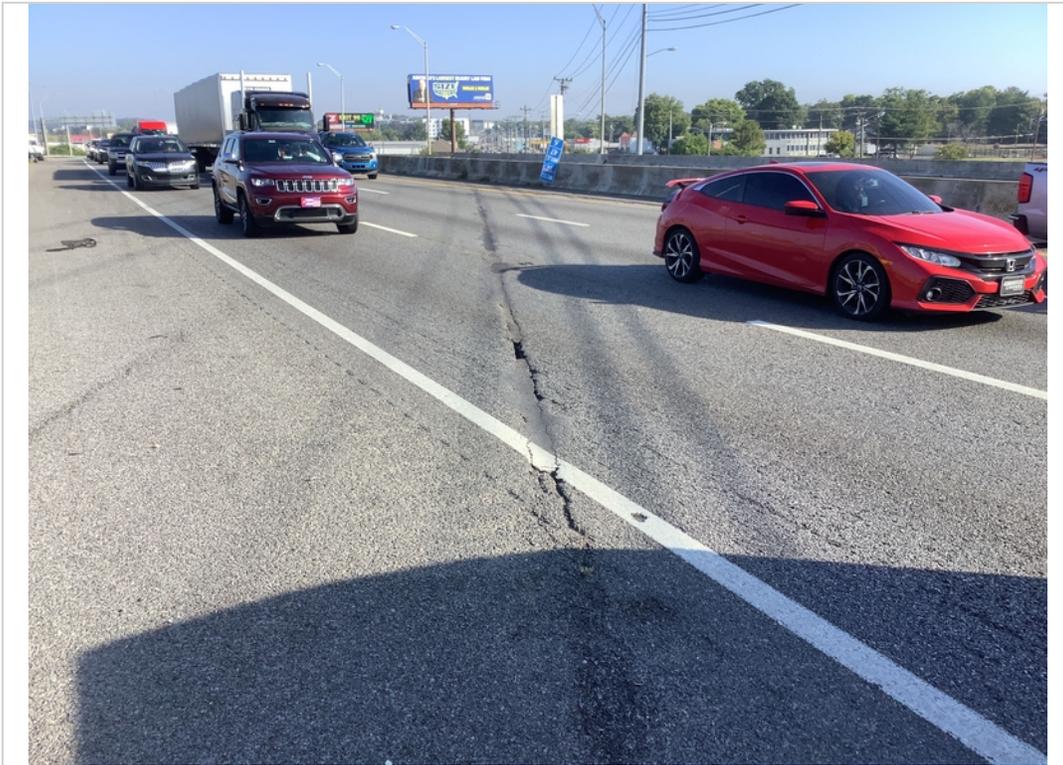
Span #1 expansion joint, partially paved over, patches, potholes

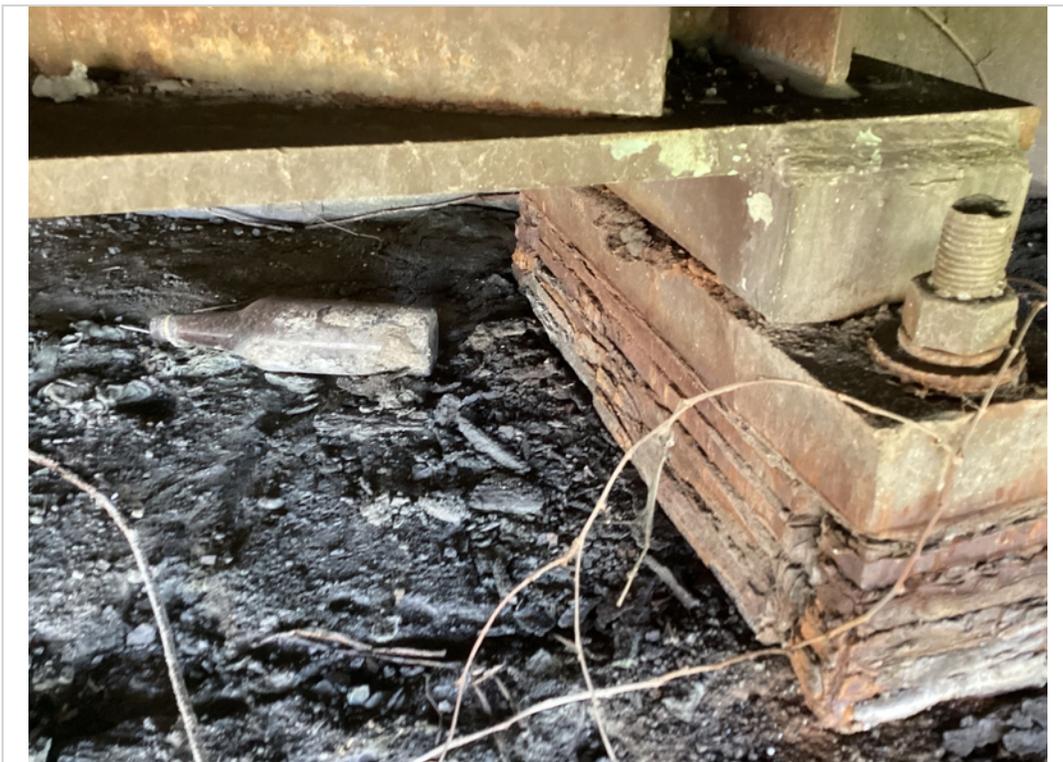
Bearing P abutment 2 corrosion

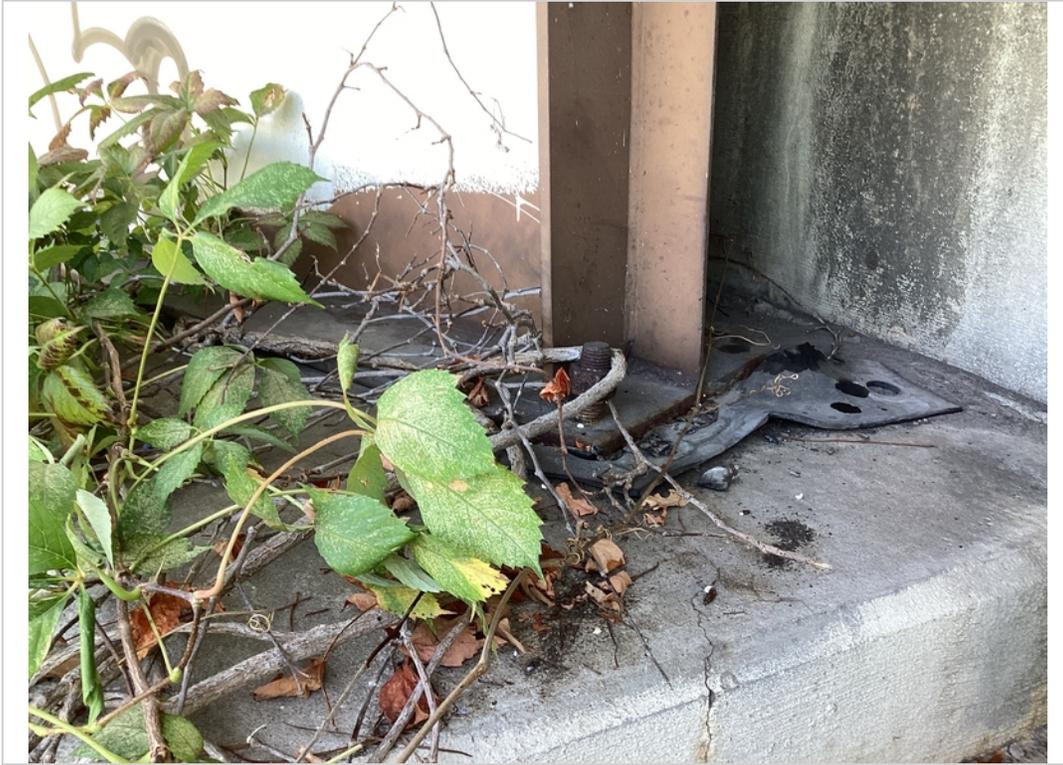
Bearing q abutment 2 loose nut slid of pad

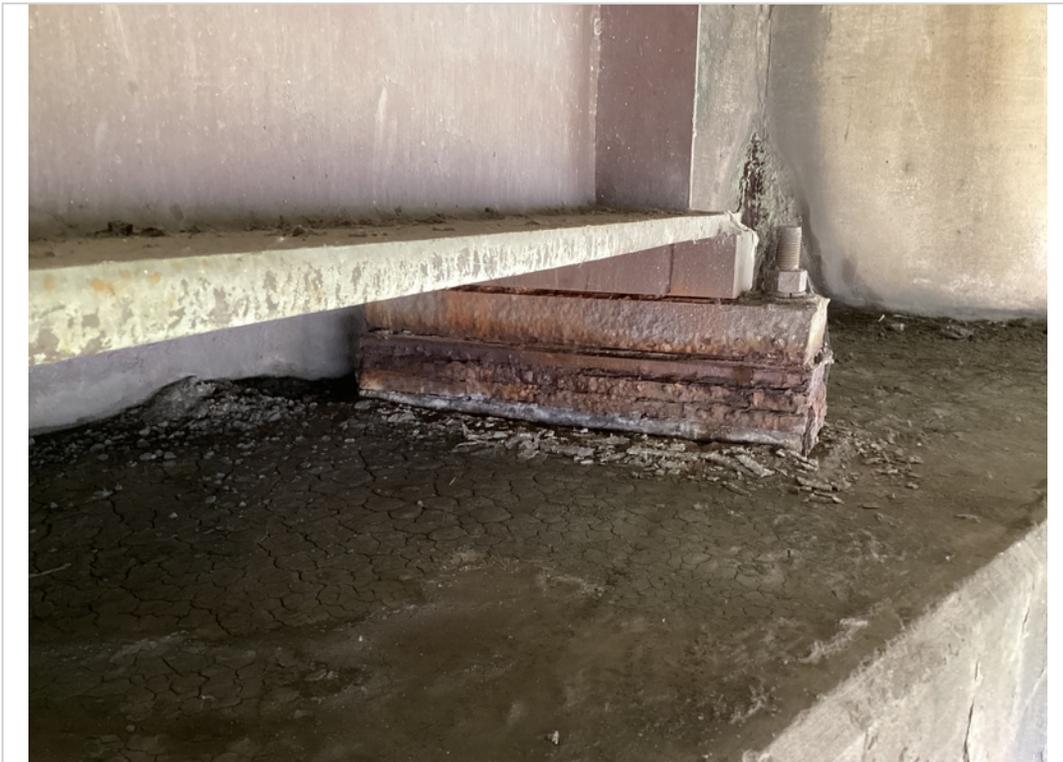
Bearing C missing bolt corrosion

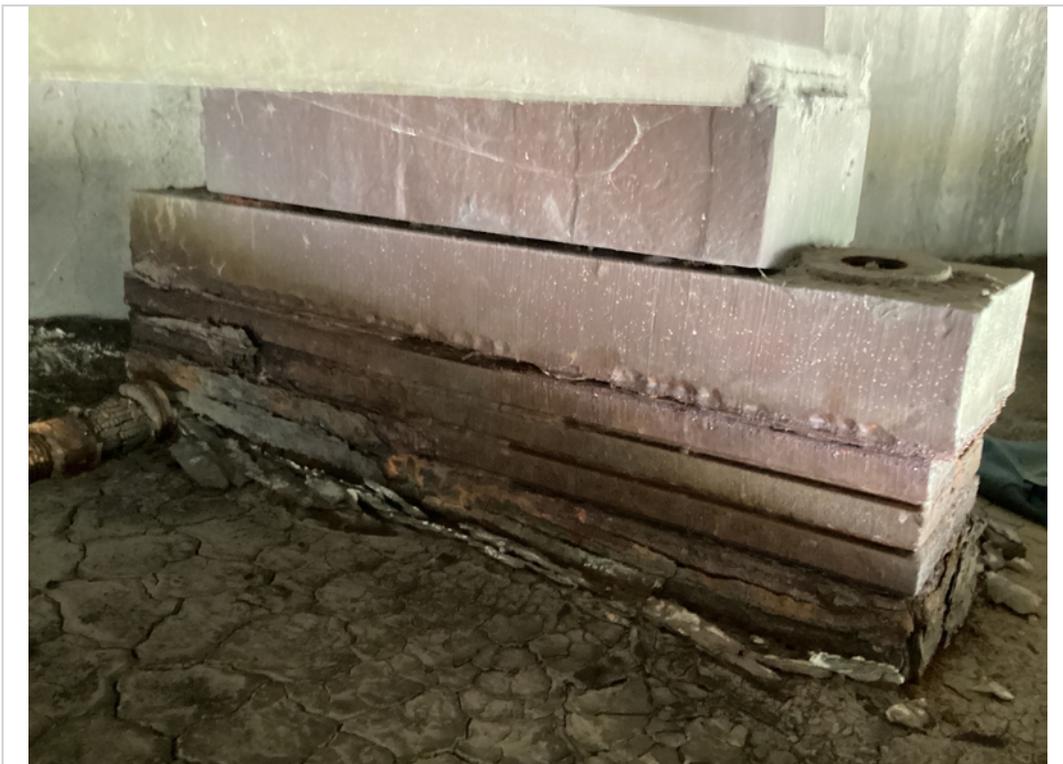
Bearing E missing bolts

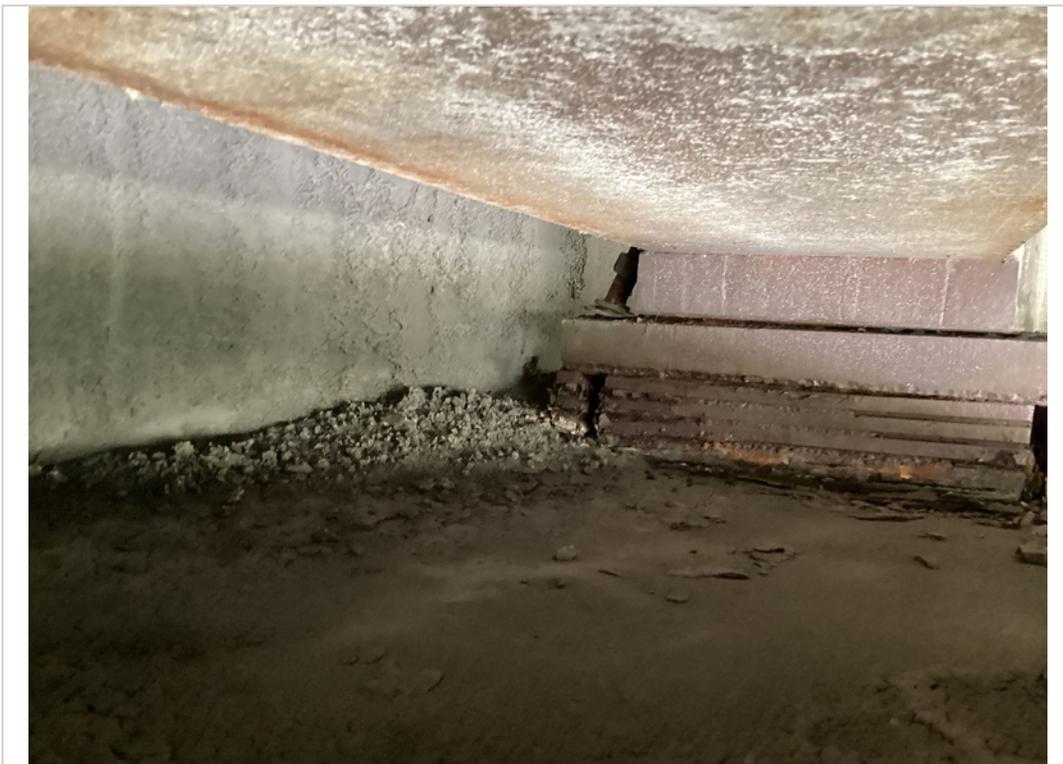
Bearing F bent bolt

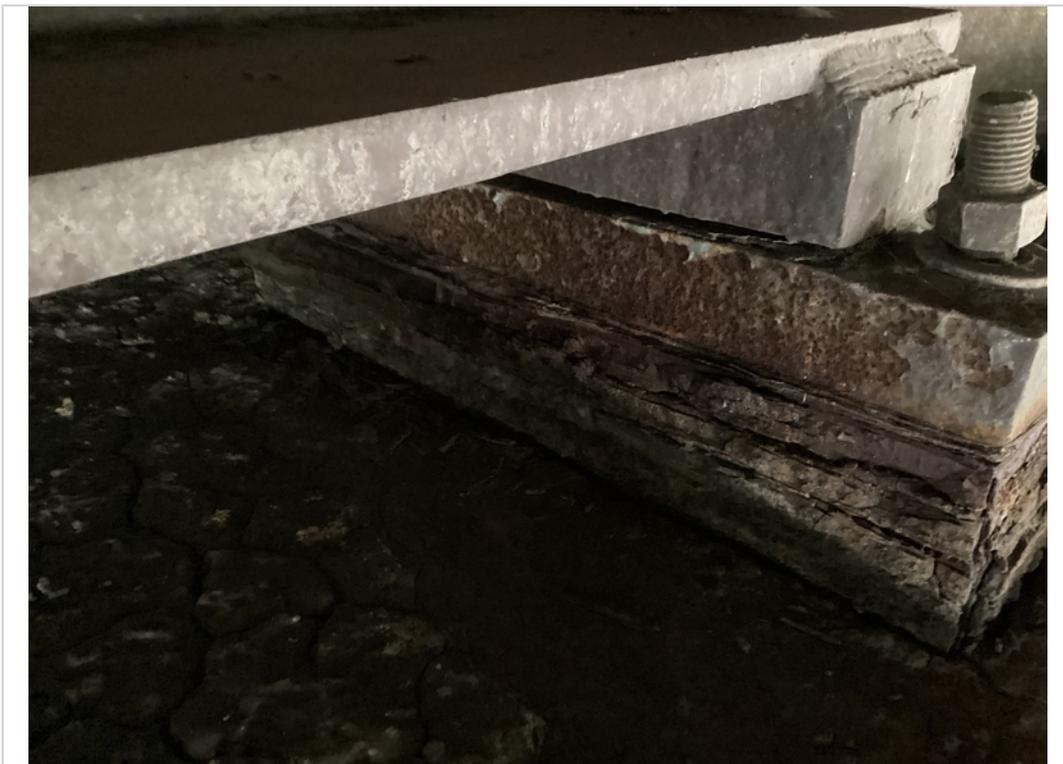
Bearing J loose nut corrosion

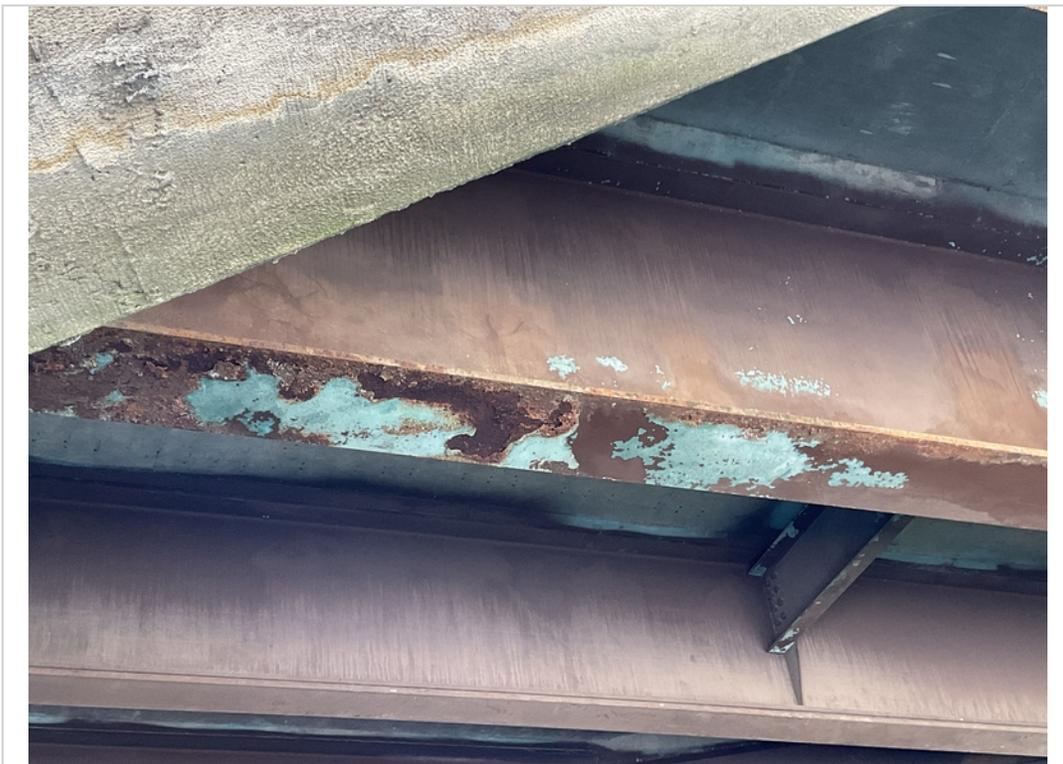
Span 4 Girder O corrosion

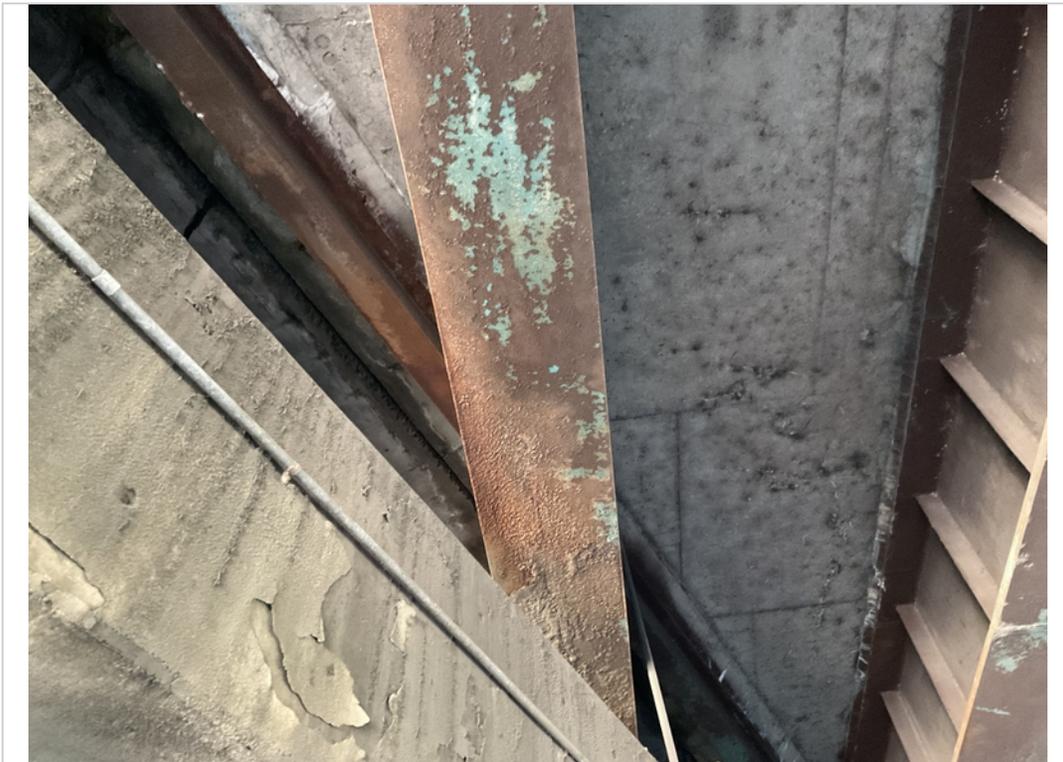
Span 3 Girder D corrosion

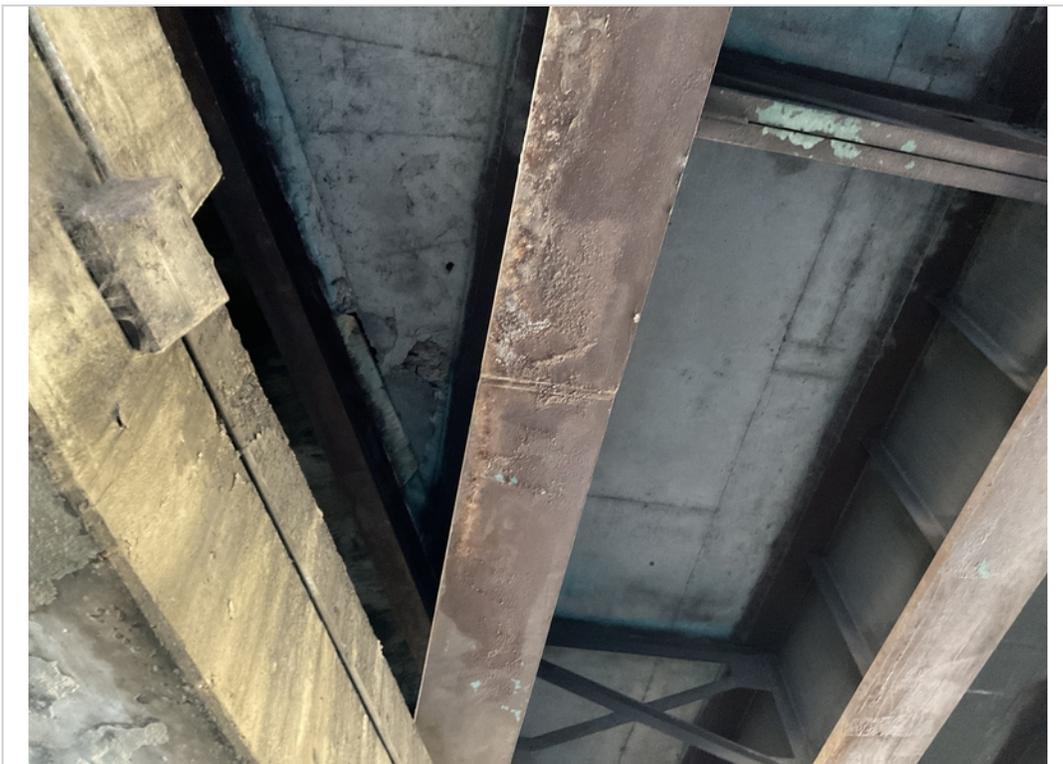
Span 2 Girder G corrosion

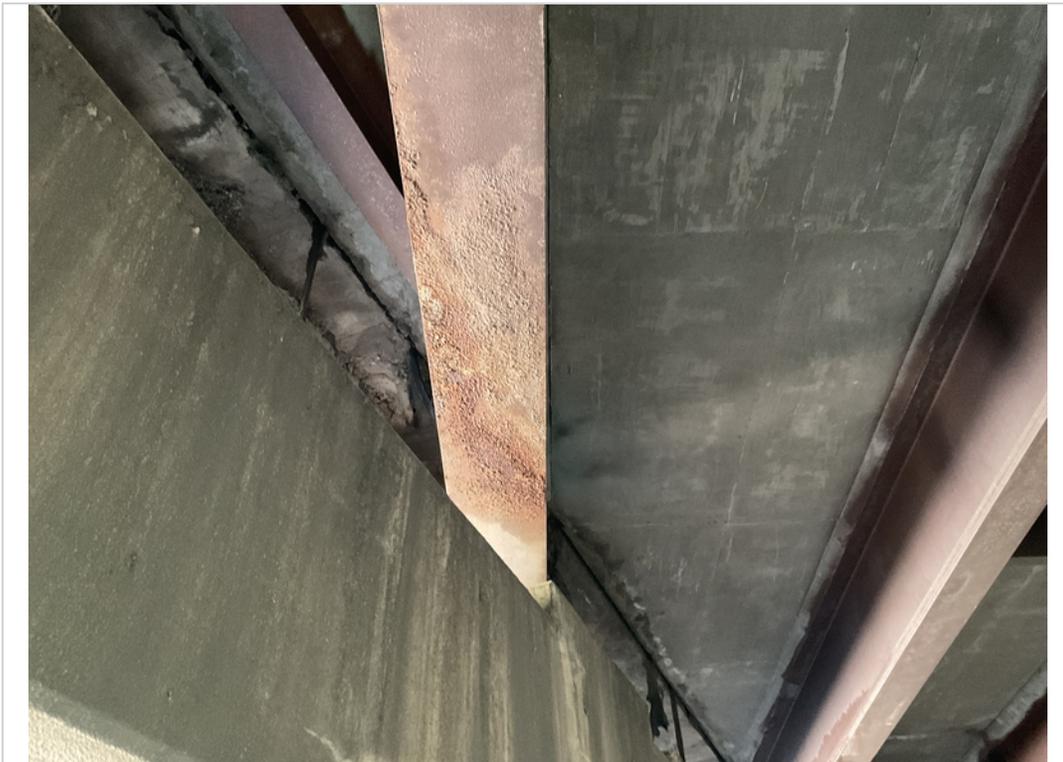
Span 1 Girder G corrosion

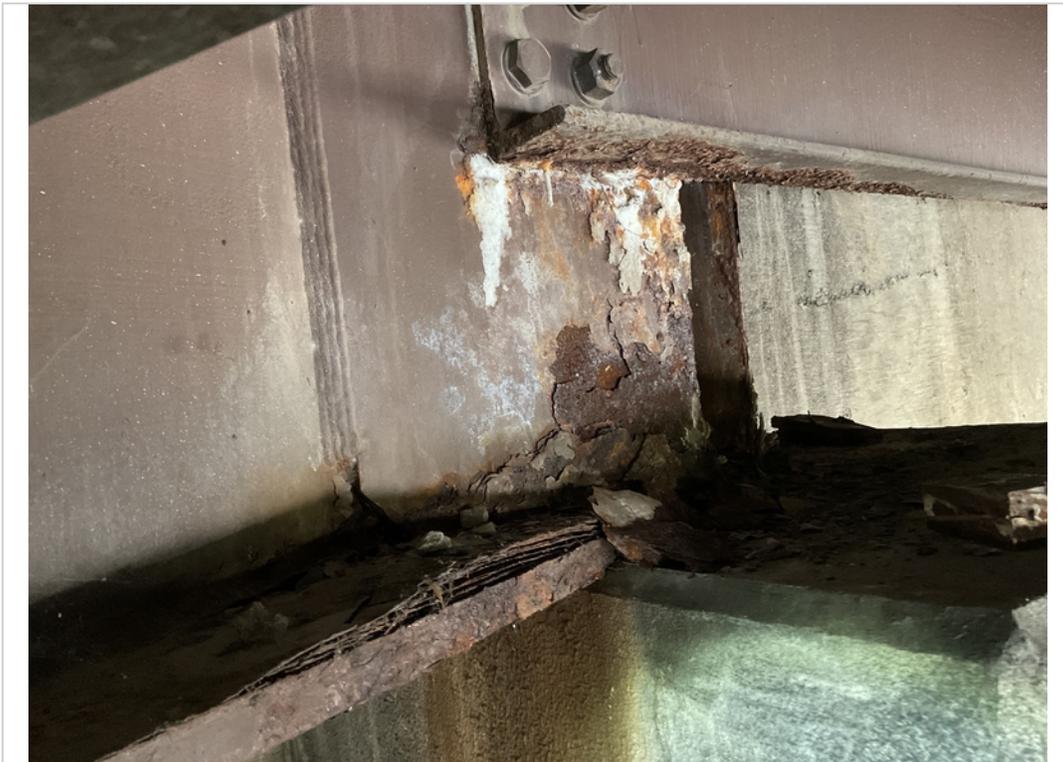
Span 1 Girder I heavy corrosion bottom flange

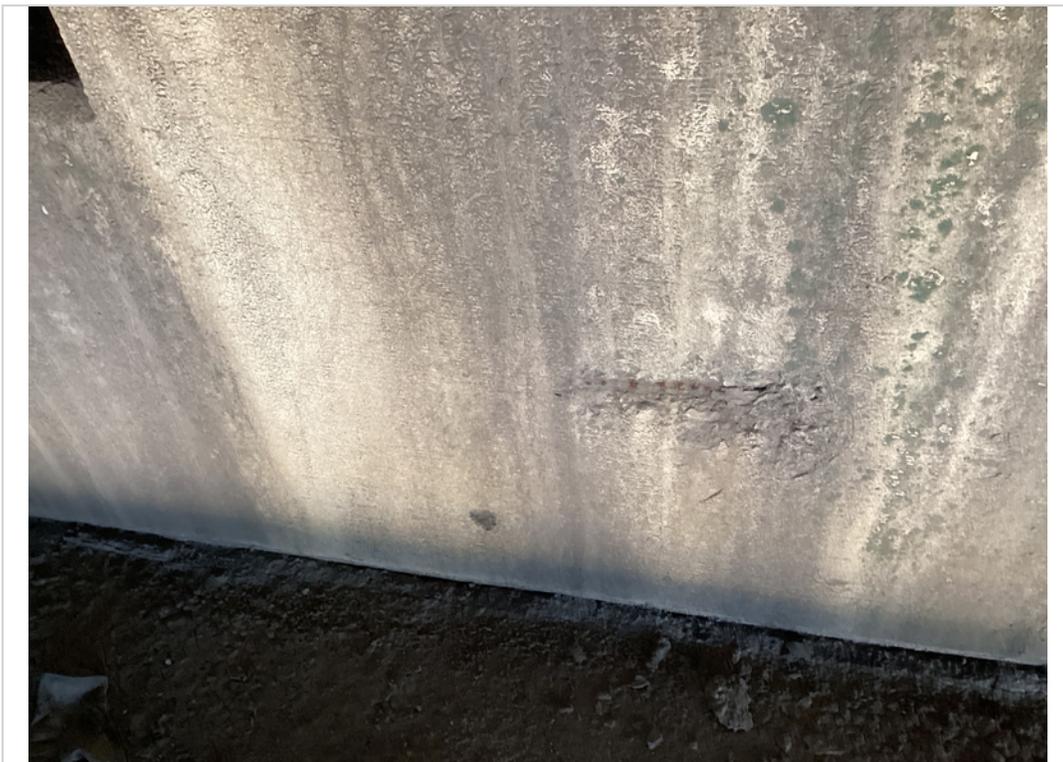
Abutment 2 cap spall with exposed steel

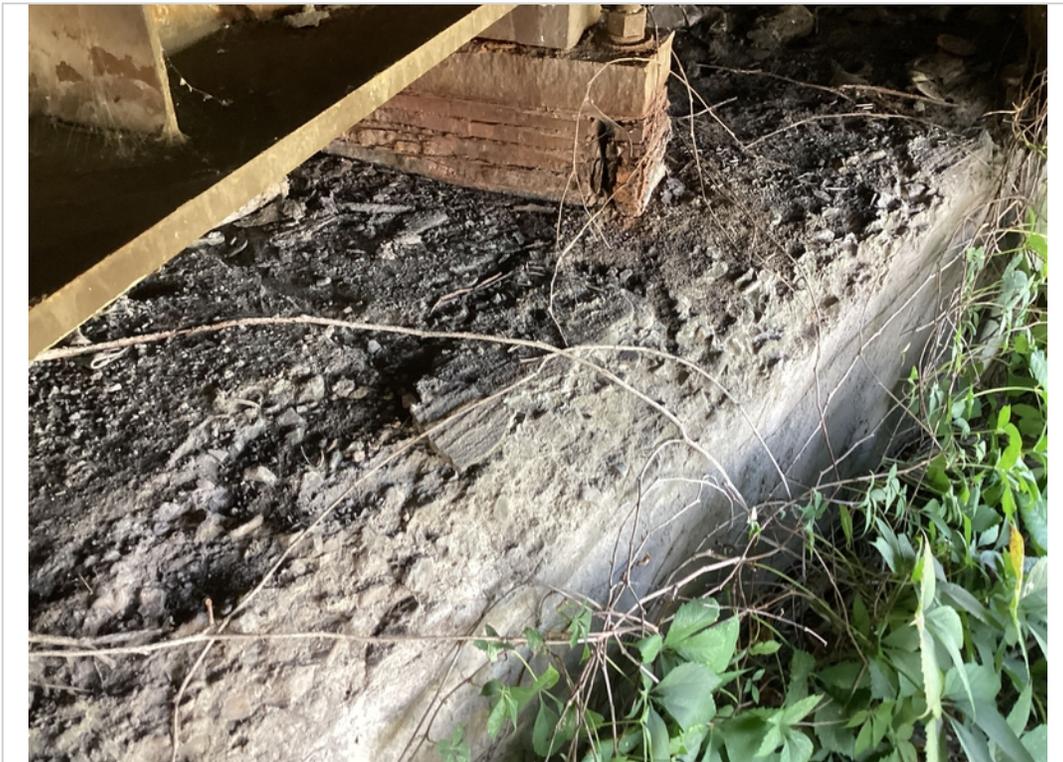
Abutment 2 scale

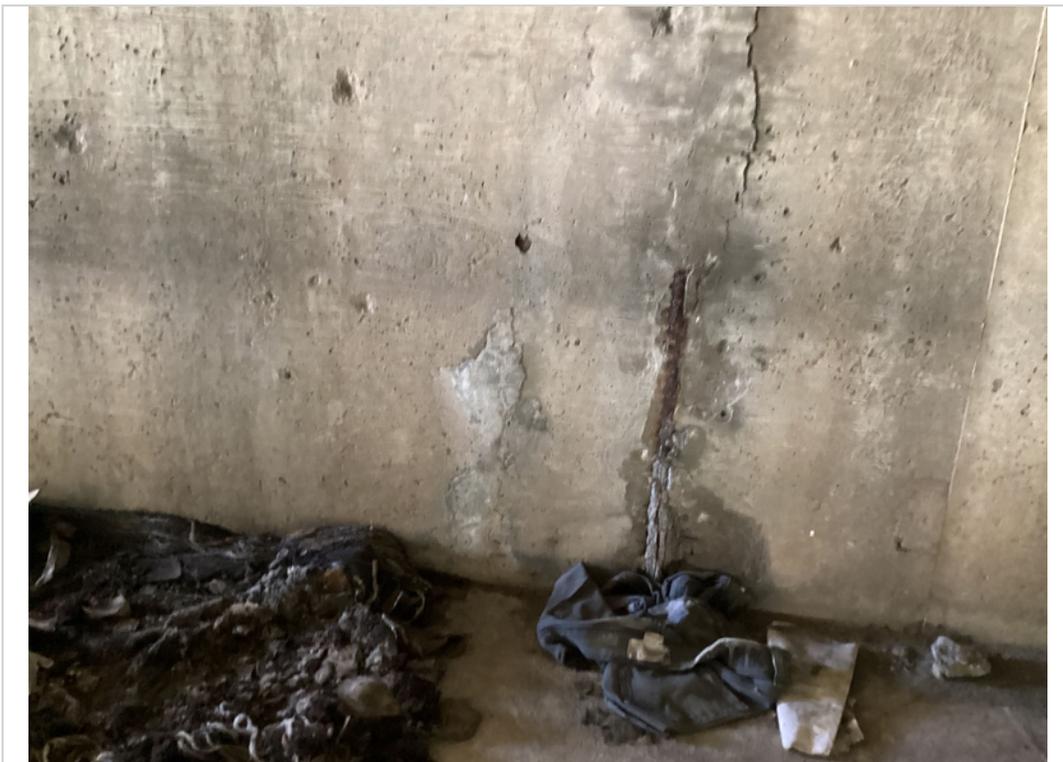
Abutment 2 backwall spall with exposed steel

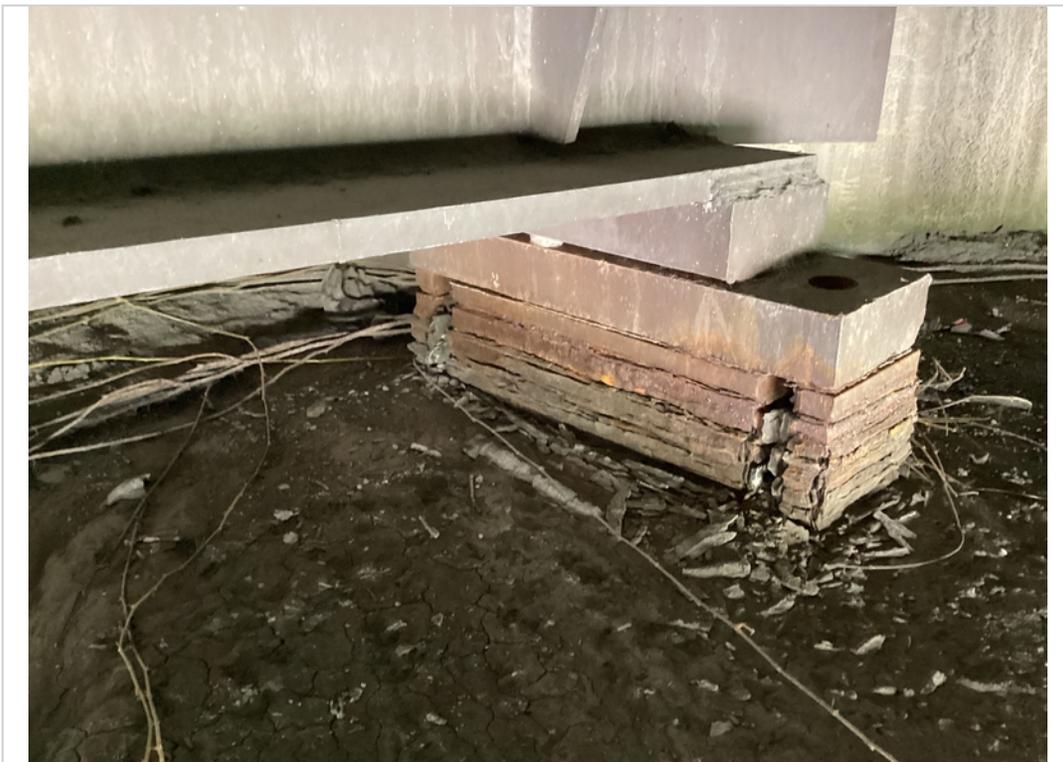
Abutment 2 bearings corrosion typical

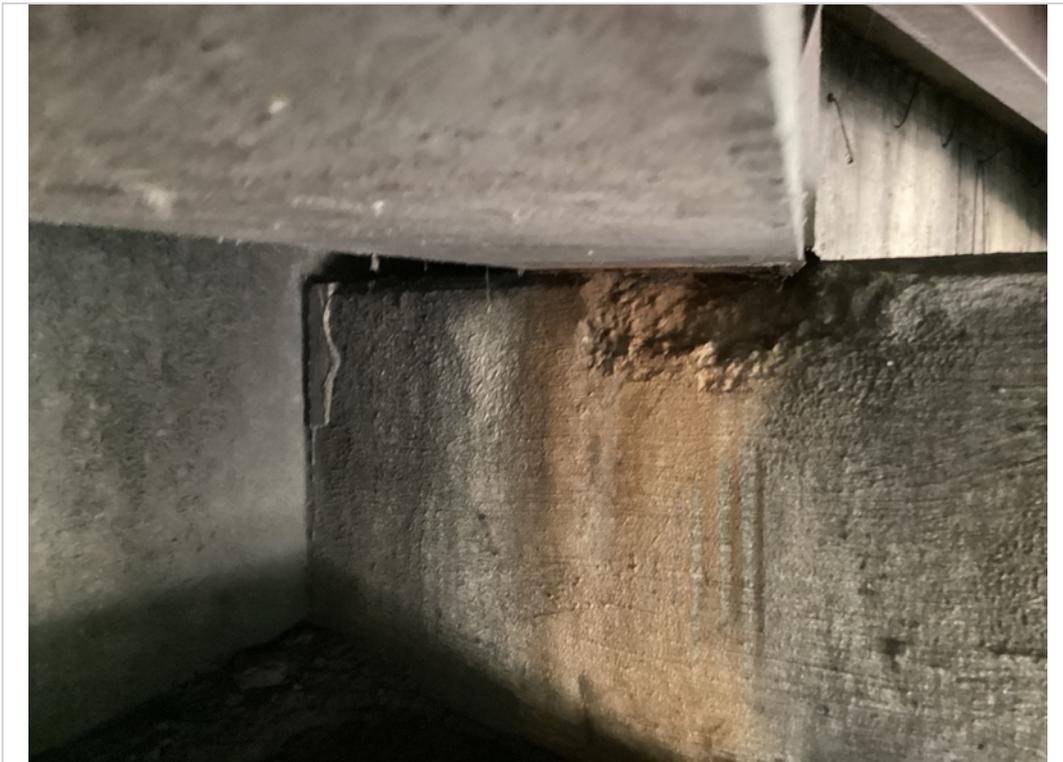
Riser K spall

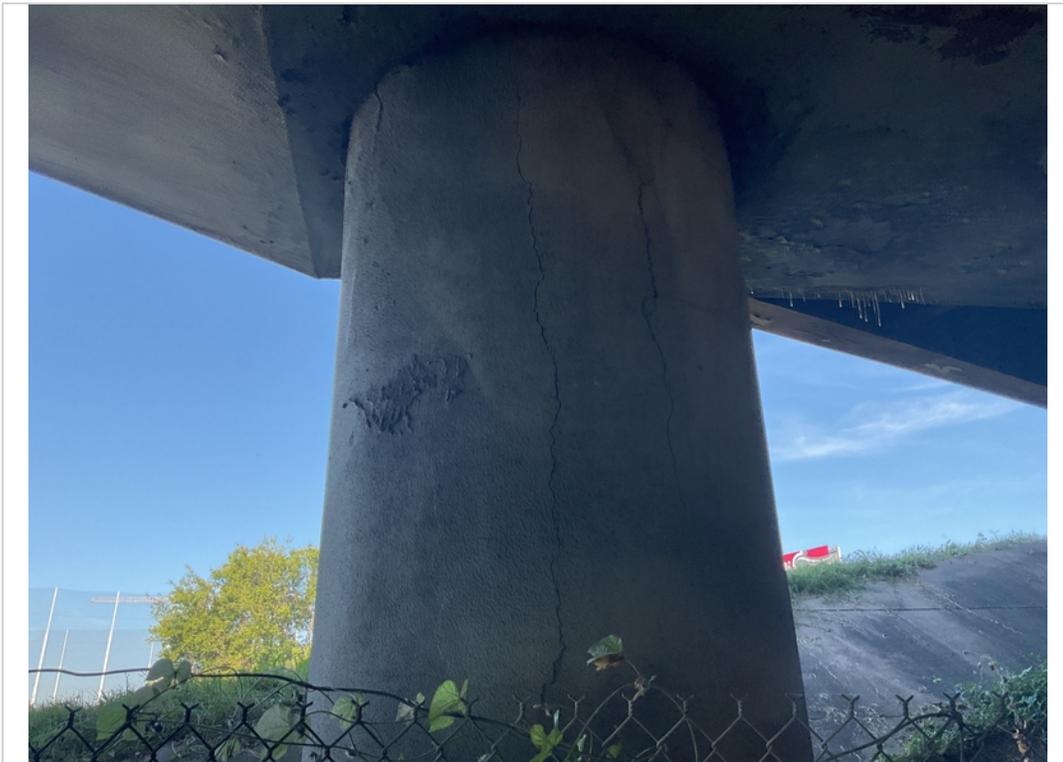
Bent 1 Column B h.c.

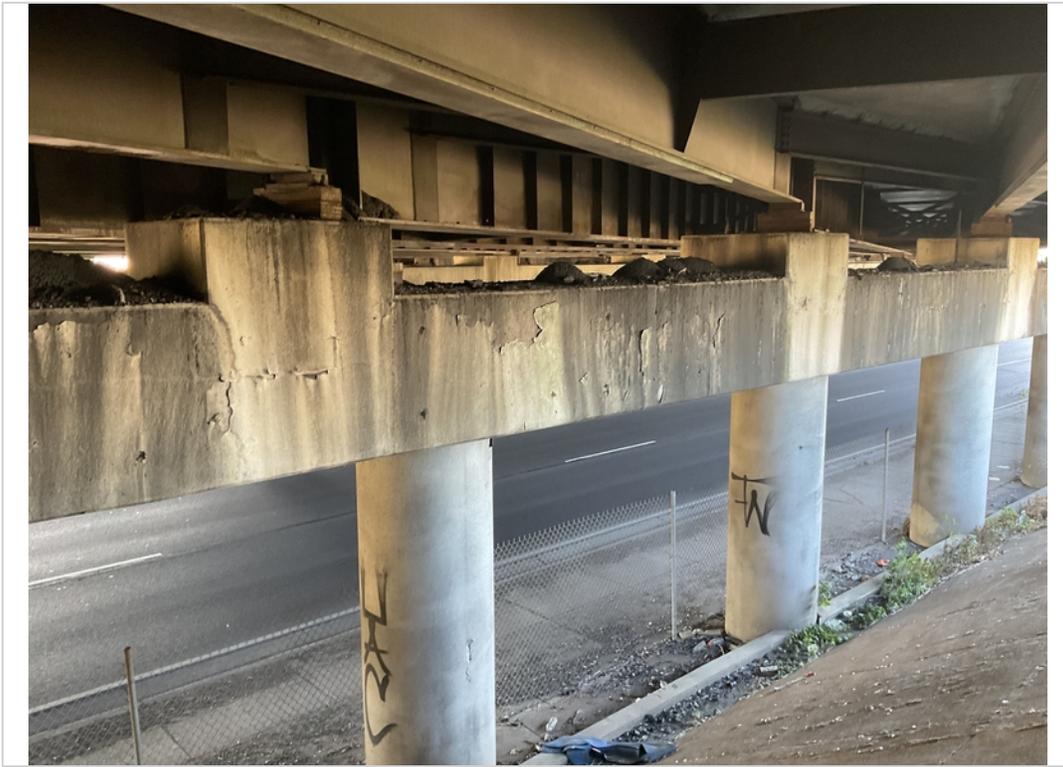
Bent 1 front texture coat peel
