I-24 Crossing I24 / NORTH FIRST ST

90 - LAST INSPECTION DATE 09/21/2021

IDENTIFICATION	
(1) State Names	47 - Tennessee
(8) Structure Number	19I00240107
(5) Inventory Route	1
(2) Highway Agency District	Region 3
(3) County Code	19 - Davidson

4 span Bridge / Cont. S.I.B
I-24 / North First Street

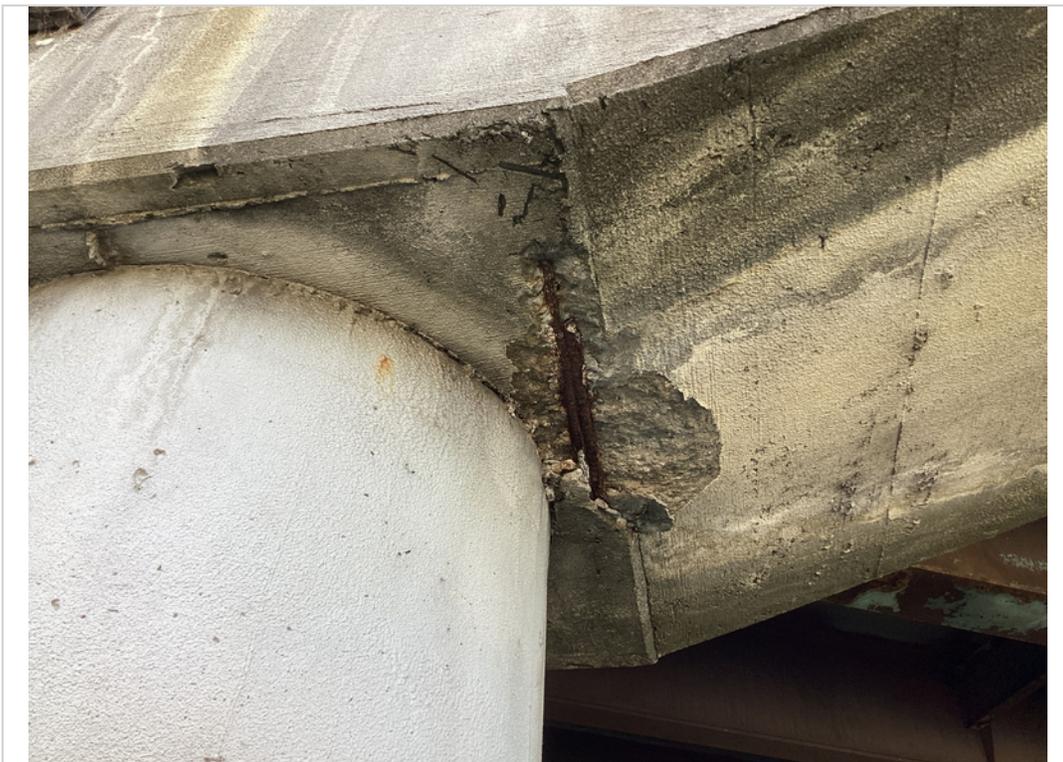
Bent 3 cap spall with exposed steel

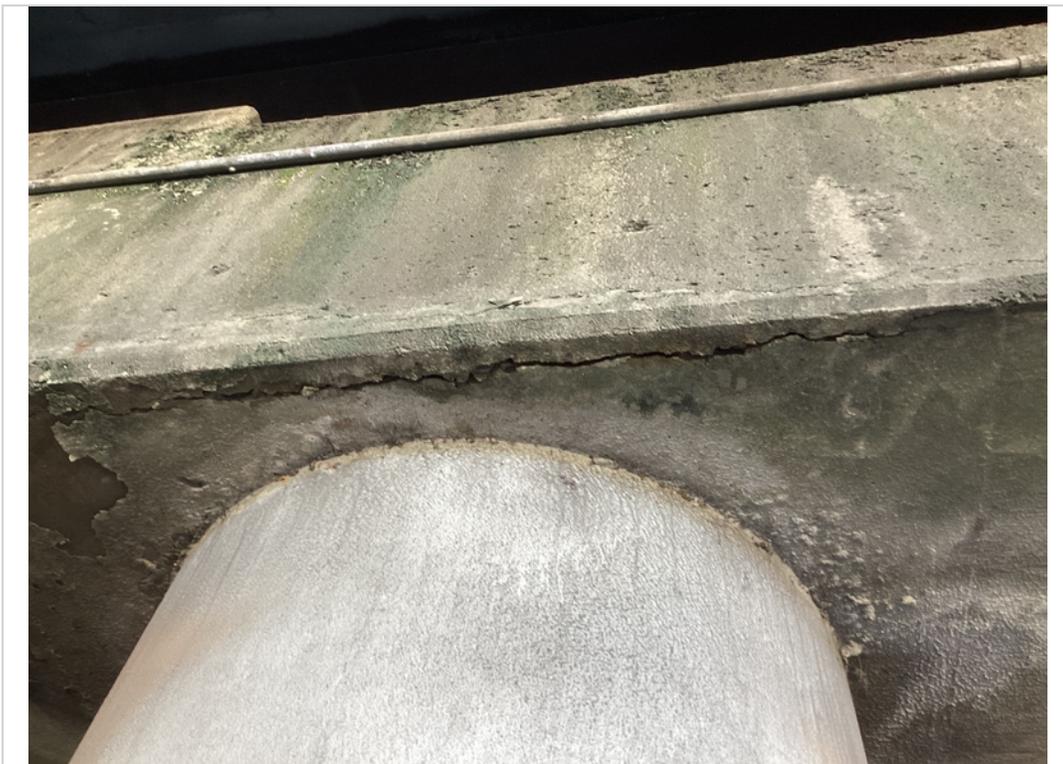
Bent 3 cap open crack

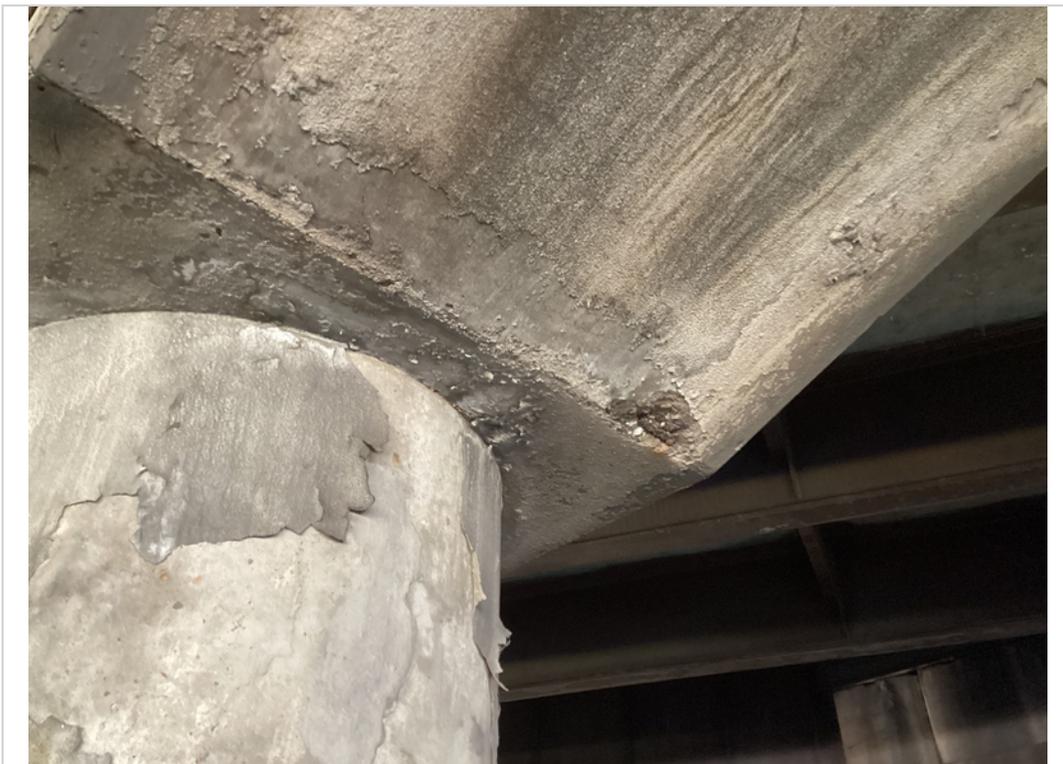
Bent 3 cap spall with exposed steel

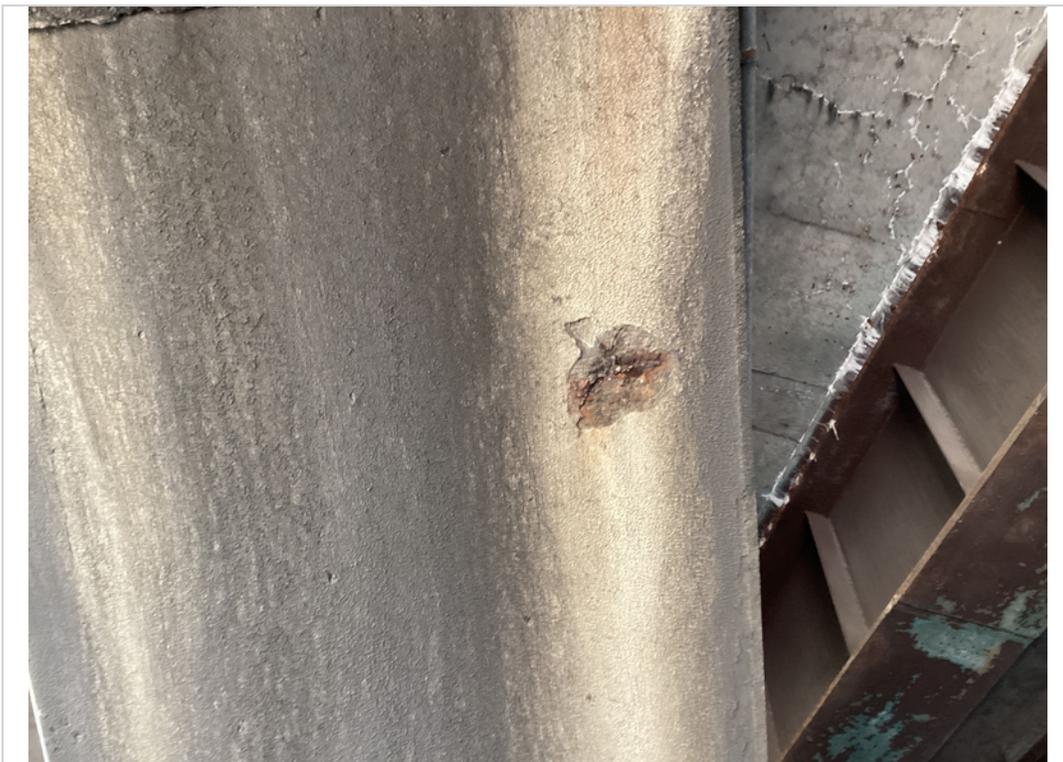
Bent 3 cap spall with exposed steel

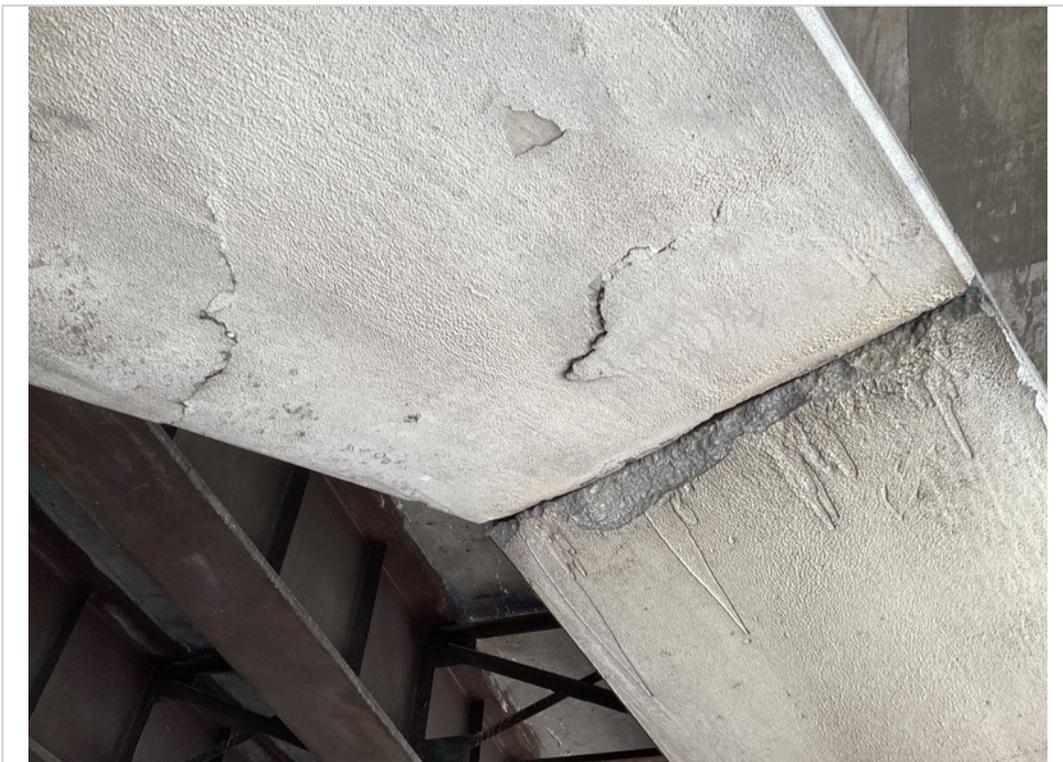
Bent 2 cap Inplace spalls scale

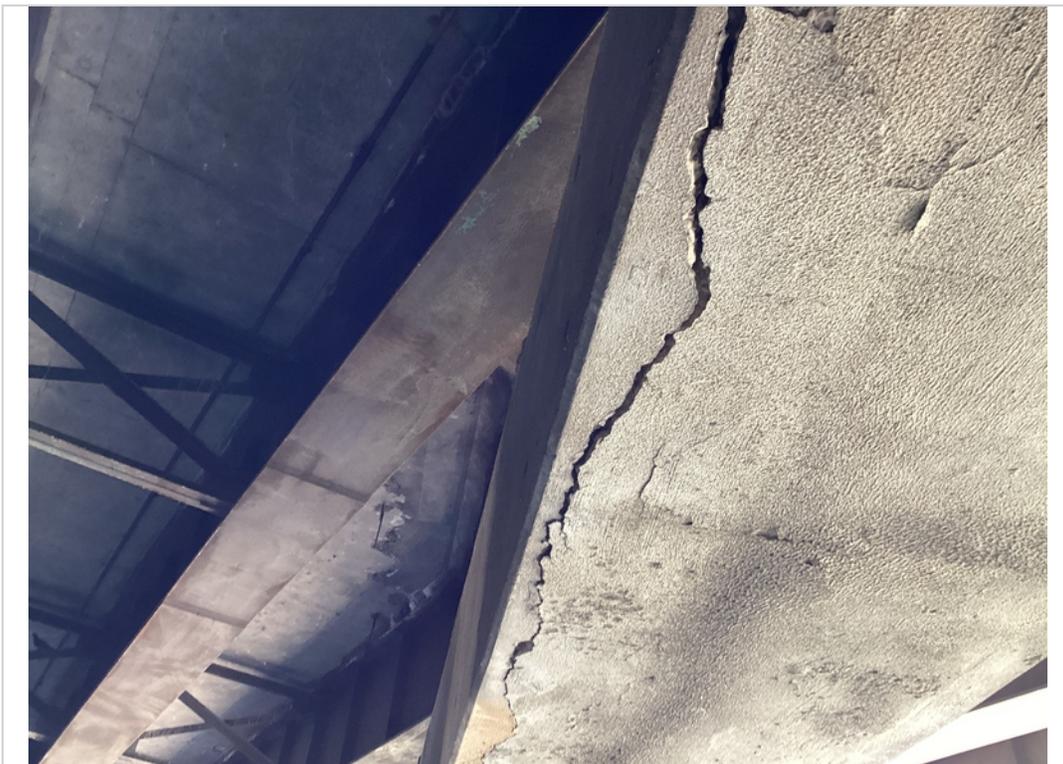
Bent 2 cap open crack

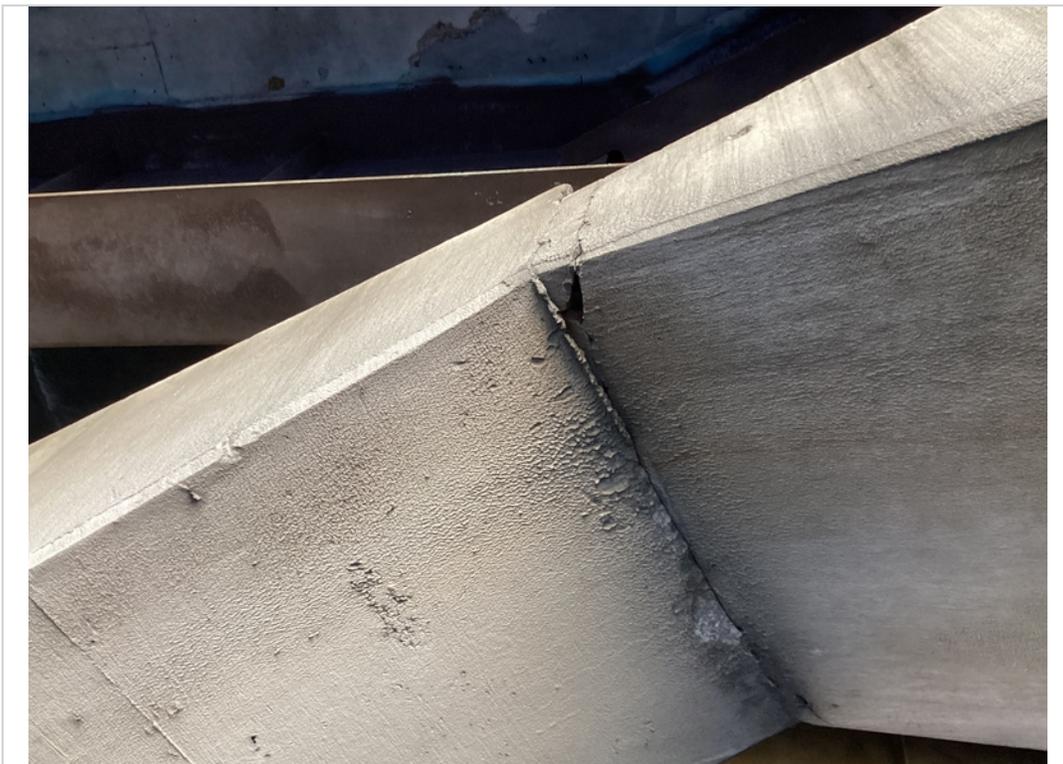
Bent 2 cap open crack at joint

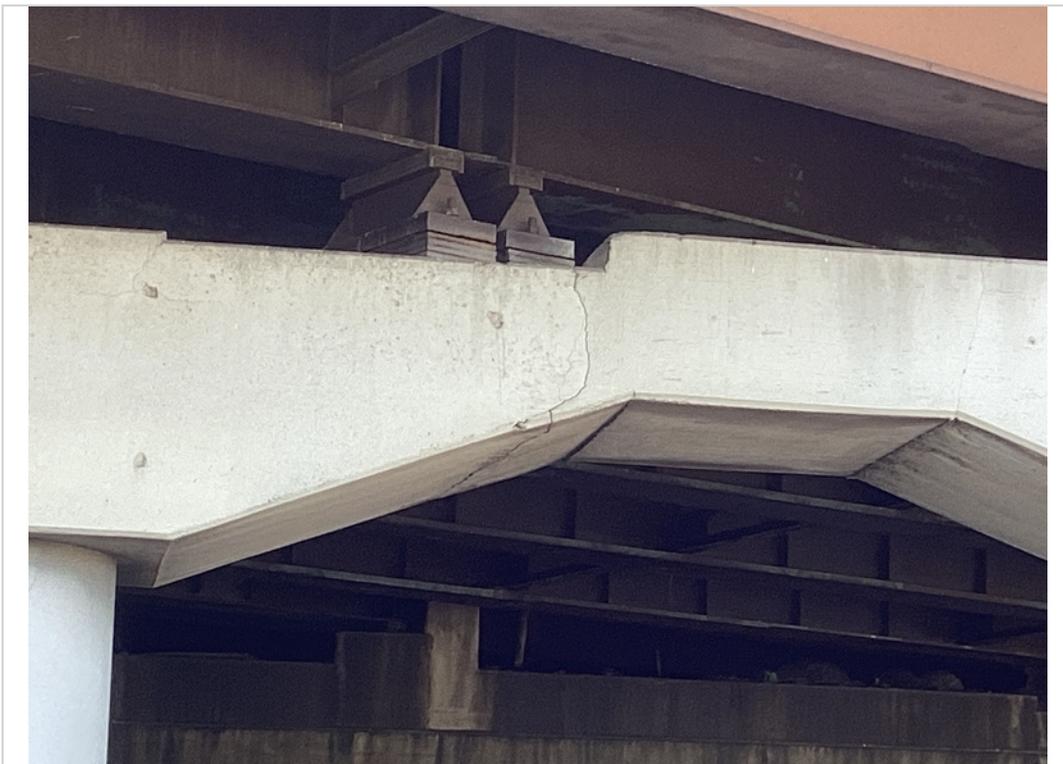
Bent 2 cap crack

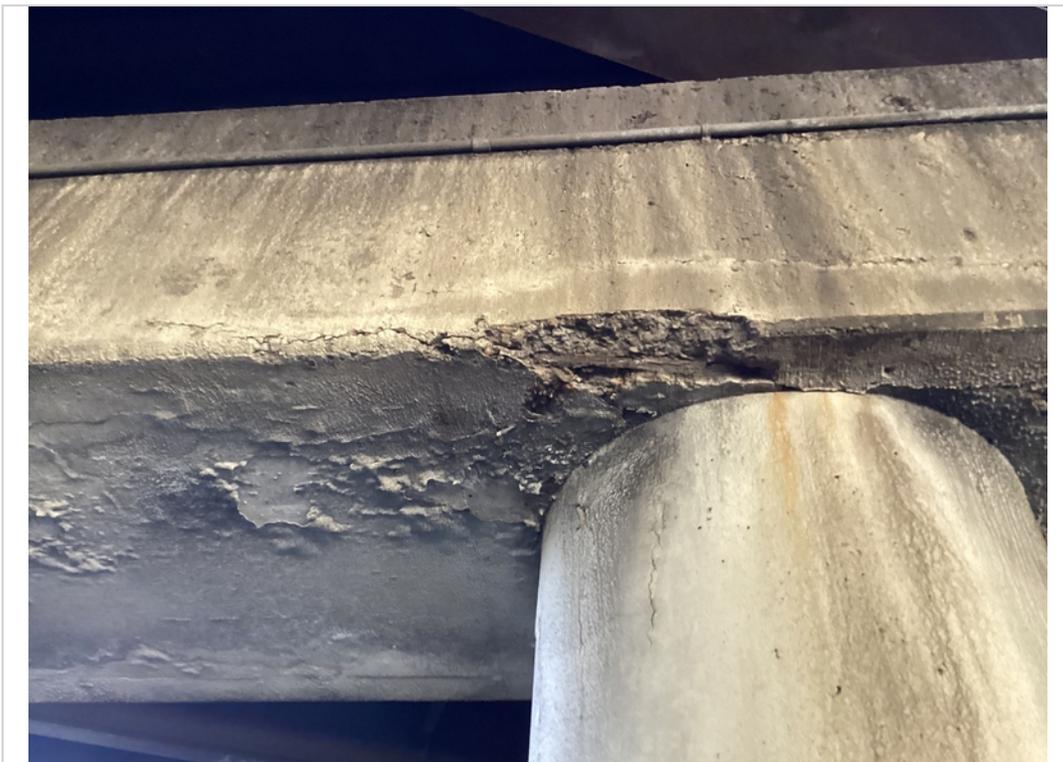
Bent 1 cap spalls with exposed steel

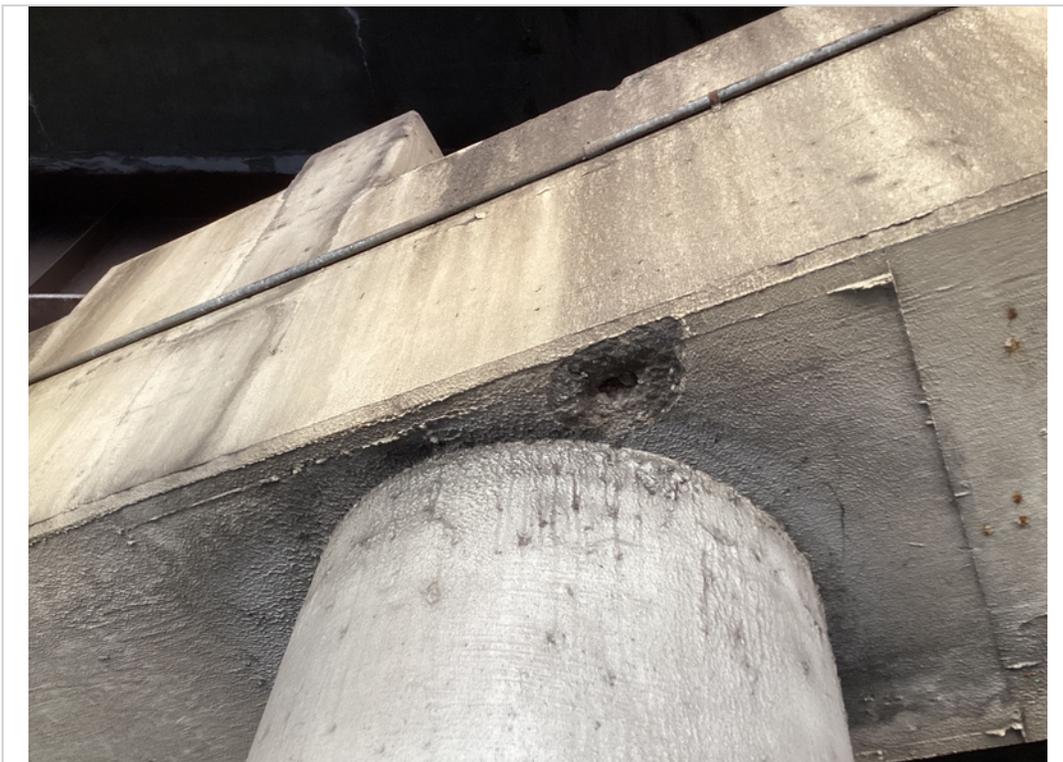
Bent 1 cap spall with exposed steel

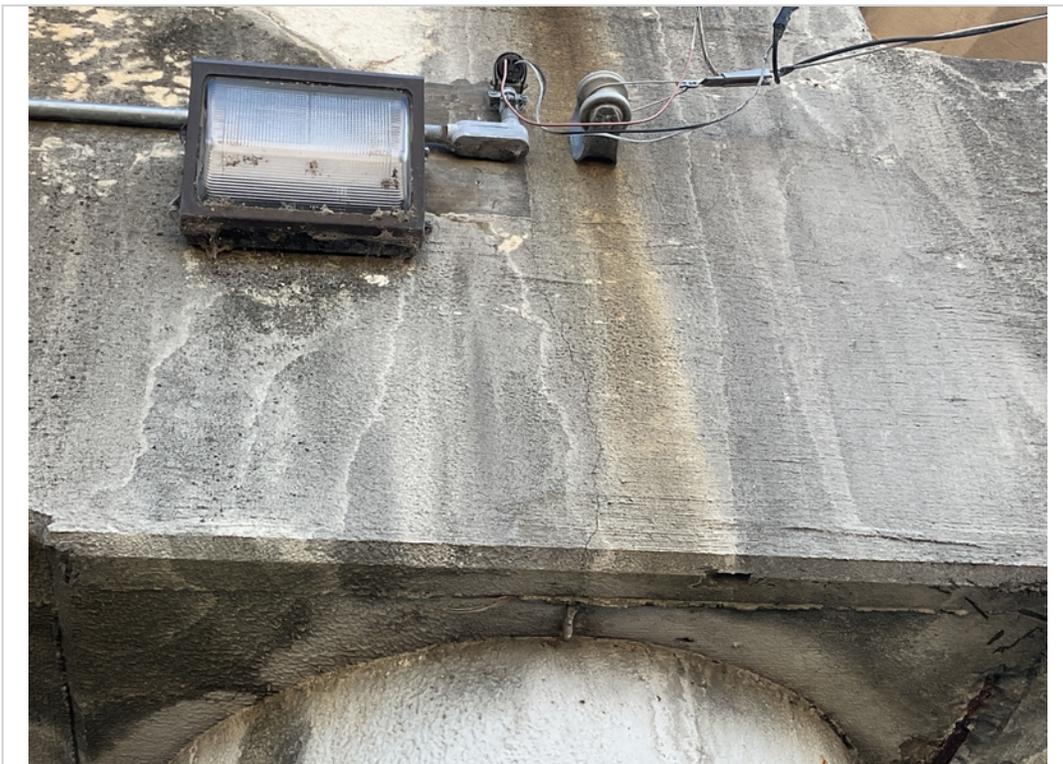
Bent 2 vert. H.C.

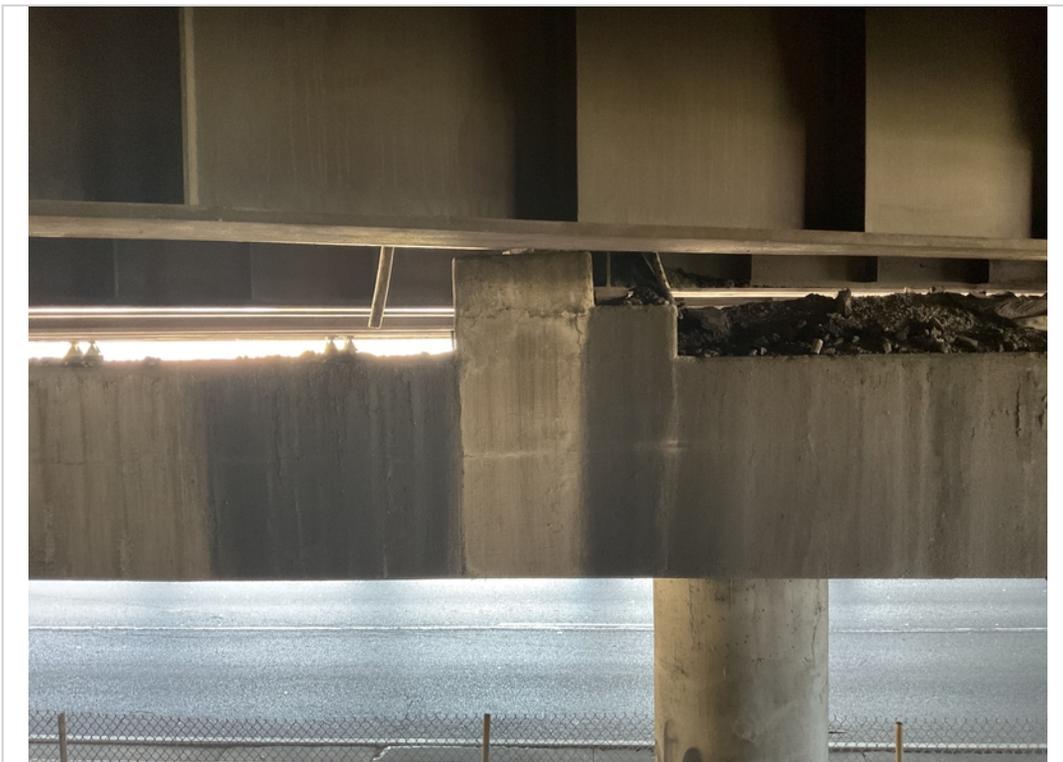
Bent 1 front map cracks

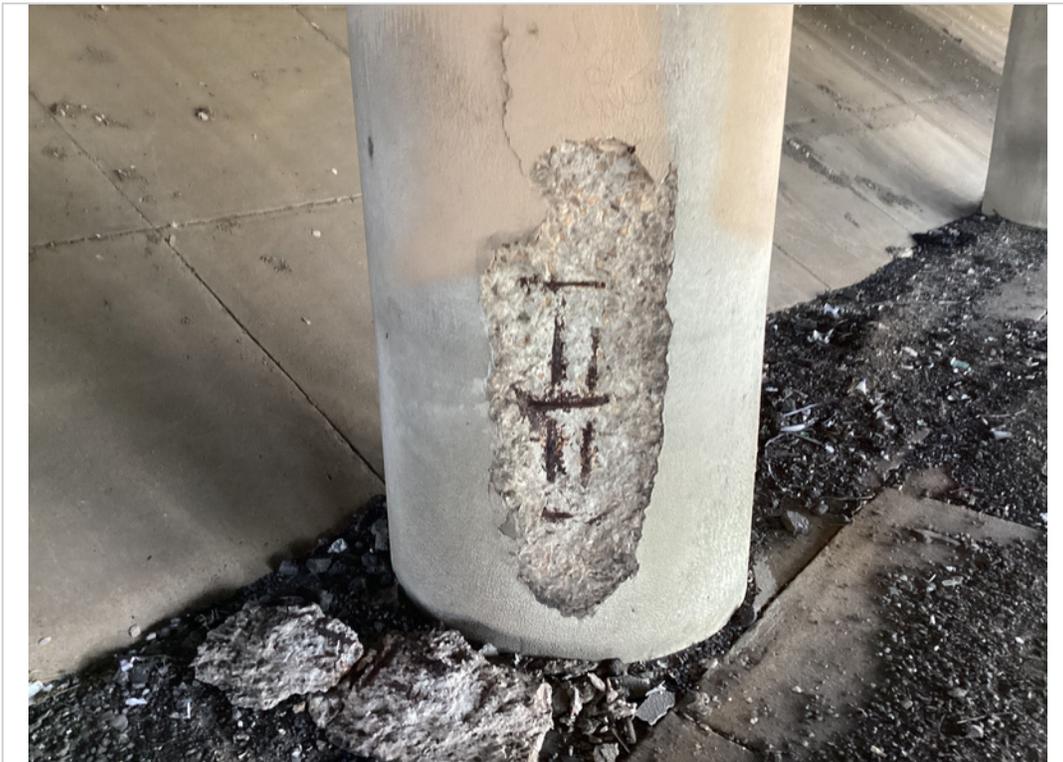
Bent 3 column H spall with exposed steel

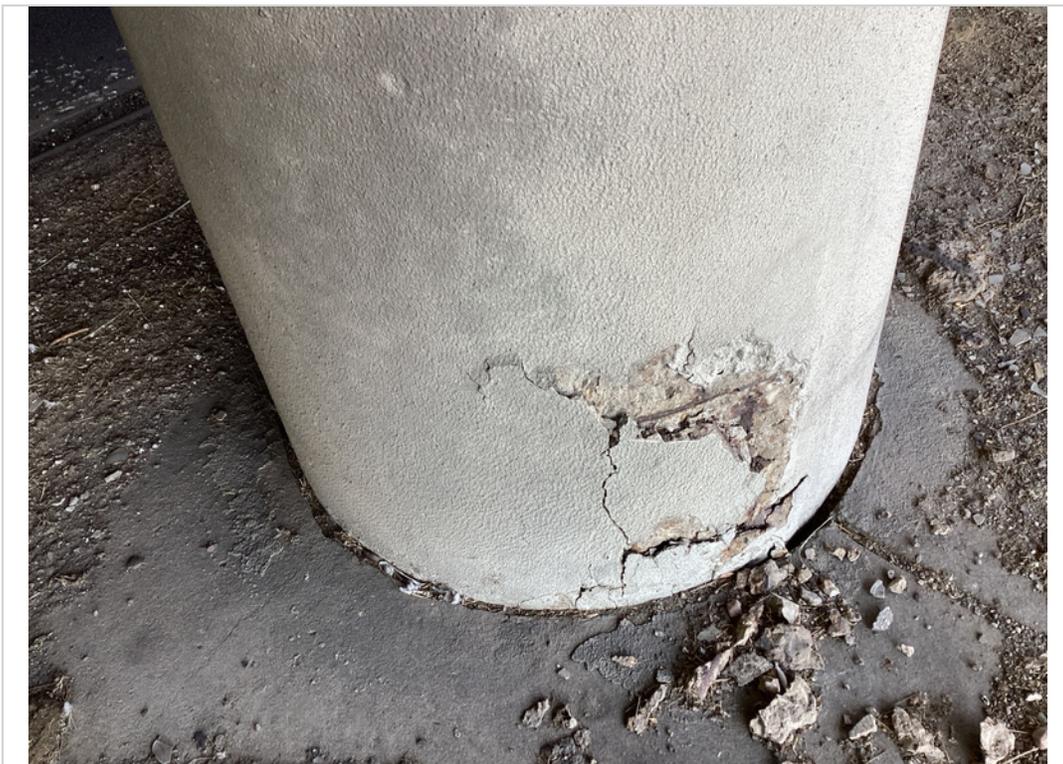
Bent 2 column D spall with exposed steel

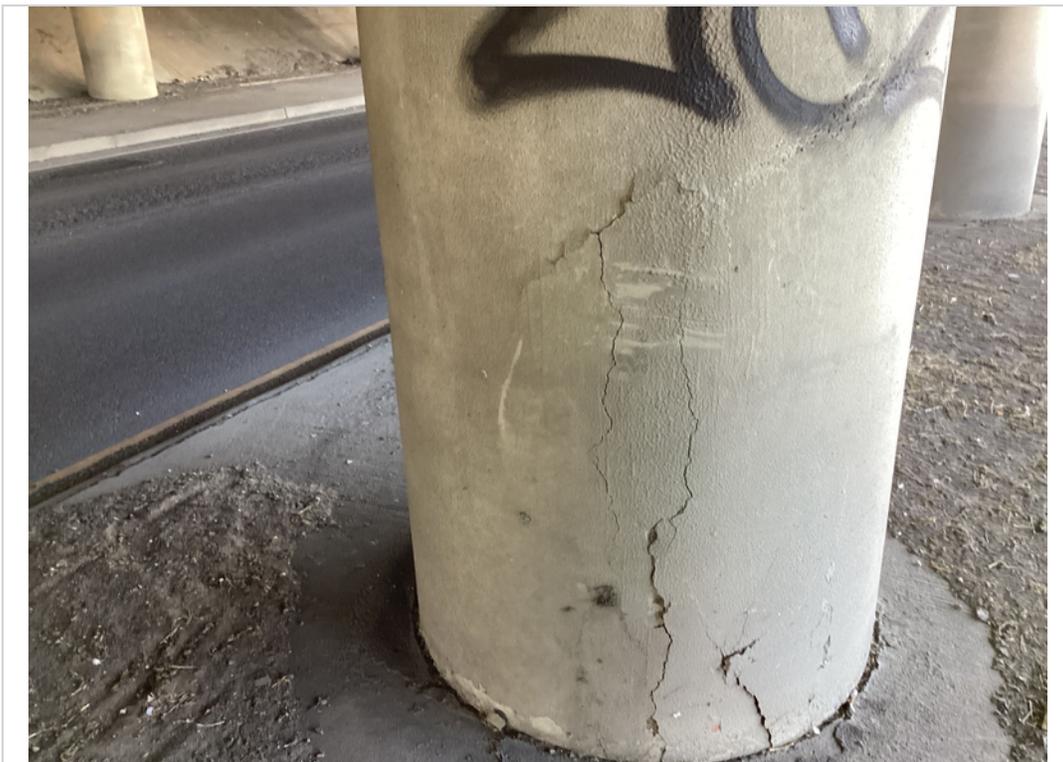
Bent 2 column M delamination

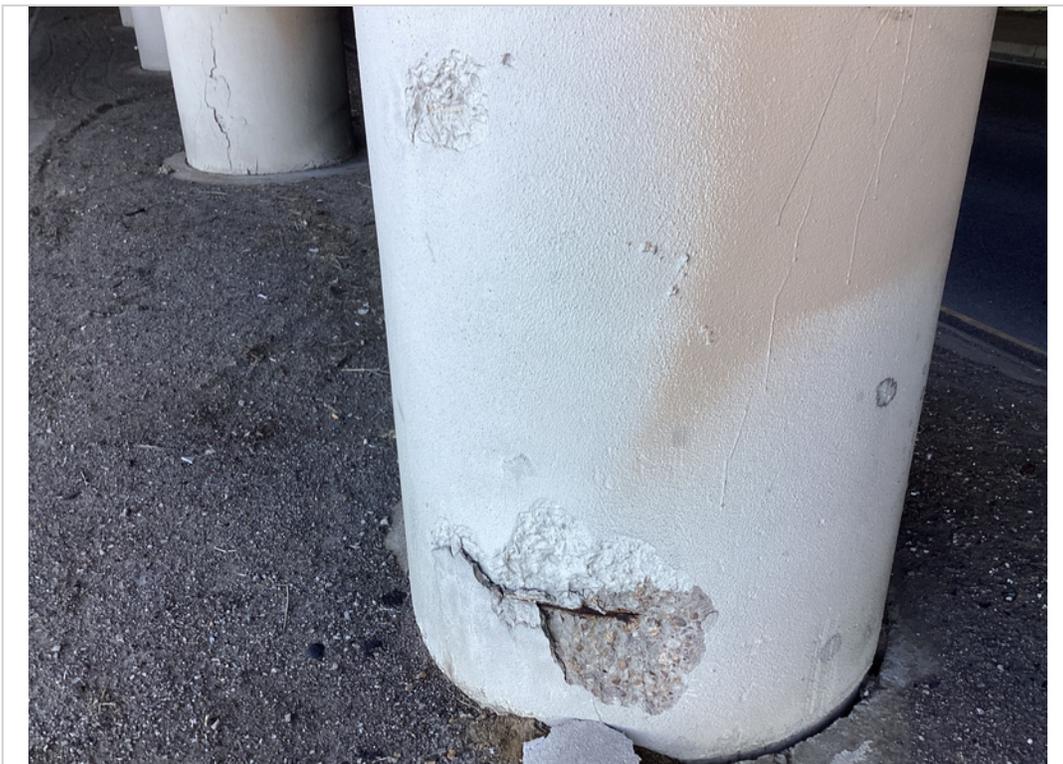
Bent 2 column P spalls with exposed steel

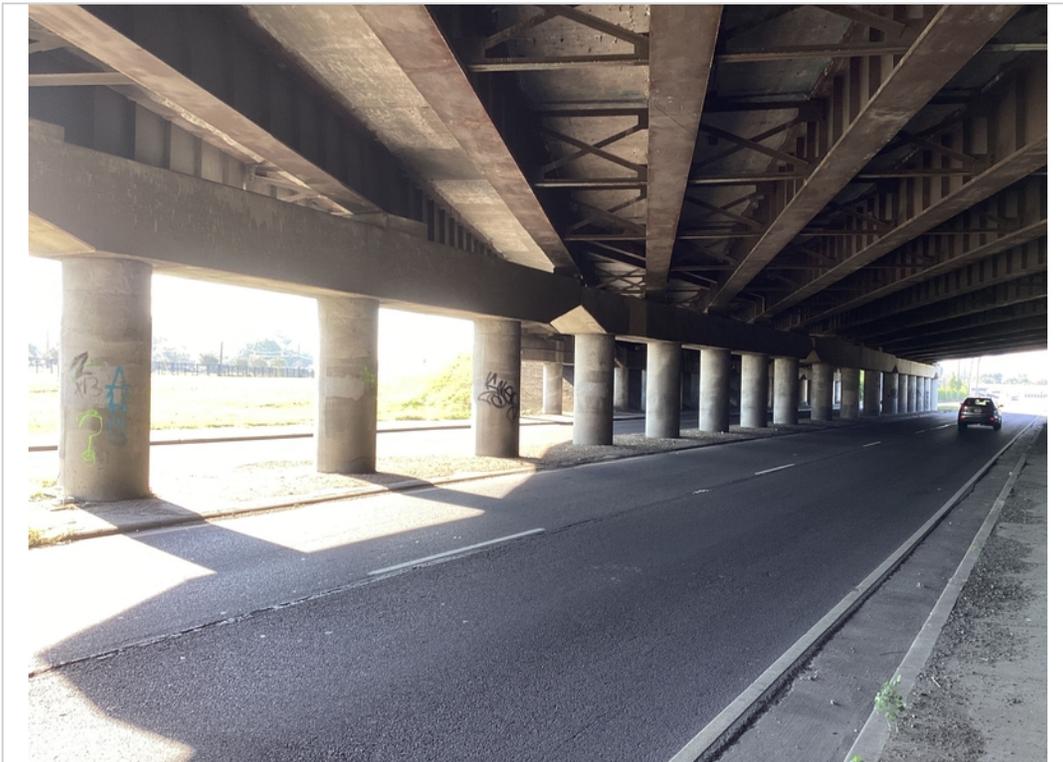
Bent 2 frontside

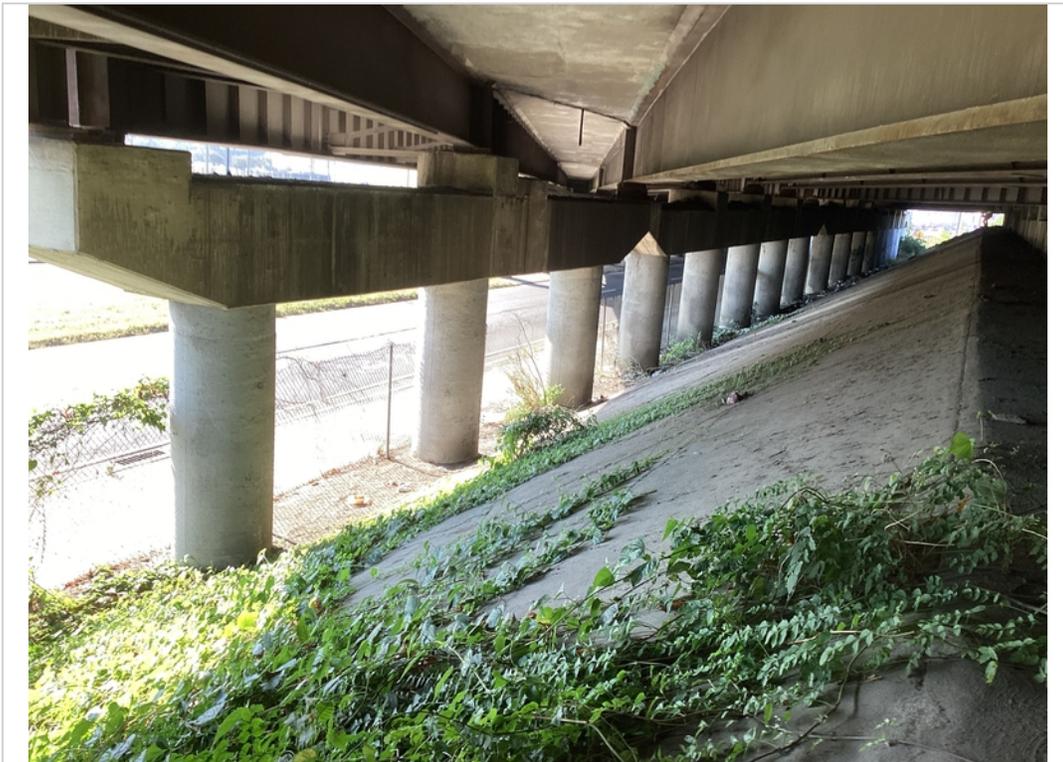
Bent 1 frontside

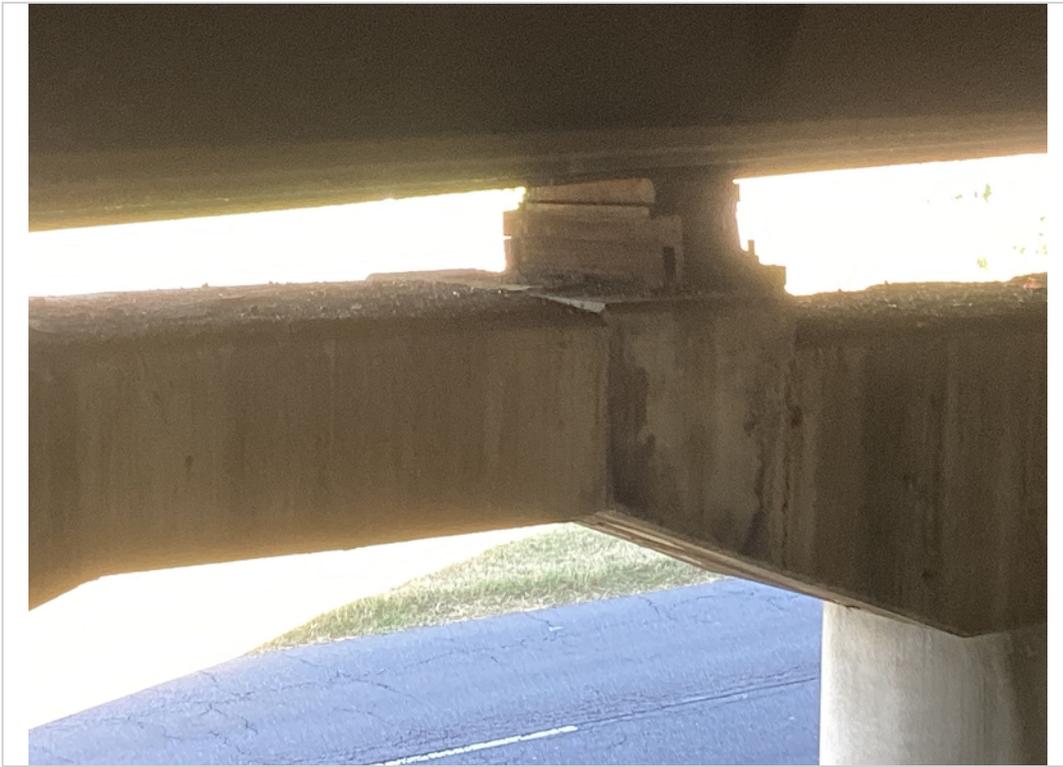
Bent 3 bearings typical

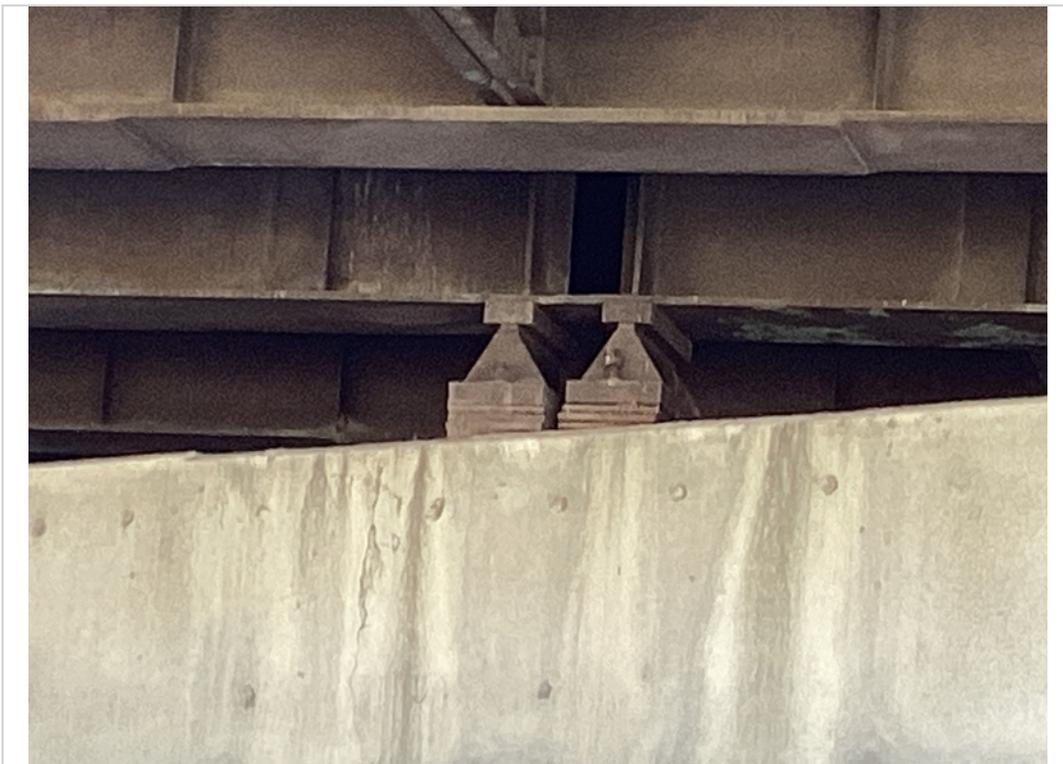
Bent 2 loose nuts on bearings typical

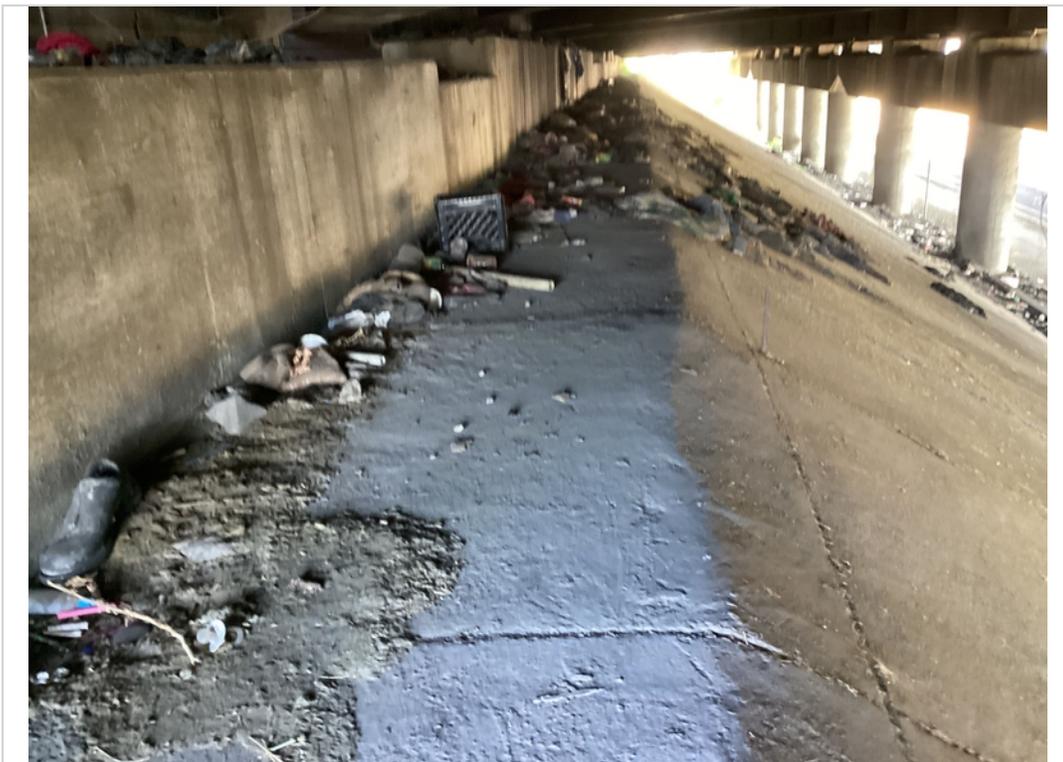
Abutment 1 trash

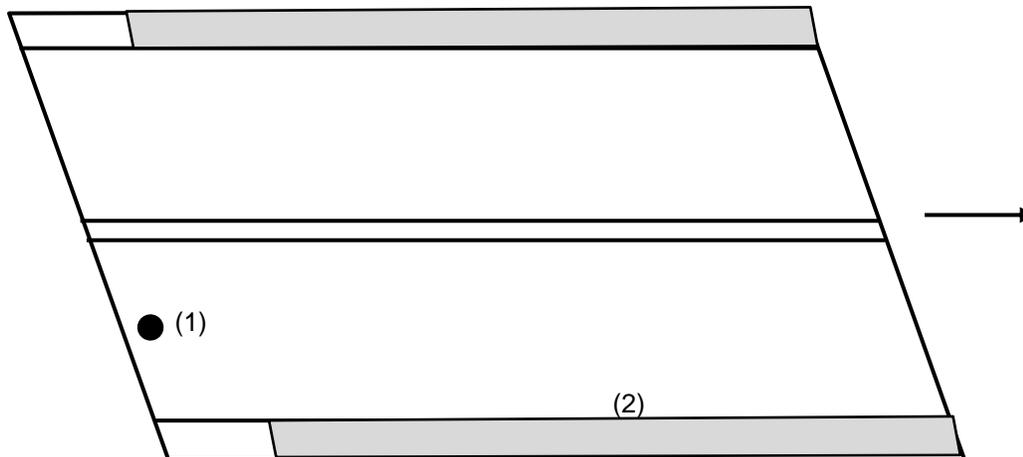
Approach 'B'

SLAB	NV	PAVED OVER
JOINT	NV	PAVED OVER
PAVEMENT	FAIR	(1) POTHOLE 1.5'D x 3"DP
EMBANKS	GOOD	
DRAIN	GOOD	LT. ONLY
G. RAILS	GOOD	(2) LGT IMPACT DMG
PARAPETS	GOOD
