I-65 Crossing I65 / SR106 & HARPETH RV

90 - LAST INSPECTION DATE 02/14/2025

| IDENTIFICATION | |
|---|---|
| (8) Structure Number | 94I00650006 |

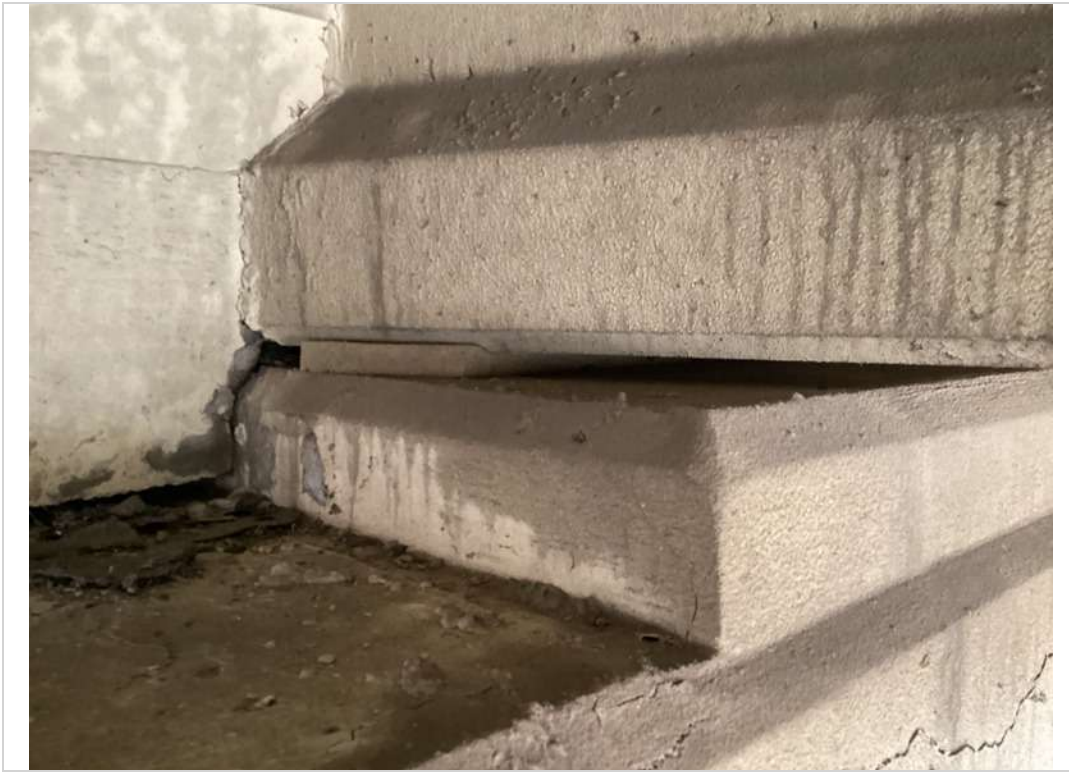
Abutment 1 bearing typical

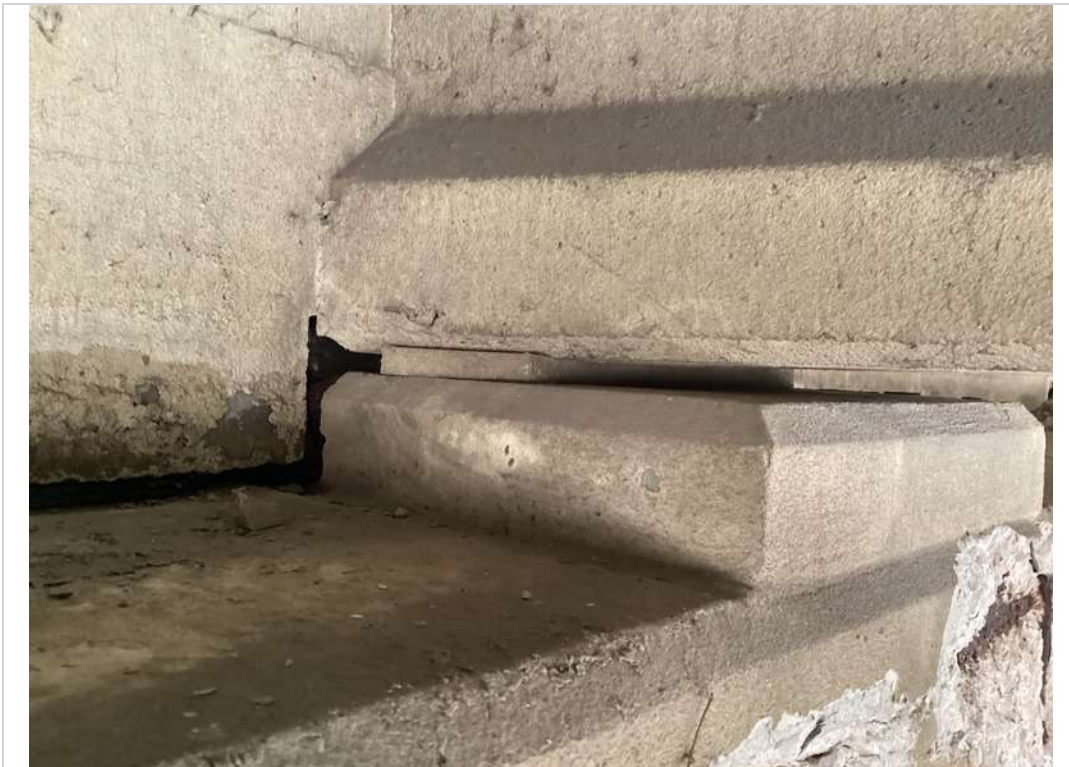
Abutment 2 bearing typ
