## Hamilton County

### Regular Inspection Report

Location: 33-I0075-01.91

4 Span Bridge

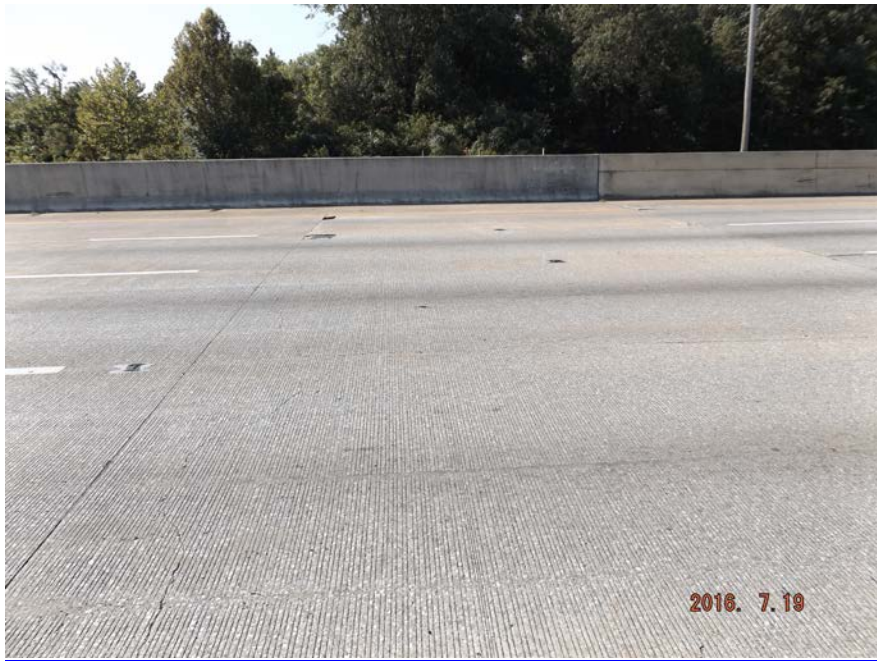
APPROACH 1 - SB

Approach Pvm:	POOR	Approach 1 - Left/Right potholes
Deck - Wearing Surface:	FAIR	NUMEROUS NARROW CRACKS. SPALL.

<b>SUGGESTED ROUTINE MAINTENANCE AND COMMENTS</b>
CLEAR DRAINS IN SPAN NO. 4 , RT.
Approach 1 - SBL - Repair potholes
CLEAR APPROACH DRAINS
REPAIR BRIDGERAIL ON RIGHT SIDE OF SPAN NO.2, 3 & 4.

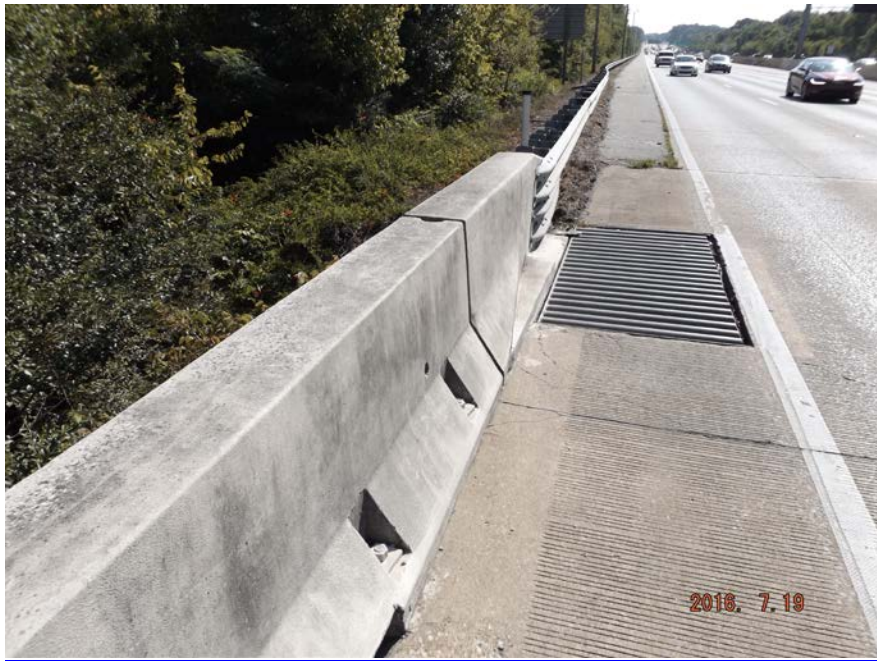
TRAFFIC SAFETY FEATURES

Bridge Rail:	POOR	STANDARD	SIGNIFICANT DAMAGE AT RIGHT SIDE
Transitions:	FAIR	NONSTANDARD	METAL BLOCKS
Approach Rail:	FAIR	NONSTANDARD	METAL BLOCKS
Terminals:	FAIR	NONSTANDARD	> 100' from bridge end
